THE ERZINCAN, TURKEY EARTHQUAKE OF 13 MARCH 1992

A FIELD REPORT BY EEFIT

EEFIT

SYNOPSIS

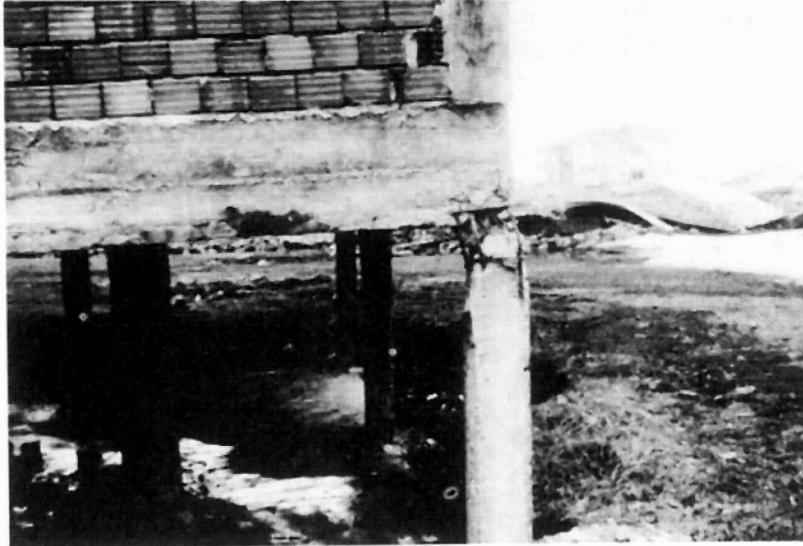
Plate 4.1

Detail of three storey RC frame apartment building with masonry infill panels and a soft storey at ground floor level, still under construction. Note the poor reinforcement detailing and the slenderness of the column in comparison with the perimeter beam. A similar building which collapsed completely can be seen in the background.

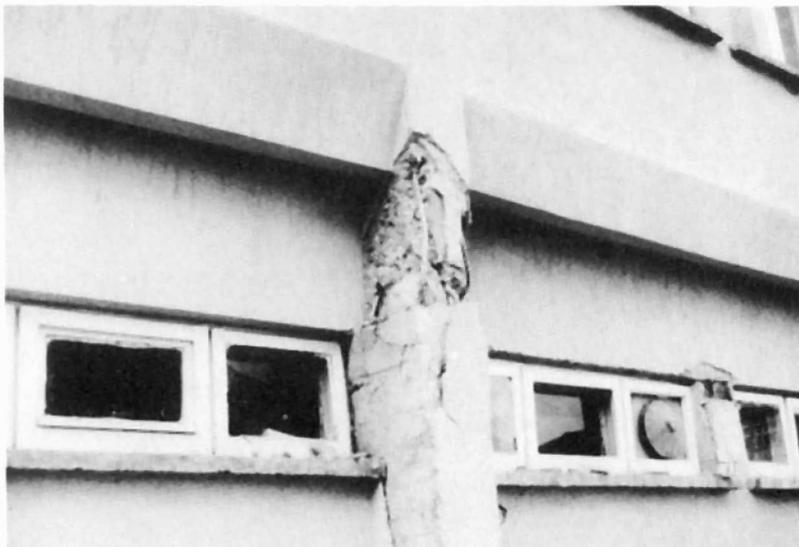
Plate 4.3

- inadequate number and size of stirrups, and in some instances complete lack of confining reinforcement (Plate 4.3);
- short columns, especially in buildings with semi-basement and industrial structures with windows spreading between columns, and also in some hospital buildings (Plates 4.3);

Inadequate column reinforcement. The longitudinal bars are made of mild steel and there is no lateral reinforcement. This plate also illustrates the short column effect.

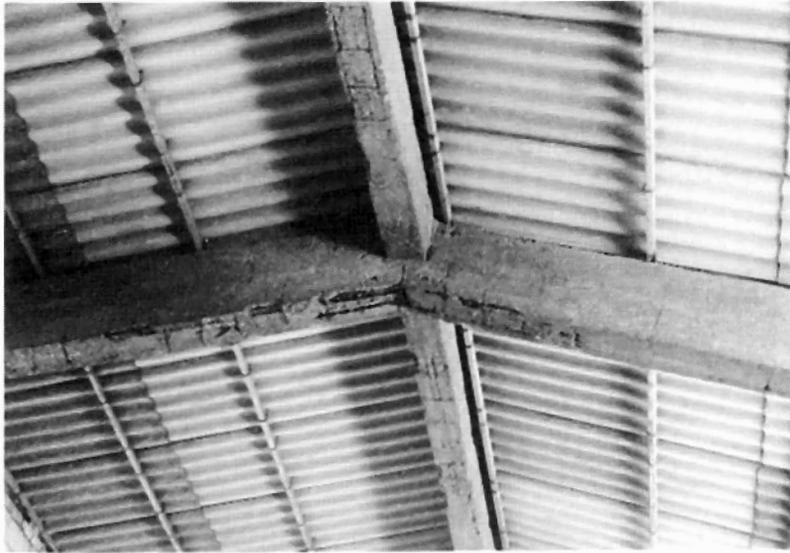
Plate 4.4

- insufficient cover to reinforcement - rusted reinforcing bars were frequently visible, especially near crucial joints; this deficiency was noted in both damaged and intact structures, e.g. Plate 4.4;

Roof of cattle shed at meat processing plant. Insufficient cover and poor compaction has resulted in corrosion of the reinforcement. Other sections of this roof collapsed completely (see Plate 4.22).

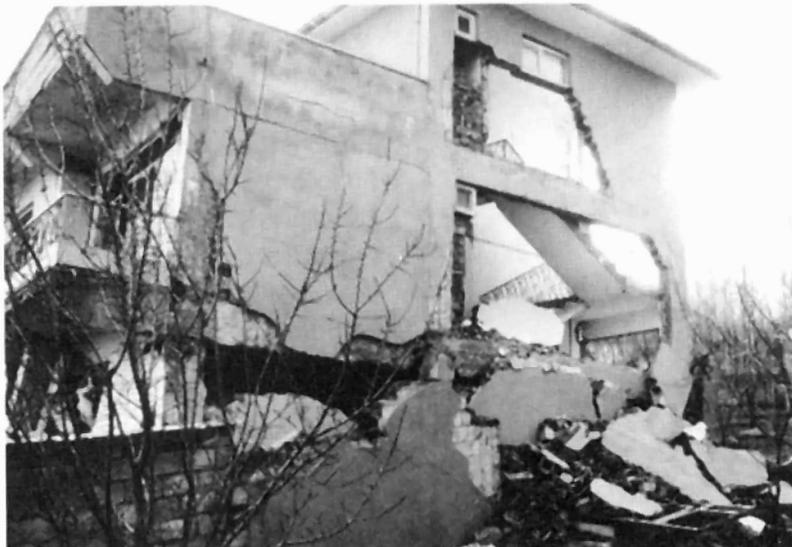
Plate 4.6

- Cases of *torsional failure* were also observed, especially in corner buildings. This mode may be caused by: a significant number of openings in street facing facades; eccentric positioning of staircases; variations in the amount of openings from floor to floor; or a combination of these factors (Plate 4.6).

Four storey RC frame which has lost its bottom two floors. Torsional loads are introduced by the top floor covering only half the plan area of the structure, and the staircase located at the back corner. *Location: Ulalar.*

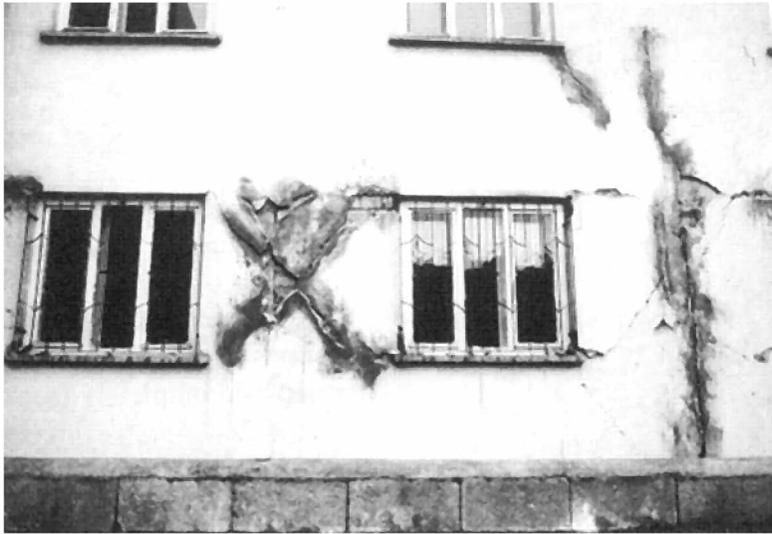
Plate 4.7
Poorly repaired structure,
the original damage
probably caused by 1983
earthquake. *Location 4.*

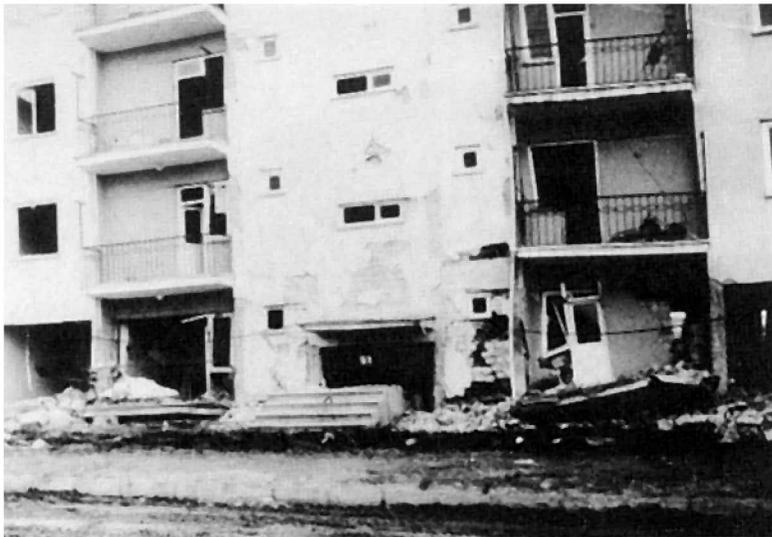
Plate 4.8
Bottom-top collapse,
starting from ground floor
level, with all the floors
above surviving. Notice the
detached entrance staircase.

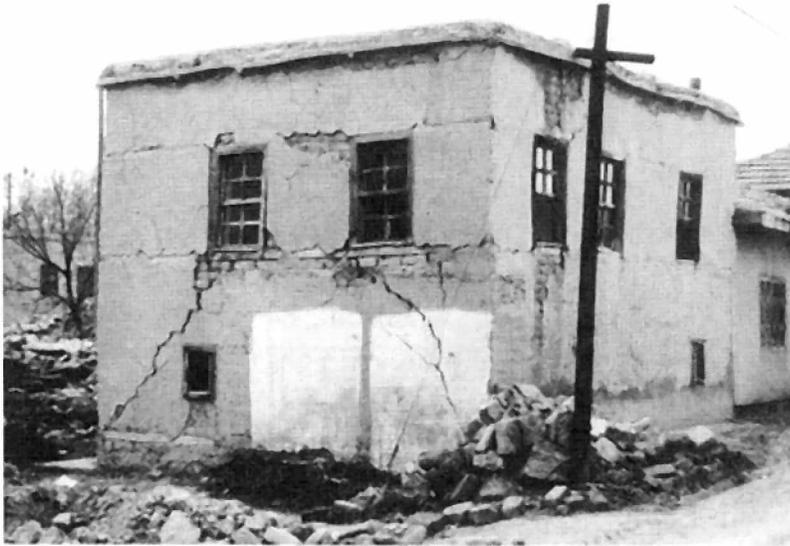
Plate 4.19
Traditional adobe house reinforced by timber hatils at the top and bottom of the windows. *Location: Altinbasak.*

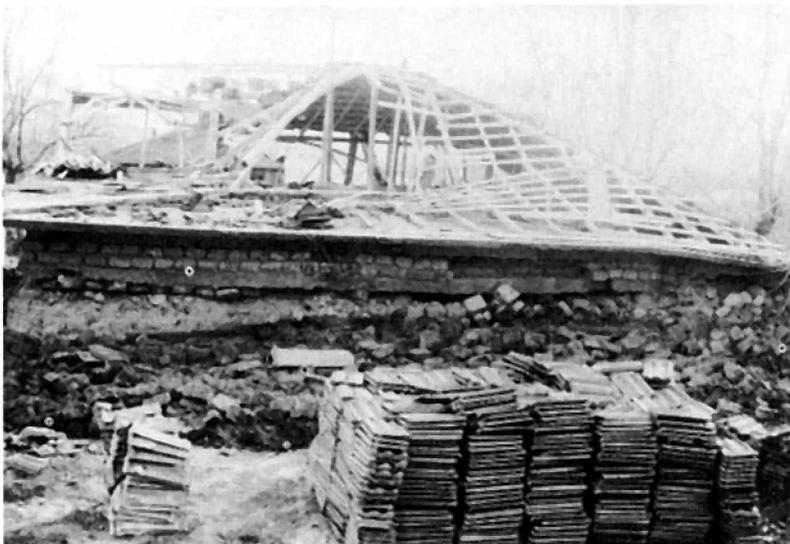
Plate 4.21
Collapse of a single storey adobe house with concrete ring beam. The roof was heavier than that in Plate 4.20, as it was clad with clay tiles. *Location: Yalnizbag.*

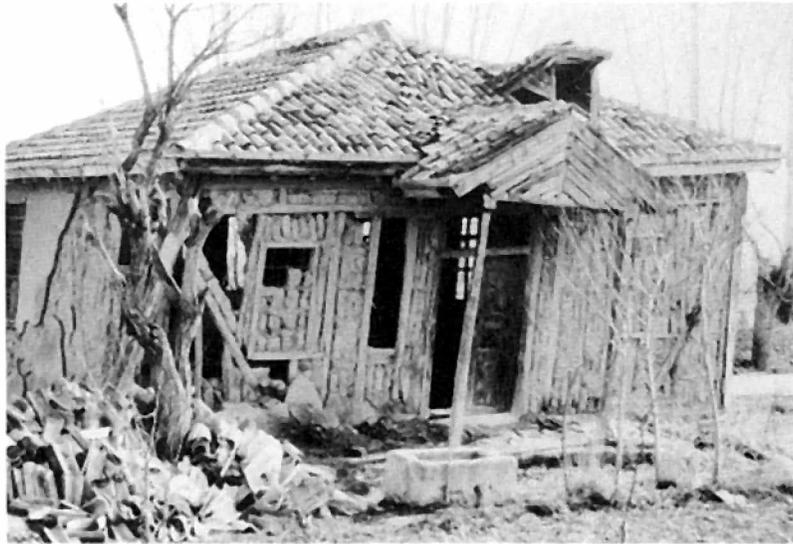
Plate 4.22

Severely damaged himis house. Two single storey concrete block masonry houses next to it collapsed. *Location: Calabzur.*

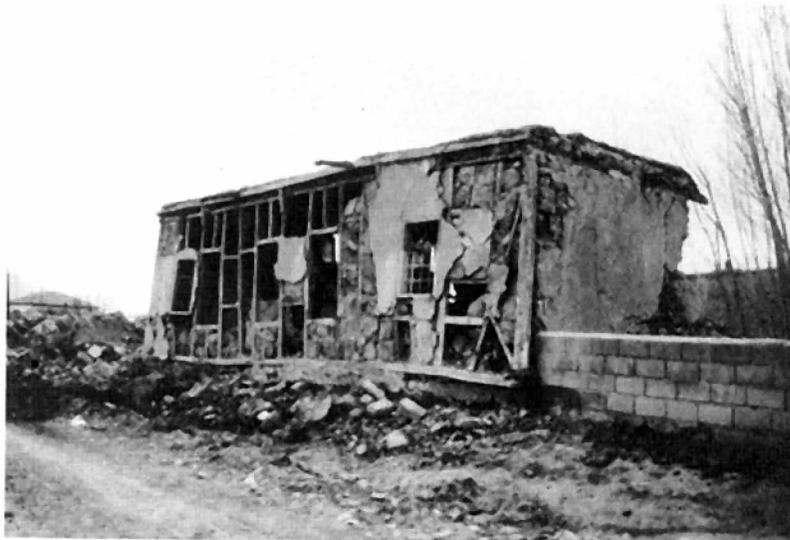
Plate 4.23

Shattered himis building, twisted and leaning, but still standing. *Location: Altinbasak.*

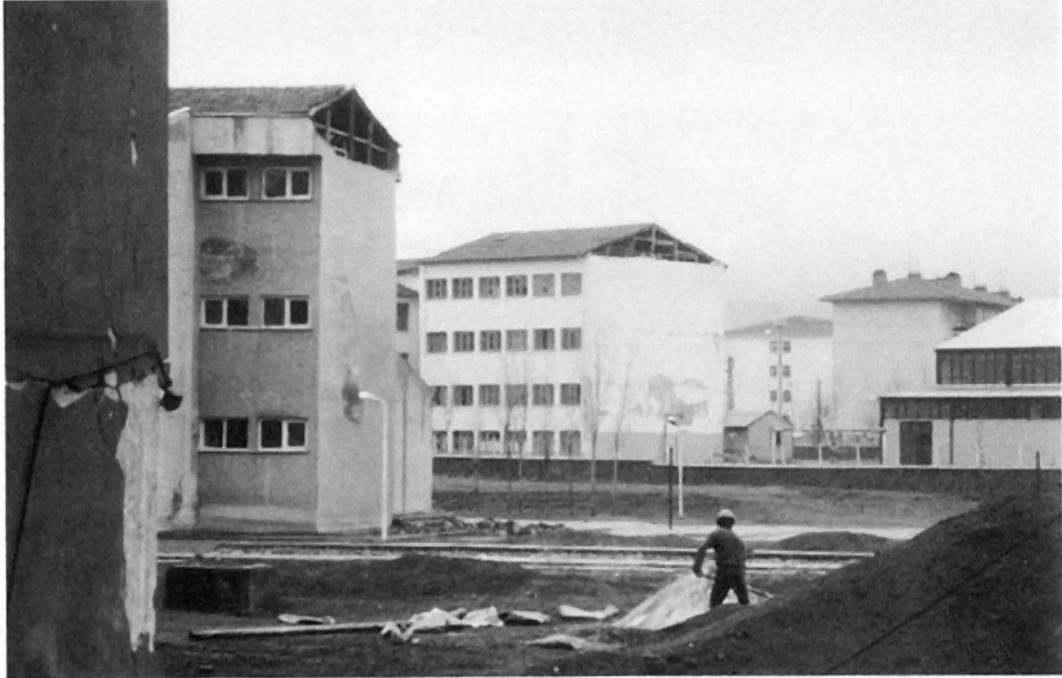
Plate 4.24
Failure of unrestrained gable ends. *Location 10.*

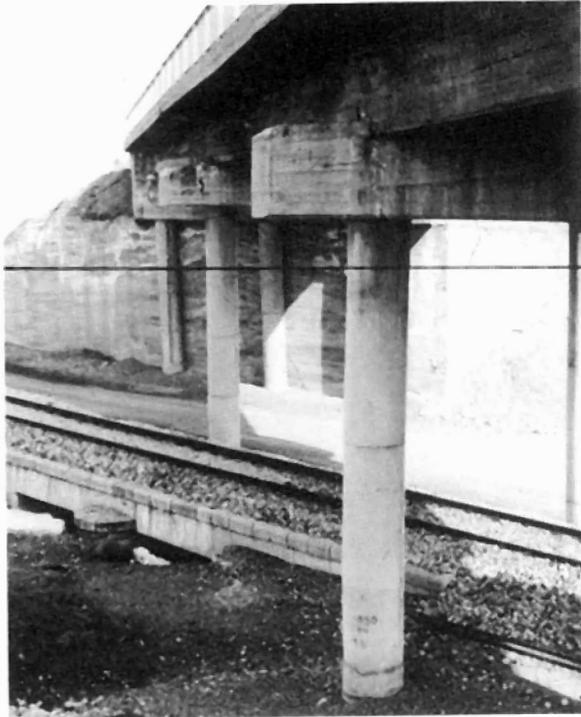
Plate 4.26

Badly damaged highway bridge on road to Kemah. Notice the lack of bearings between the crossheads and main beams. The nearest column is badly bent.

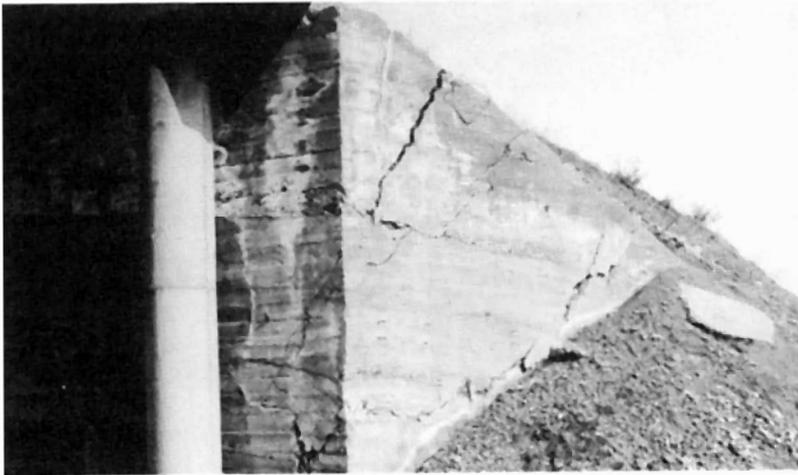
Plate 4.27

Severe cracking of embankment wall of the same bridge.

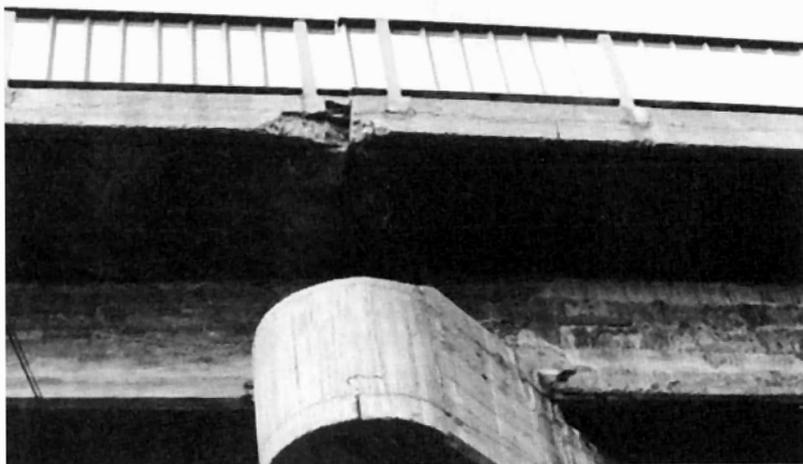
Plate 4.28

Detail of column head of the same bridge, showing poor construction quality and damage due to pounding between adjacent deck segments.

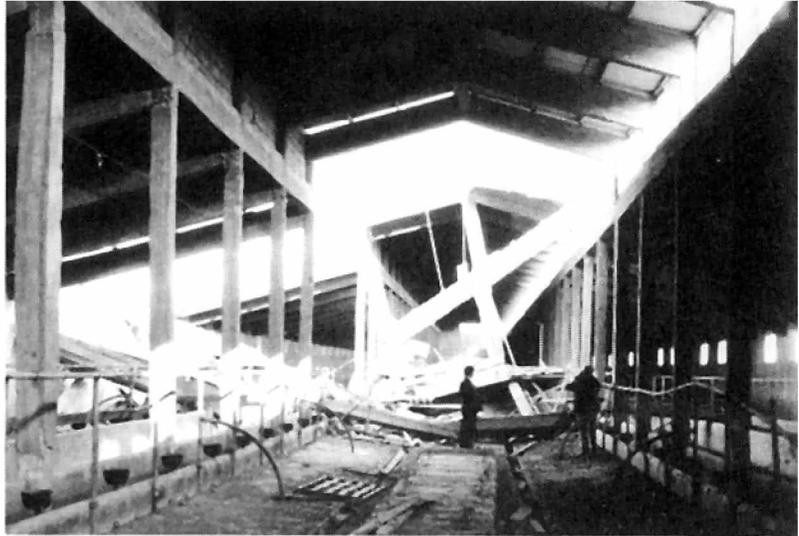
Plate 4.32

Collapse of the roof of an RC frame cattle shed at the meat processing plant. The columns are considerably more slender than the roof beams, and the standard of construction is very poor (see also Plate 4.4).

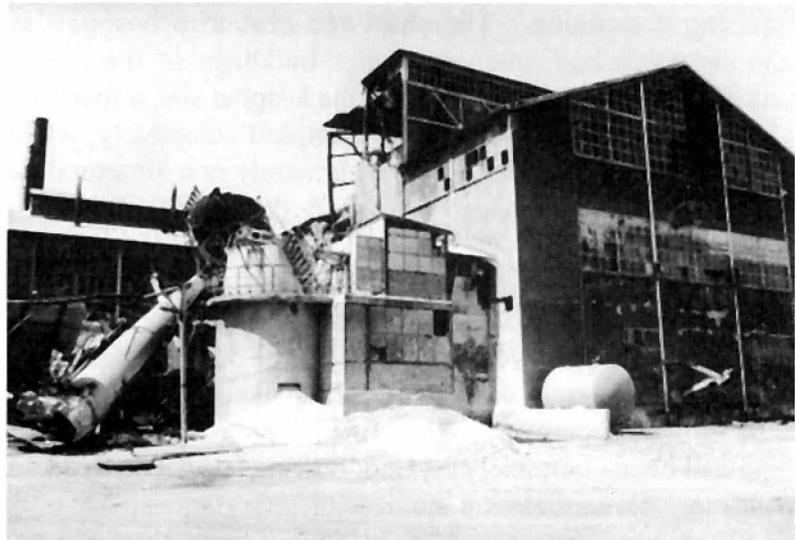
Plate 4.33

Erzincan sugar factory. The 36 m high silo collapsed, causing some secondary damage; otherwise the structure stood up well.

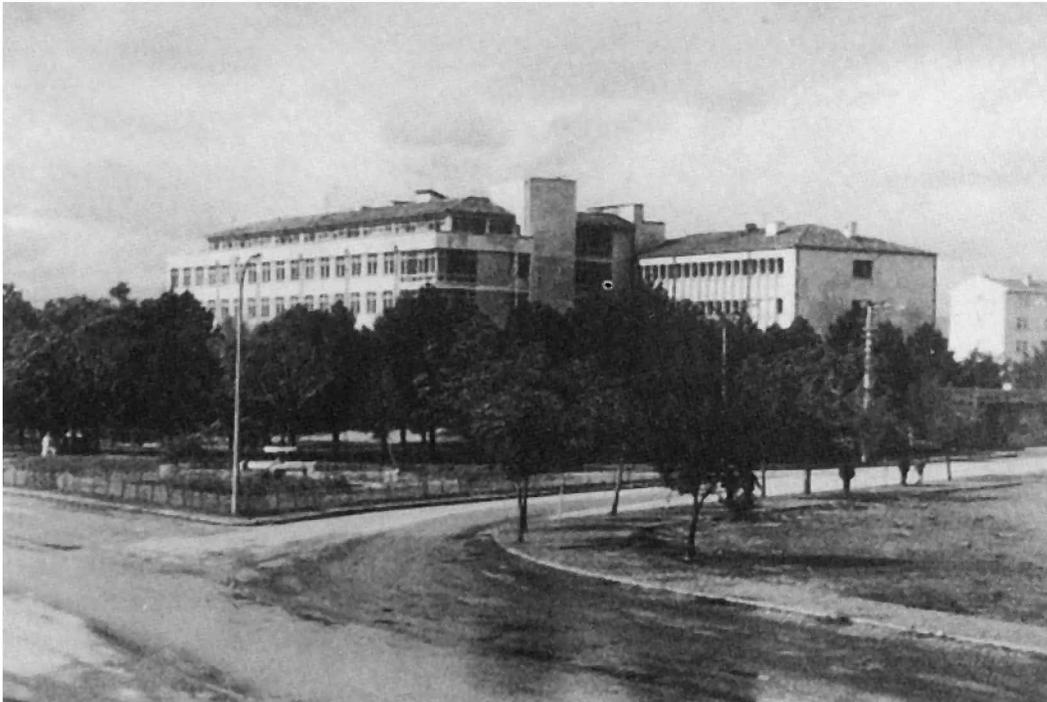
Plate 5.4
Operations clinic, state hospital, northern façade. Notice the identical location of damage to the infill walls at ground floor level. *Location 14.*

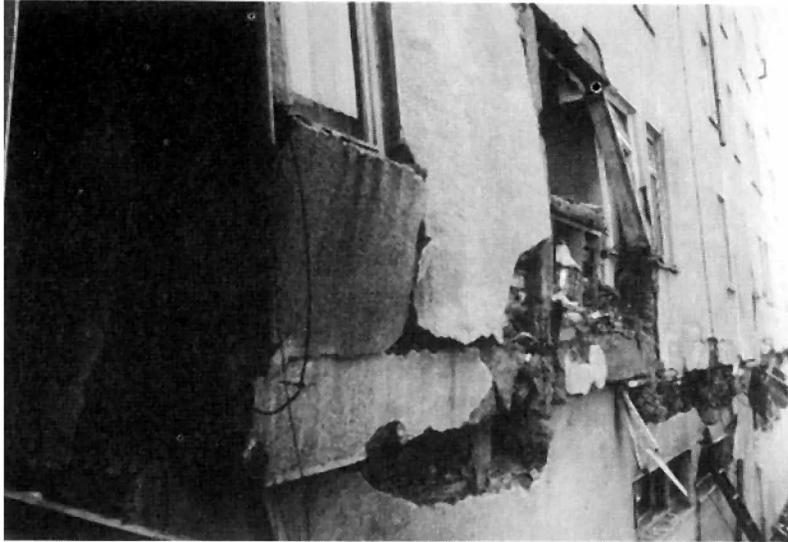
Plate 5.8

Western half of the military hospital after the earthquake. The end section has collapsed completely while the remainder has lost its first floor. The eastern half was severely damaged but remained standing.

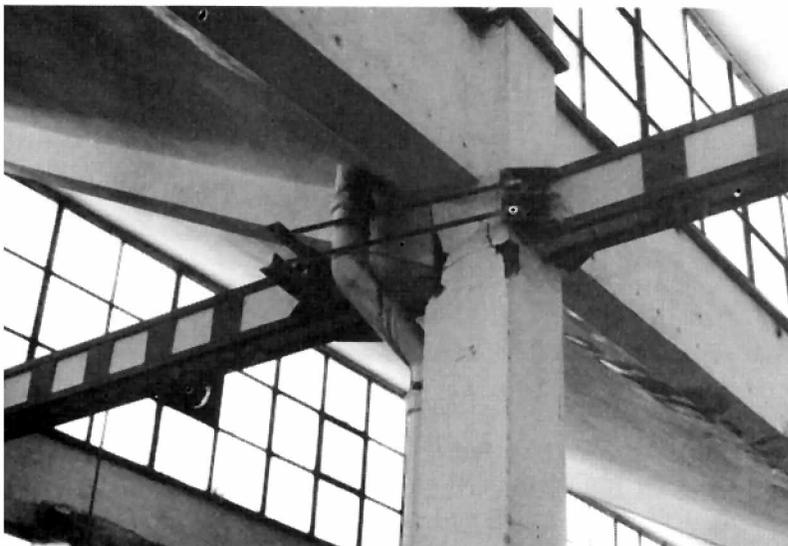
Plate 5.10
Sumerbank textile factory, main machine hall. Severe damage to column head adjacent to span where crossbeams are absent. The ducting was flexibly attached and mostly survived well, but the pipework suffered several ruptures. *Location 16.*

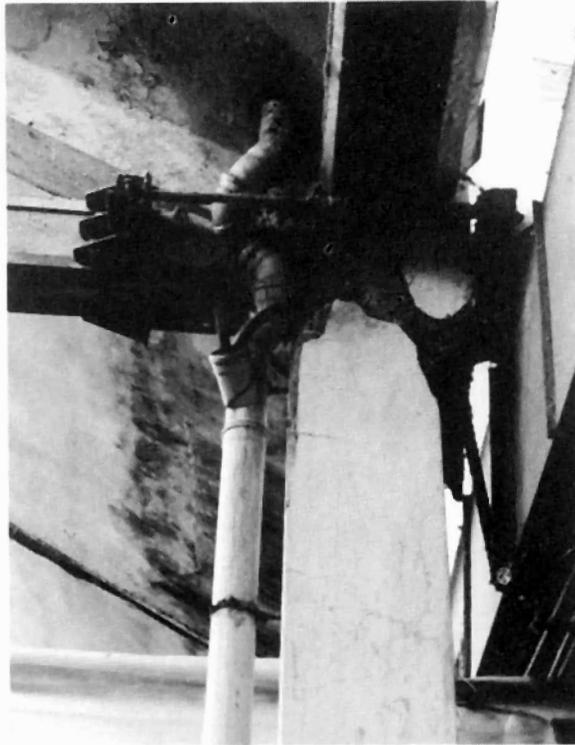
Plate 5.11
Sumerbank textile factory, main hall. Column heads across which the crossbeams were continuous suffered less damage. Note the attempt at external reinforcement of the beams and the joint. *Location 16.*

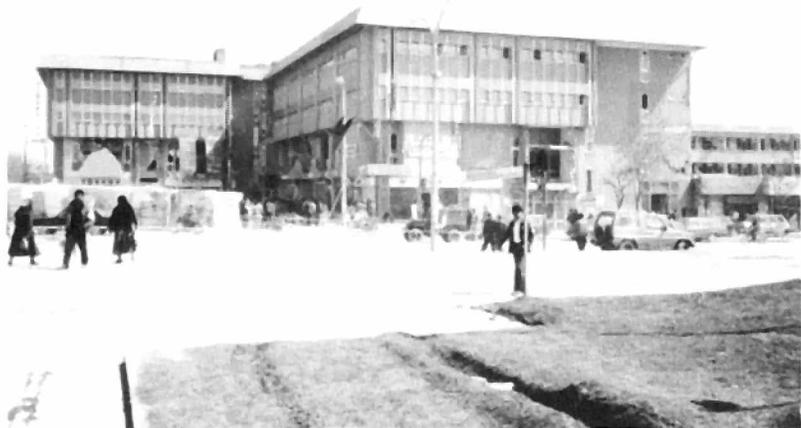
Plate 5.16

City centre. General view of shop and office building showing facade finishes and damage. *Location 17.*

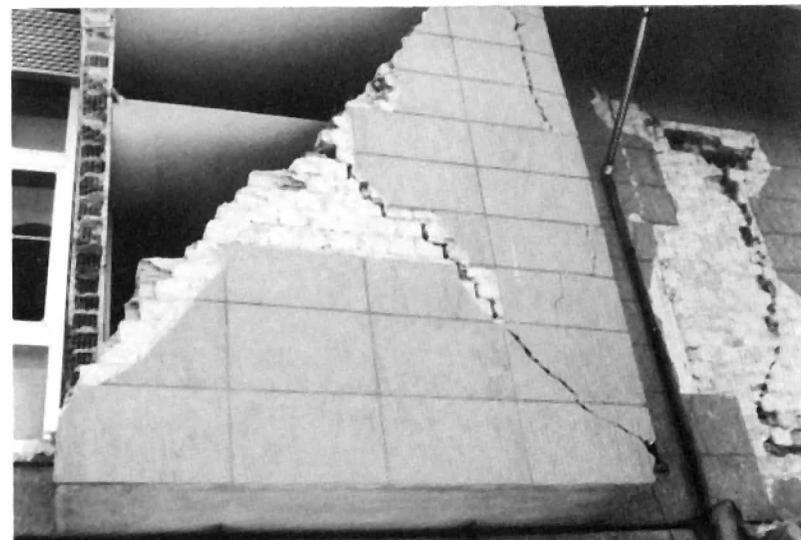
Plate 5.17

City centre. Diagonal cracking of cantilevered masonry panel. *Location 17.*

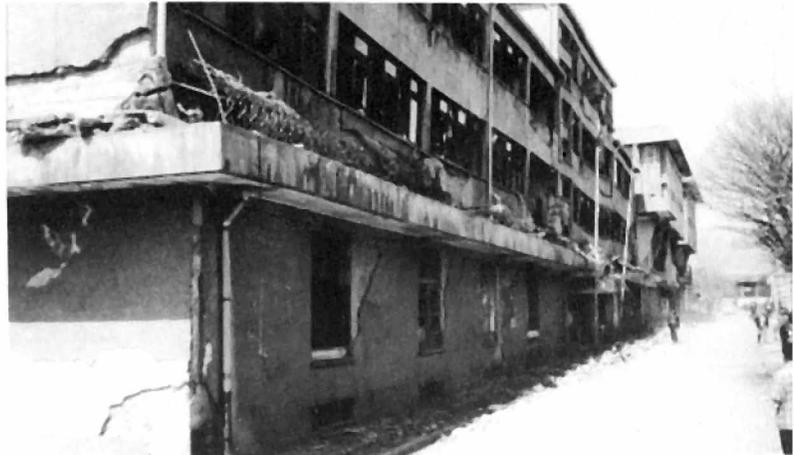
Plate 5.20
City centre. Mid-storey collapse of PTT offices, other floors severely damaged. *Location 17.*

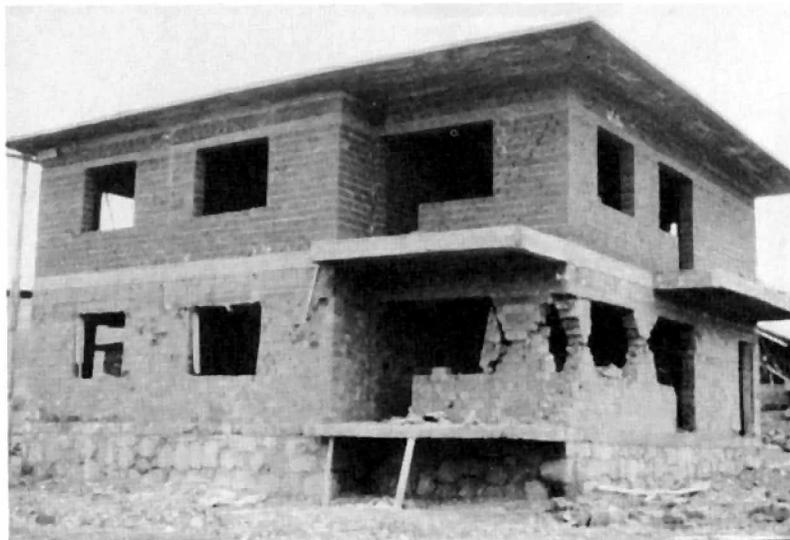
Plate 5.23

Cooperative Housing Estate, Uzumlu. View of house no. 12, one of the first to exhibit slight damage in the form of diagonal shear cracks at the right hand corner of the ground floor.

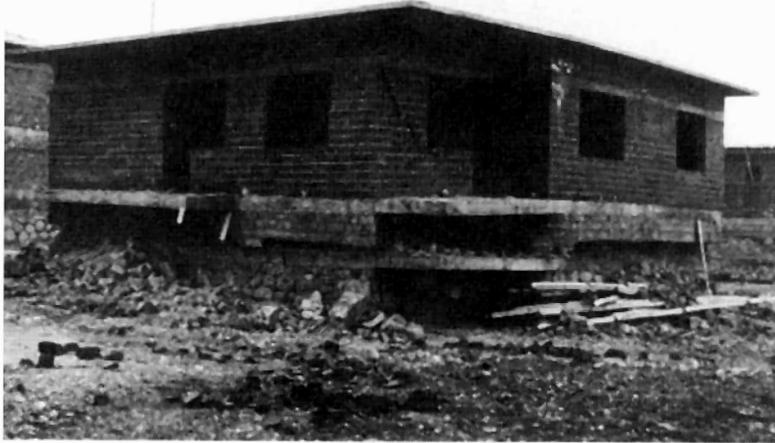
Plate 5.24

Cooperative Housing Estate, Uzumlu. House no. 21. Severe damage at the ground floor corner.

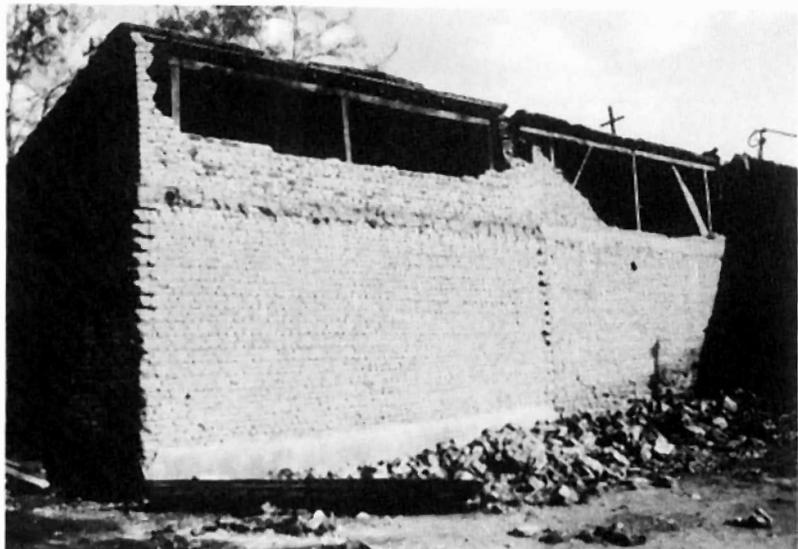
Damage survey around meteorology station. Typical solid brick masonry building with lime mortar, found mostly in the southern part of the surveyed area. The loss of a gable wall was the most common damage.
