# 2015 Nepal Earthquake: Seismic Performance and Post-Earthquake Reconstruction of Stone Masonry Buildings

**Rohit Kumar Adhikari and Dina D'Ayala**

Department of Civil, Environmental and Geomatic Engineering,  
University College London

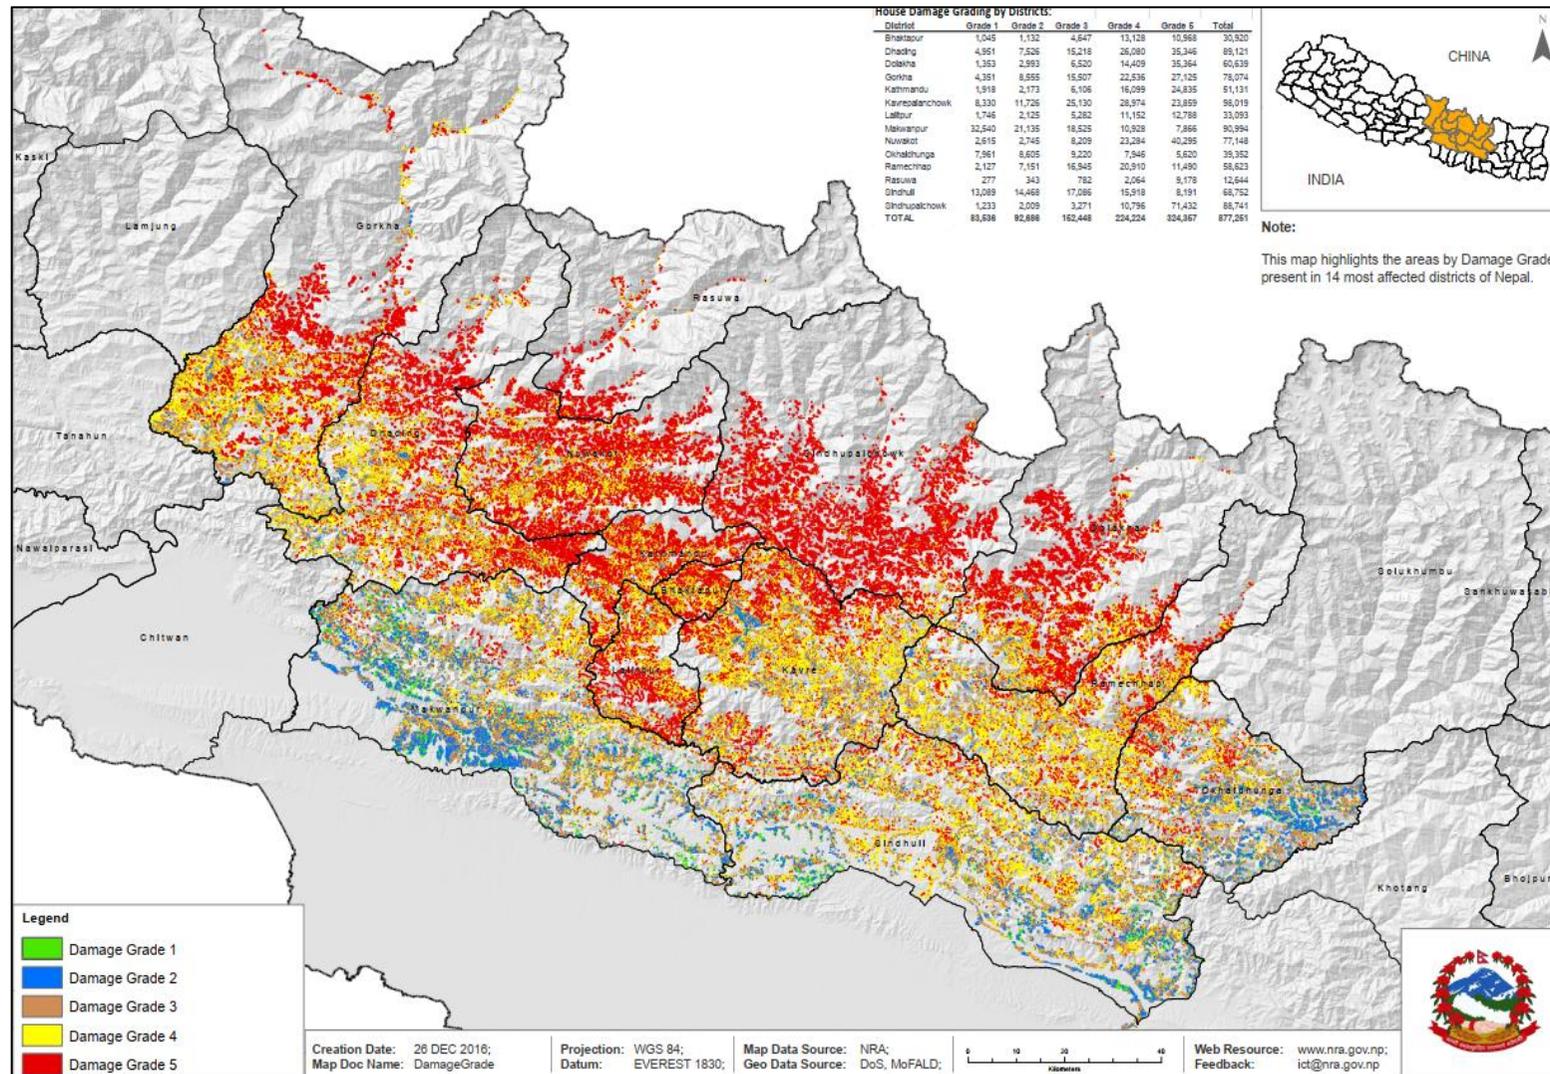
Figure 3. Damage grade distribution of residential houses in 14 most affected districts (NRA, 2016a).

As can be seen from Figure 3 which presents the distribution of damage grade at building level in the affected districts, the highest damage grade i.e. 'damage grade 5' is mostly concentrated in the rural mountainous region where the SMM typology is most common, and in the Kathmandu valley where the traditional Newari construction in adobe/brick in mud mortar construction was most common. Among the damaged buildings in all the affected districts, about 96% were of load bearing masonry typology and only 4% of the damaged buildings were RC constructions (NPC, 2015). Figure 4 shows example photographs of typical damage sustained by low-strength masonry and non-engineered RC construction during the 2015 earthquake sequence. Typical damage to different typologies of residential buildings, cultural heritage structures as well as school buildings due to the 2015 earthquake sequence can be found in more detail in Bhagat et al. (2018).

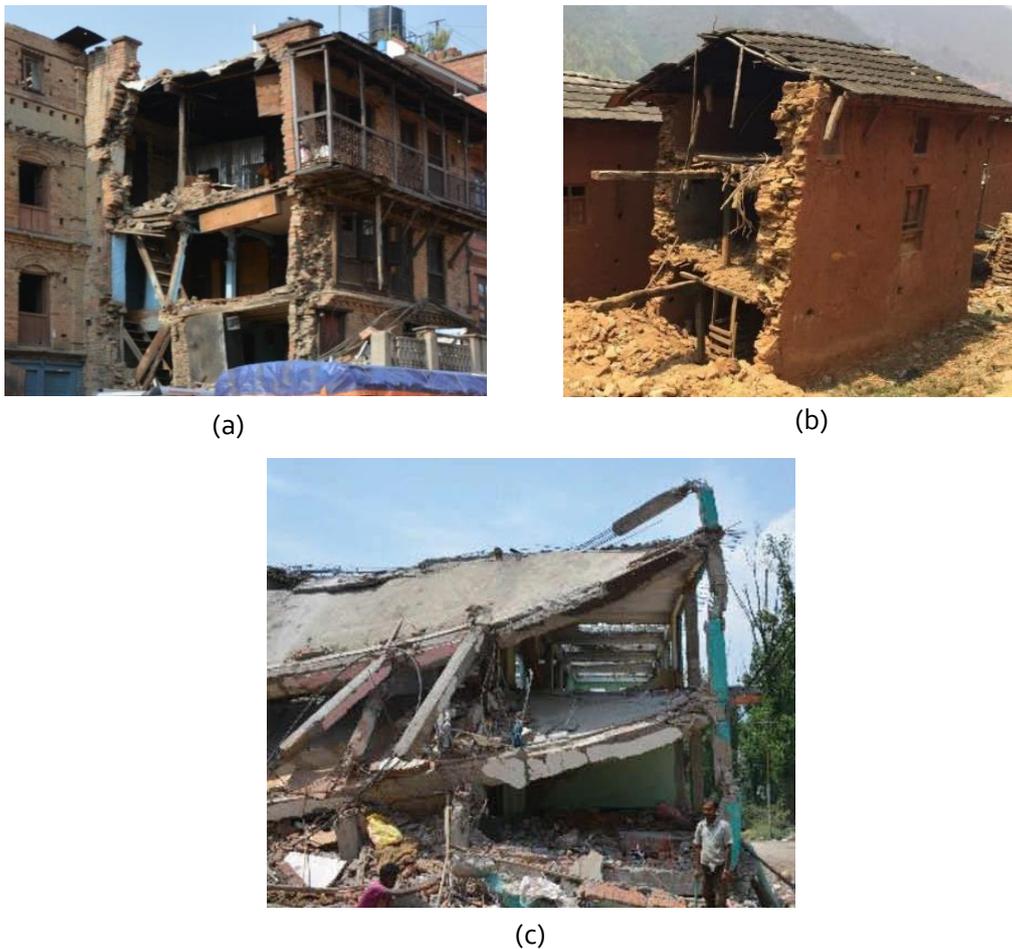
Figure 4. Damage sustained by residential buildings in the 2015 Nepal earthquake: (a) out-of-plane collapse of brick in mud mortar masonry wall in traditional Newari construction (Photo from Bhaktapur), (b) out-of-plane collapse of SMM masonry (Photo credit: Build Change) and (c) Complete collapse of non-engineered RC construction.

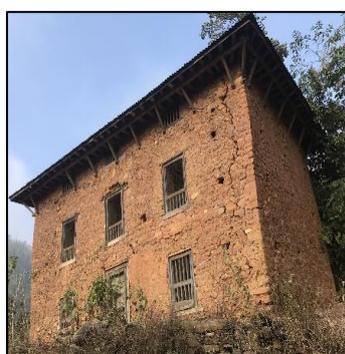
(a) Separation of short wall at cross-wall connection

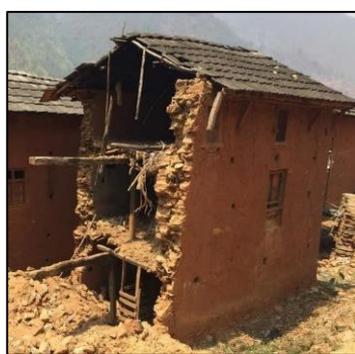
(b) Complete out-of-plane collapse (Photo: Build Change)

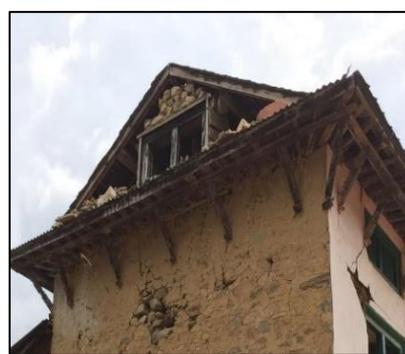
(c) Collapse of gable (Photo: Build Change)

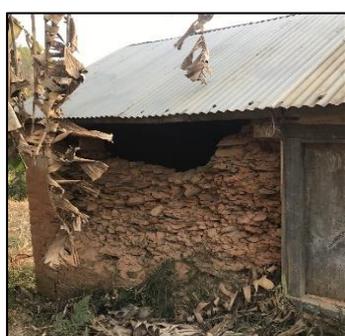
(e) Out-of-plane bulging and debonding

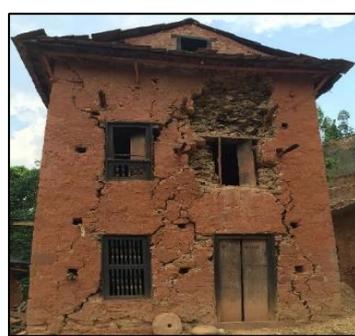
(d) Shear damage in in-plane walls with openings

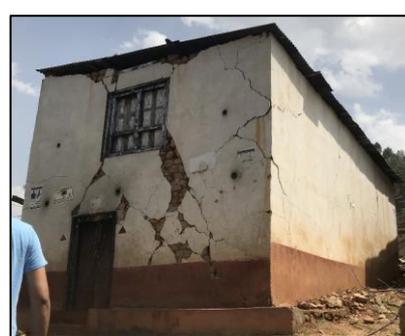
Figure 6. Main failure mechanisms of PRE-SMM typology observed in the 2015 Nepal earthquake.

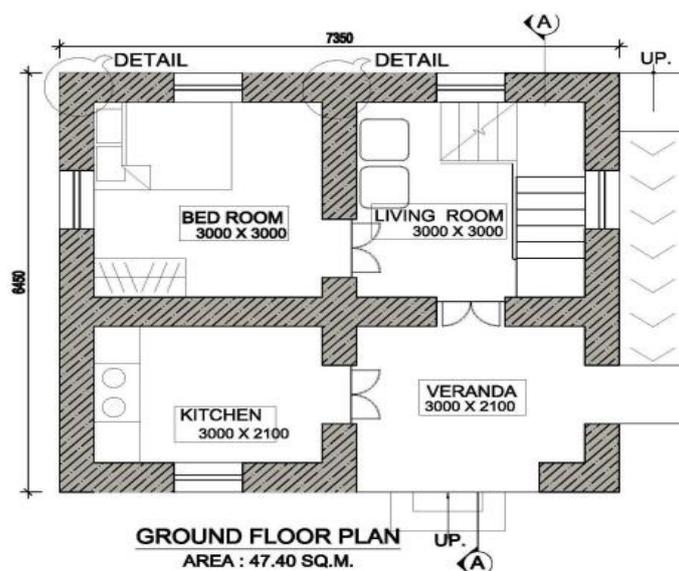
Figure 7. Layout of a SMM model house included in NRA design catalogue (NRA, 2015).

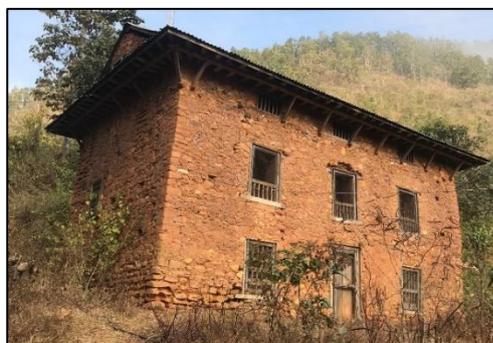
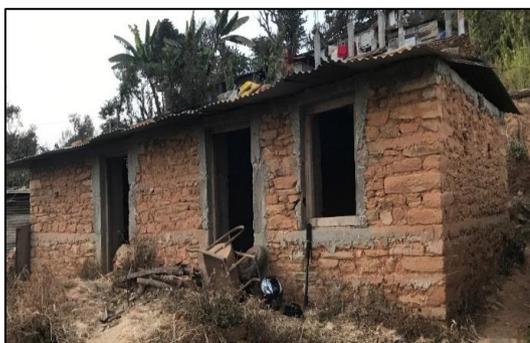
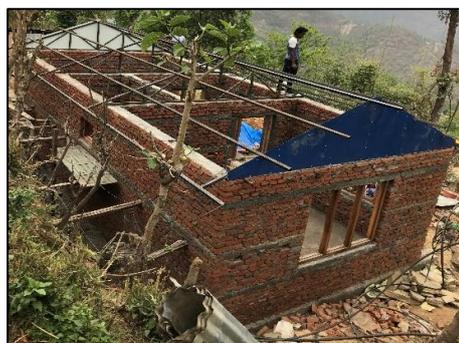
Figure 8. Photographs of typical (a) PRE-SMM, (b) POST-SMM and (c) POST-BCM buildings (Photos from Chautara, Sindhupalchowk).

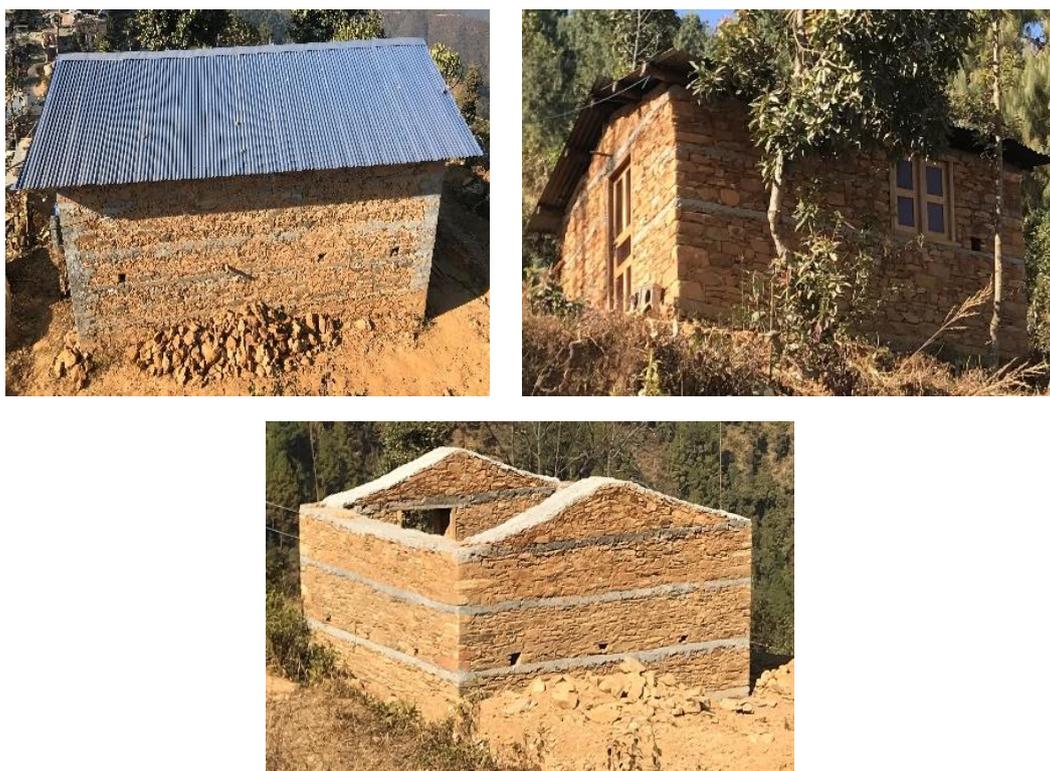
Figure 9. Examples of newly built small 'box-type' POST-SMM houses around the Chautara area of Sindhupalchowk district. Plan area of these houses is smaller than 35 m<sup>2</sup>.

and newly built houses is comparable at about 36 m<sup>2</sup> (refer to Figure 38 for dimensions). However, while the existing houses were mostly two storied with an attic making available gross floor area of about 108 m<sup>2</sup>, newly built houses (both POST-SMM and POST-BCM (Brick in Cement Mortar) typologies) are mostly single storied with only the usable ground floor area of about 36 m<sup>2</sup> which is as only as one third of the floor area of the common PRE-SMM buildings. Figure 9 shows further examples of single-storied POST-SMM houses with one to two-rooms, some of which have been already abandoned.

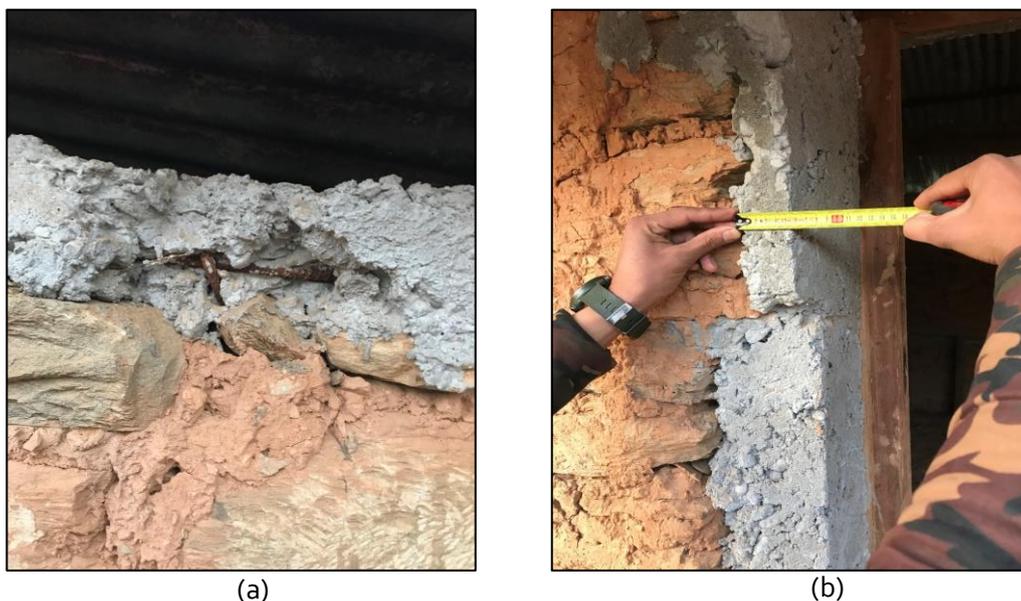
Figure 11. Poor workmanship and/or poor-quality concreting in the seismic bands in POST-SMM constructions.

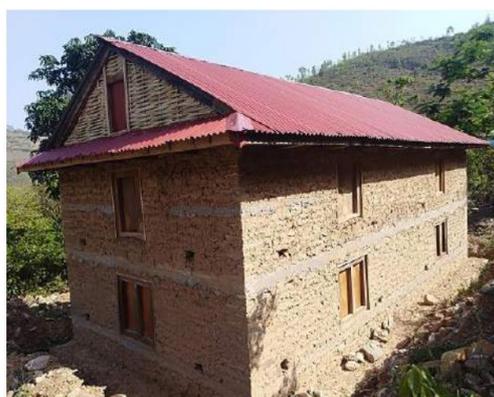
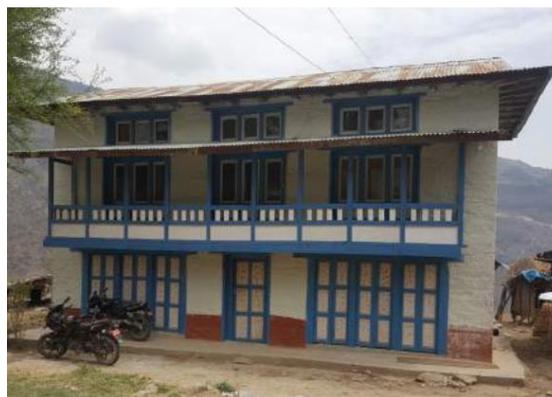
Figure 12. Photographs of multi-storied non-compliant houses built without technical assistance because NRA engineers were unable to provide timely technical guidance as they didn't receive training for multi-storied SMM constructions (HRRP, 2018).

limited technical assistance from the NRA field engineers as they themselves lacked relevant trainings (HRRP, 2018, see Figure 12).

Although some households have constructed more than one storied SMM buildings (see Figure 12), these buildings often have issues such as lack of technical assistance, non-compliance etc. as the NRA engineers are not well trained for providing technical assistance in multi-storied SMM construction as discussed in section 3.3 (see also HRRP, 2018).

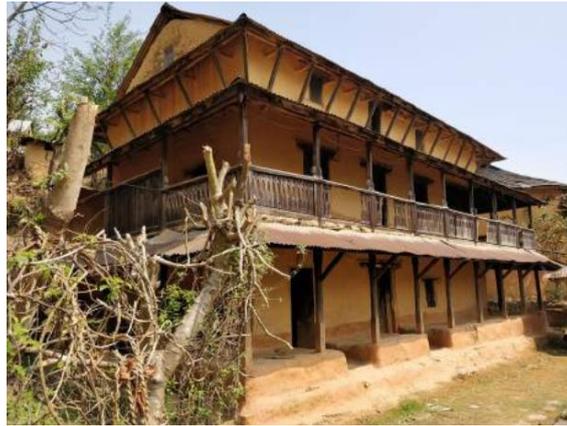
Figure 13. An 80 years old vernacular SMM house in Syangja that has survived three major earthquakes: one in 1934, one in 2011 and the recent 2015 seismic sequence. This house has traditional seismic resistant features of timber elements such as bands (two per story), lacing, vertical posts and timber roofing system that includes keys and compression struts (HRRP, 2018).

Sustainable construction materials such as timber and stone have been replaced by modern materials such as concrete and steel (see section 3.3). The beautiful timber roof structure (see Figure 13, Figure 23) in the existing stone masonry buildings i.e. PRE-SMM typology, which also provides stiff diaphragm action during seismic loading, can no more be seen in the newly constructed POST-SMM houses.

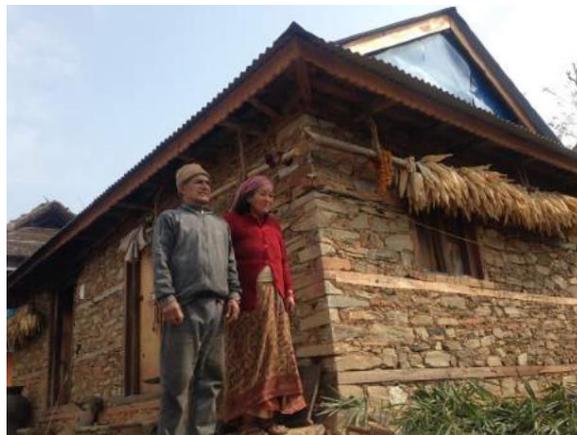
Figure 14. Photograph of a POST-SMM house with seismic resistant features of timber elements (HRRP, 2018).

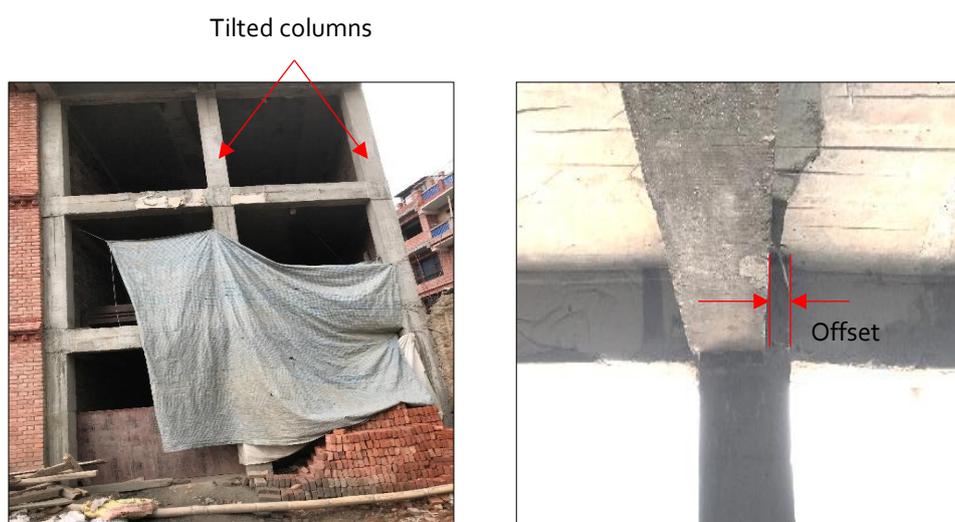
Figure 15. An under-construction RC framed building with tilted columns (left) and poor workmanship of a joint resulting in offset of beams (right) (Photos from Bhaktapur district).

Even in urban areas and in modern RC constructions, workmanship issues can be observed. Figure 15 shows photographs of an under-construction RC framed building in which the tilted columns can be seen. In the same building, some of the beams were at an offset from the column lines resulting in weaker beam-column joints.

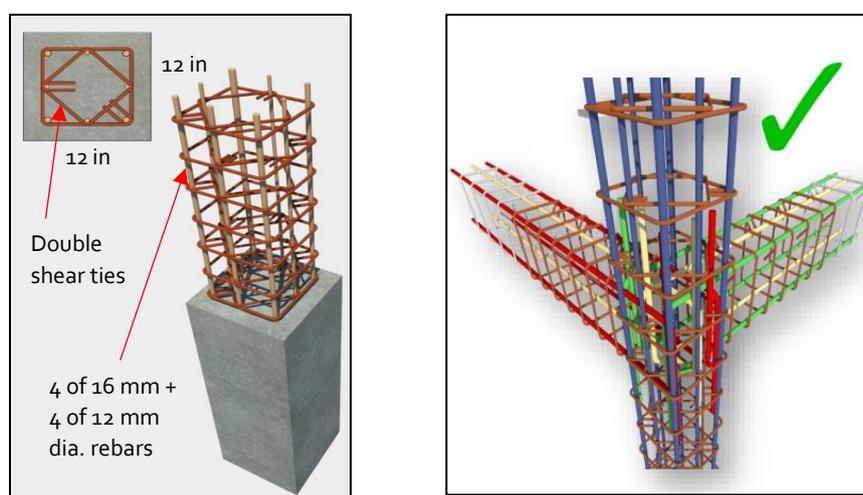
Figure 21. Reinforcement detailing in newly built RC constructions: column size and reinforcement detailing (left) and beam-column joint reinforcement detailing (right) (NRA, 2016c).

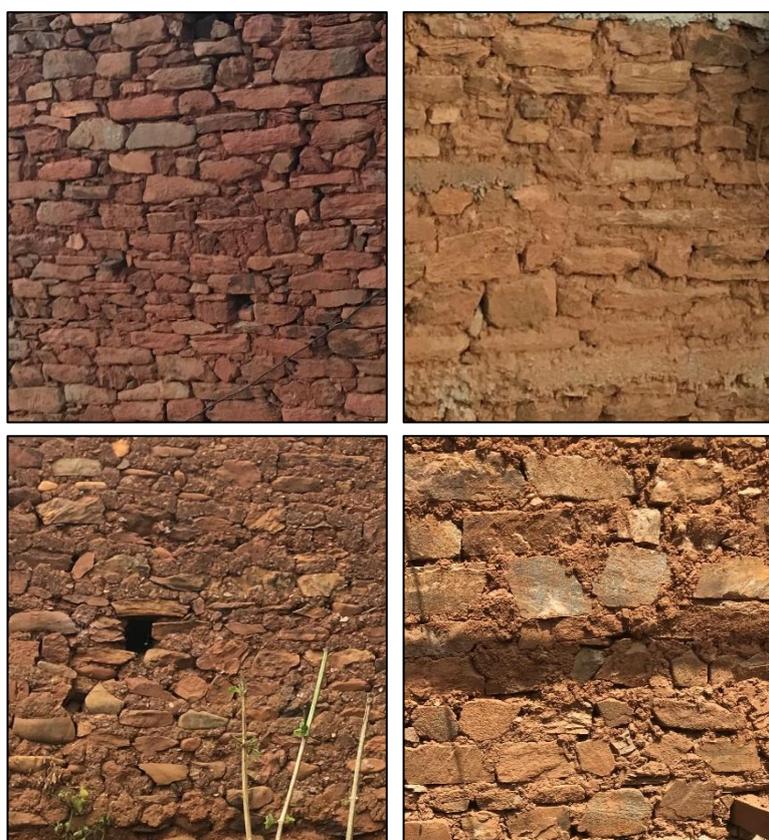
Figure 22. Stone masonry bond pattern from 4 different Nepalese SMM buildings.

In this study, to account for the random irregular shape of rubble stone, a triangular 3-D mesh is first created, and then random shaped units are generated by clustering these triangular applied elements by means of the 'unit' springs. Figure 27 is self-explanatory where different coloured cluster represents each single stone unit. It should be noted that such modelling technique inherently presents some uncertainty as the wall construction itself presents great variability in terms of shape and size of units and the resulting bond pattern (also refer to Figure 22)

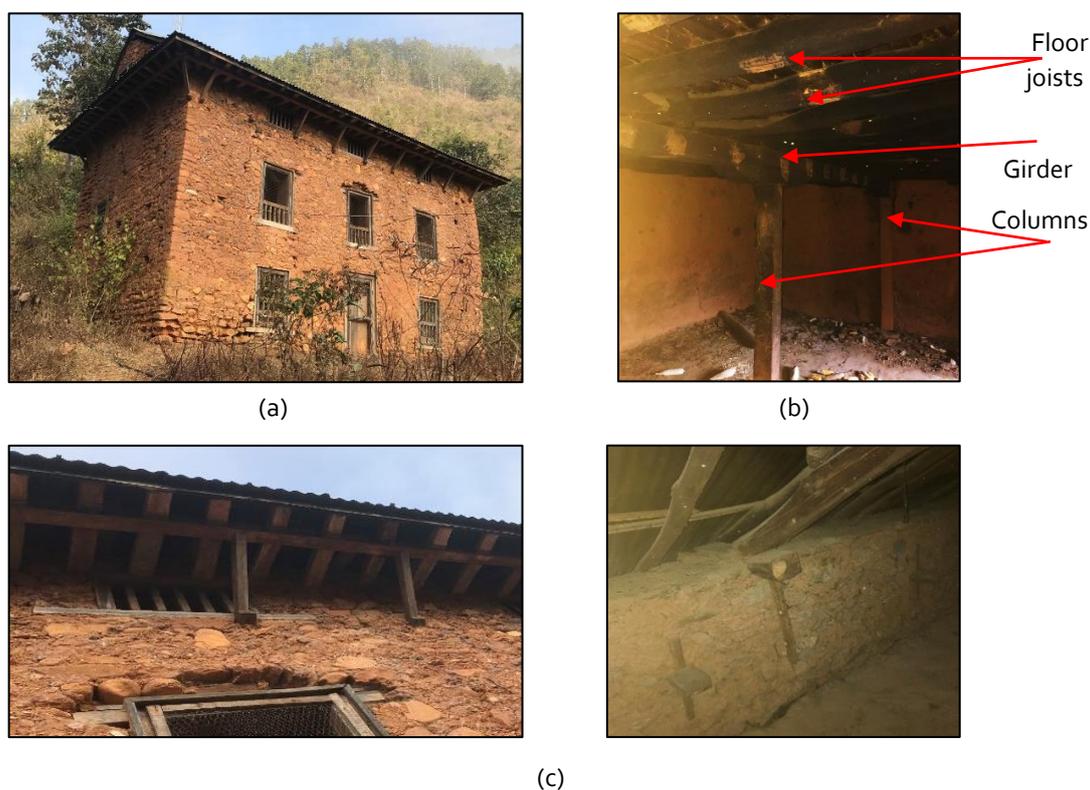
Figure 23. Construction characteristics of a typical PRE- SMM building in Sindhupalchowk district: (a) 3-D view of the building, (b) timber framing structure, (c) timber roofing system with timber keys and compression struts: outside view (left) and inside view (right).

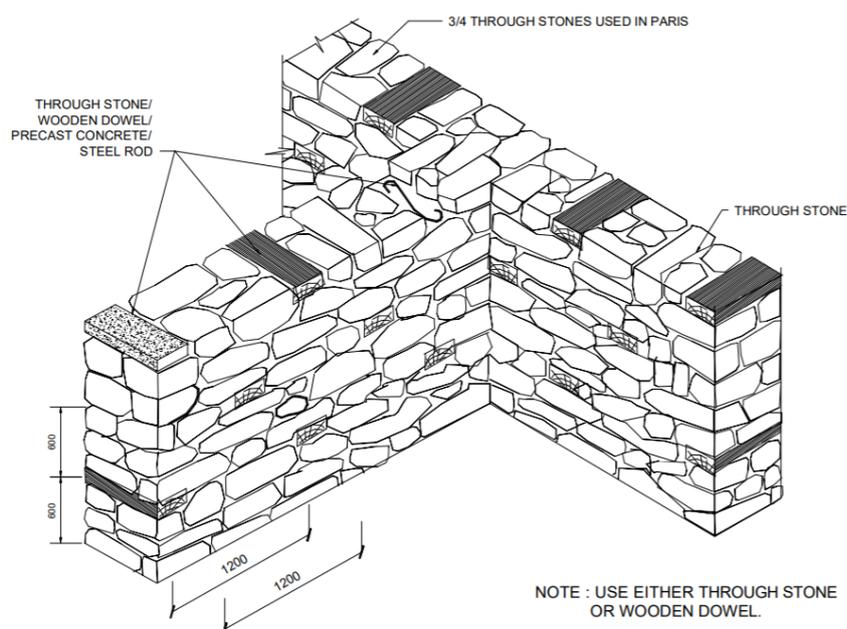
Figure 24. Stone masonry wall construction detail as per NBC 203: 2015.

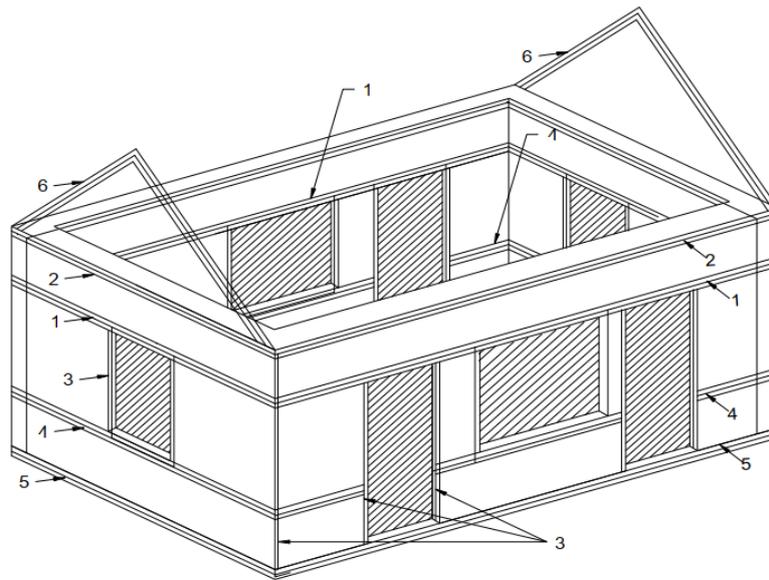
- 1 - Lintel Band
- 2 - Roof Band ( only for pitched roofs and under roofs and floor )
- 3 - Vertical steel.
- 4 - Sill Band.
- 5 - Plinth Band.
- 6 - Gable Band.

Figure 25. Seismic-resistant components in load bearing masonry buildings as per NBC 203: 2015.

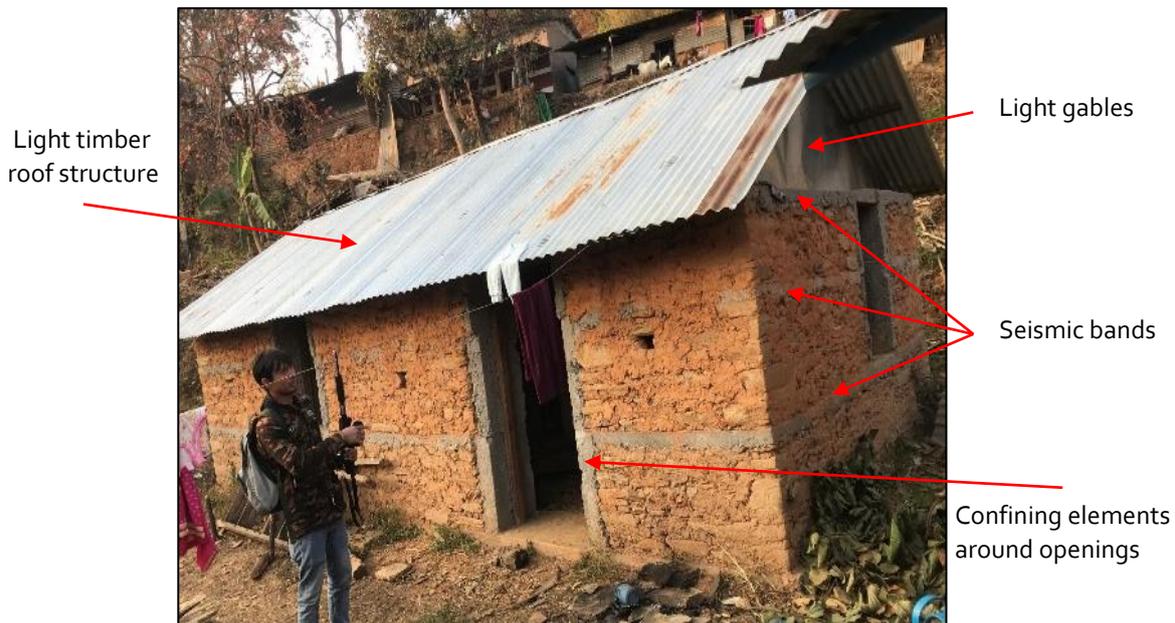
Figure 26. Construction characteristics of typical POST-SMM buildings (Photo from Sindhupalchowk district).

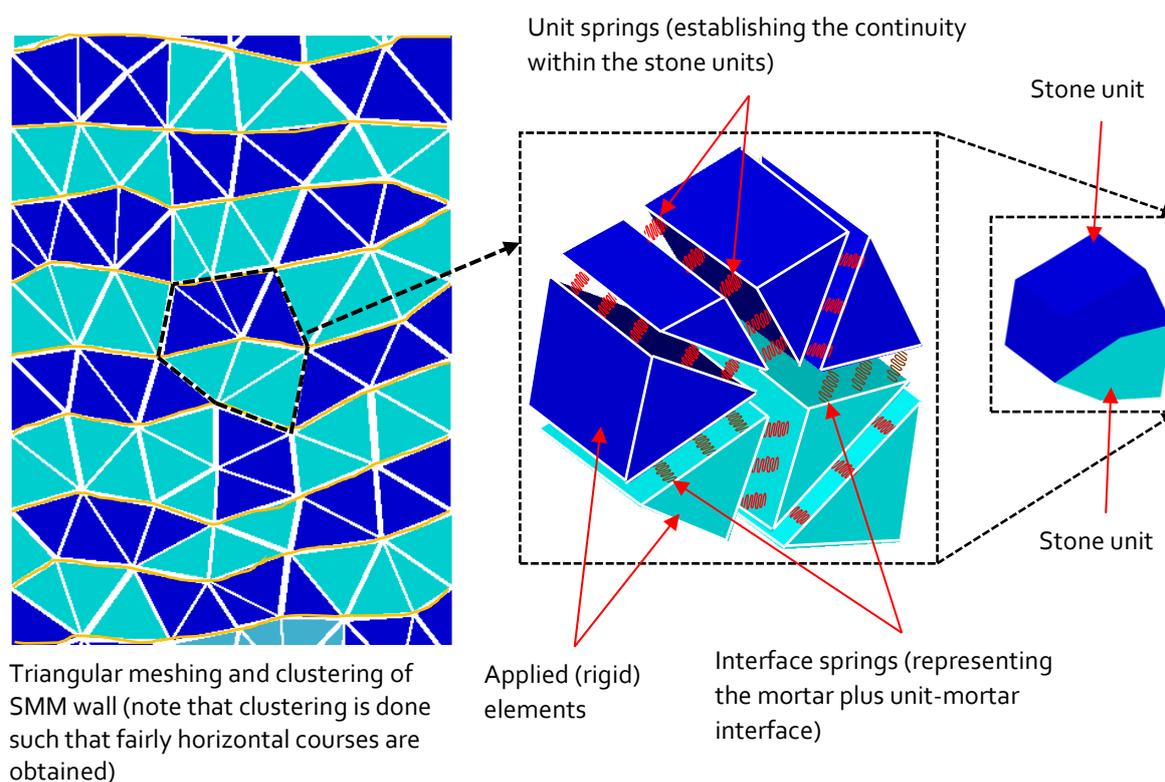
Figure 27. Schematic of simplified micro-modelling of random rubble stone masonry using AEM.

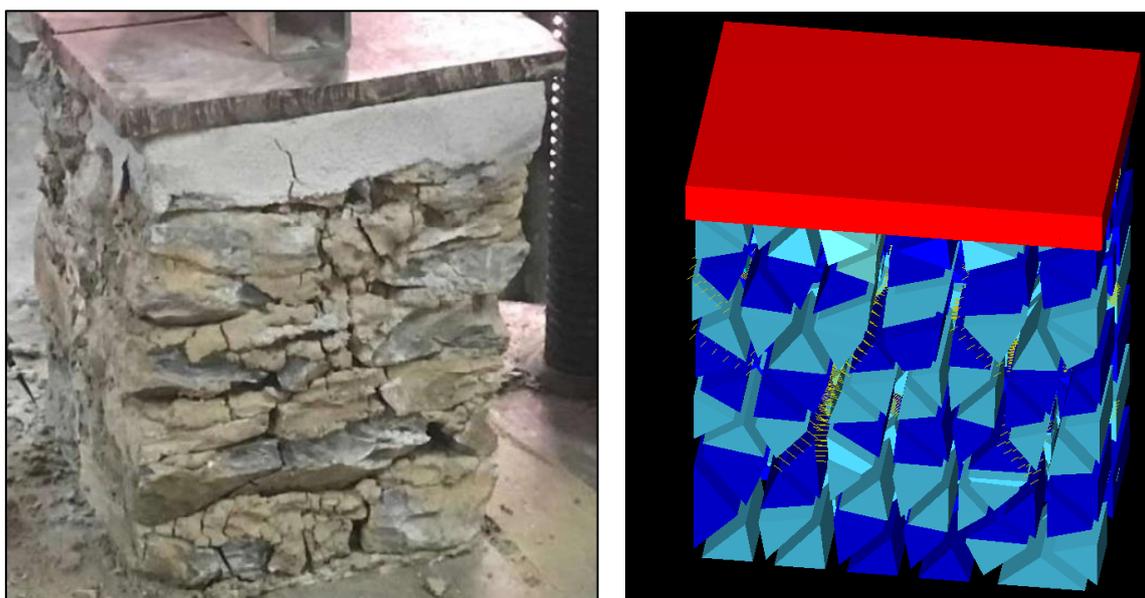
Figure 28. Experimental and AEM analysis results comparison: failure pattern under uniaxial compression.

Figure 28 and Figure 29 compare the numerical crack patterns and the stress-strain diagram to the experimental results for the SMM wallete subjected to vertical uniaxial compression. Vertical and inclined cracks are observed which mainly pass through the mud mortar joints, both in the experiment and numerical analysis result. In terms of load-deformation behaviour, apart from a slight discrepancy in the initial stiffness, the average Young's modulus as well as peak strength and strain are well predicted by the numerical analysis. The difference in the initial stiffness is most probably due to the fact that the test specimen presented some voids and hence showed non-linearity at the beginning of testing.

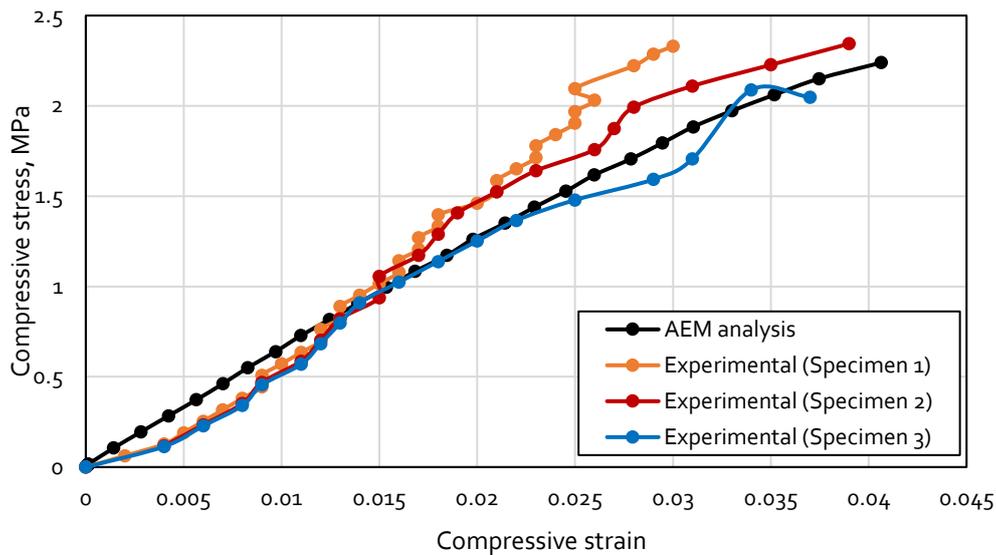
Figure 29. Experimental and AEM analysis results comparison: stress-strain curve under uniaxial compression.

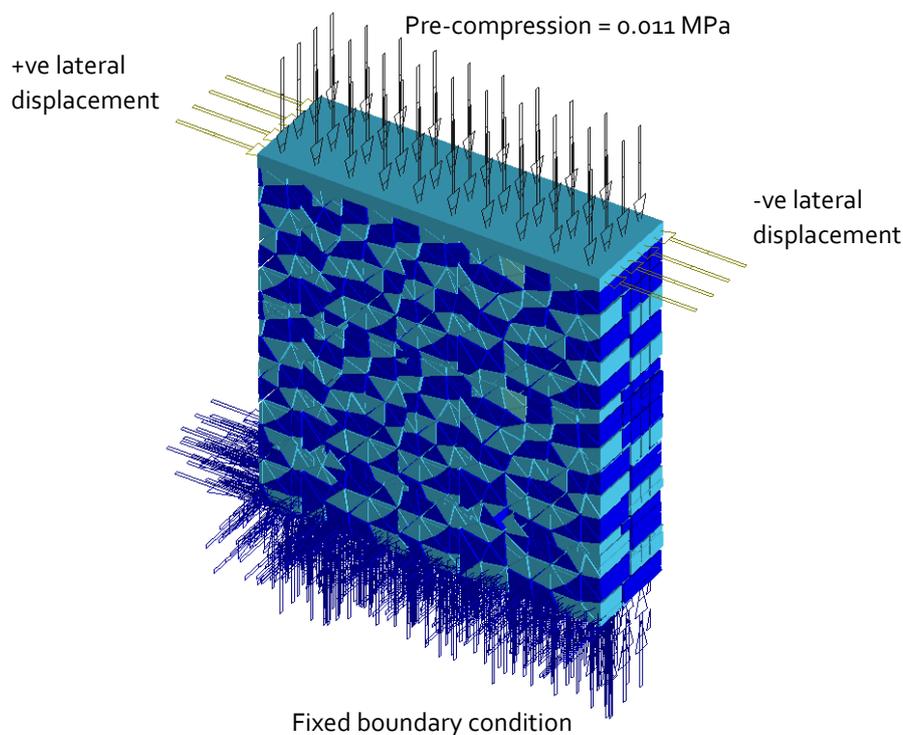
Figure 30. AEM numerical model of the SMM wall showing the boundary condition and loading condition.

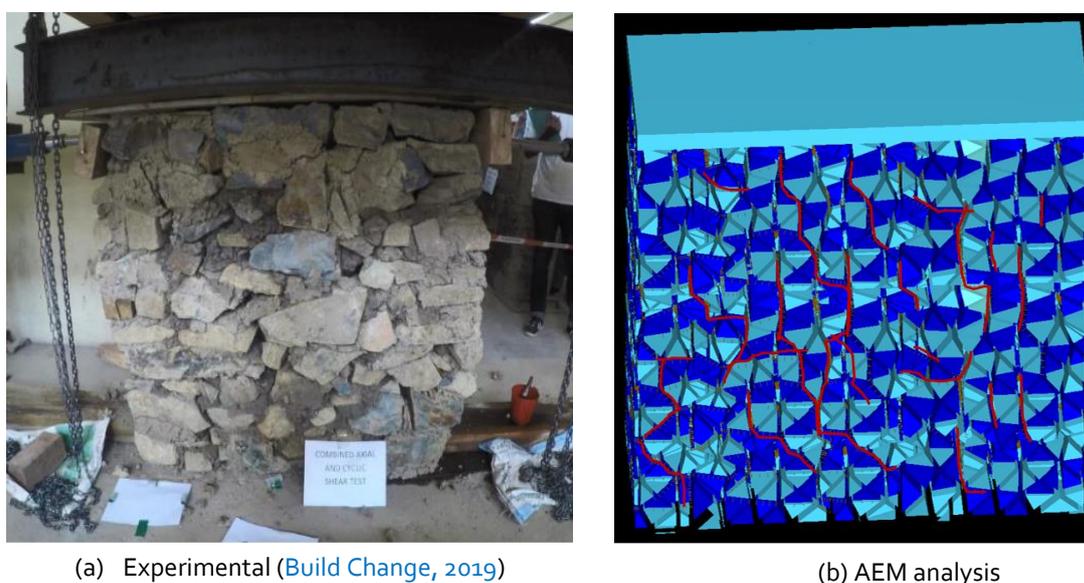
Figure 31. Crack patterns comparison under cyclic shear-compression loading (maximum crack opening is 20 mm).

Figure 31 shows the ultimate crack pattern under cyclic shear-compression loading. As the cyclic displacement level increases, the cracks become widely distributed all over the wall surface, passing mostly through the mud mortar joint/interfaces. Similar crack patterns were obtained in another test on a larger wall conducted on Nepalese random rubble stone masonry wall (Wang et al., 2018), see Figure 32. As the pier was tested until complete collapse in the experiment, out-of-plane delamination (see Figure 33) of the wall was observed at ultimate state of cyclic loading (48 mm top lateral displacement). However, the AEM numerical analysis became unstable after reaching a top lateral displacement of about 36 mm (i.e. 3%) due to the concentration of displacement in one crack leading to numerical instability. However, such out-of-plane debonding is triggered mainly after the in-plane cracks become wide and hence loose frictional interlocking.

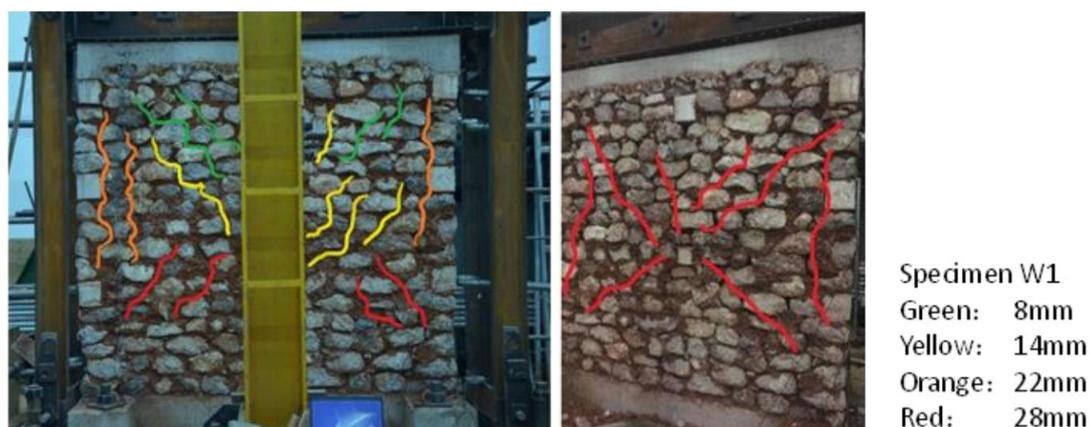
Figure 32. Ultimate crack pattern for random rubble stone masonry wall in mud mortar (Wang et al., 2018).

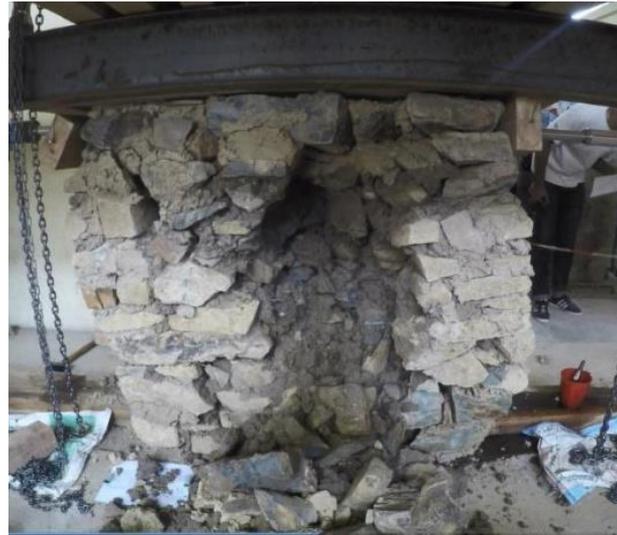
Figure 33. Delamination of the SMM wall specimen at ultimate state (Build Change, 2019).

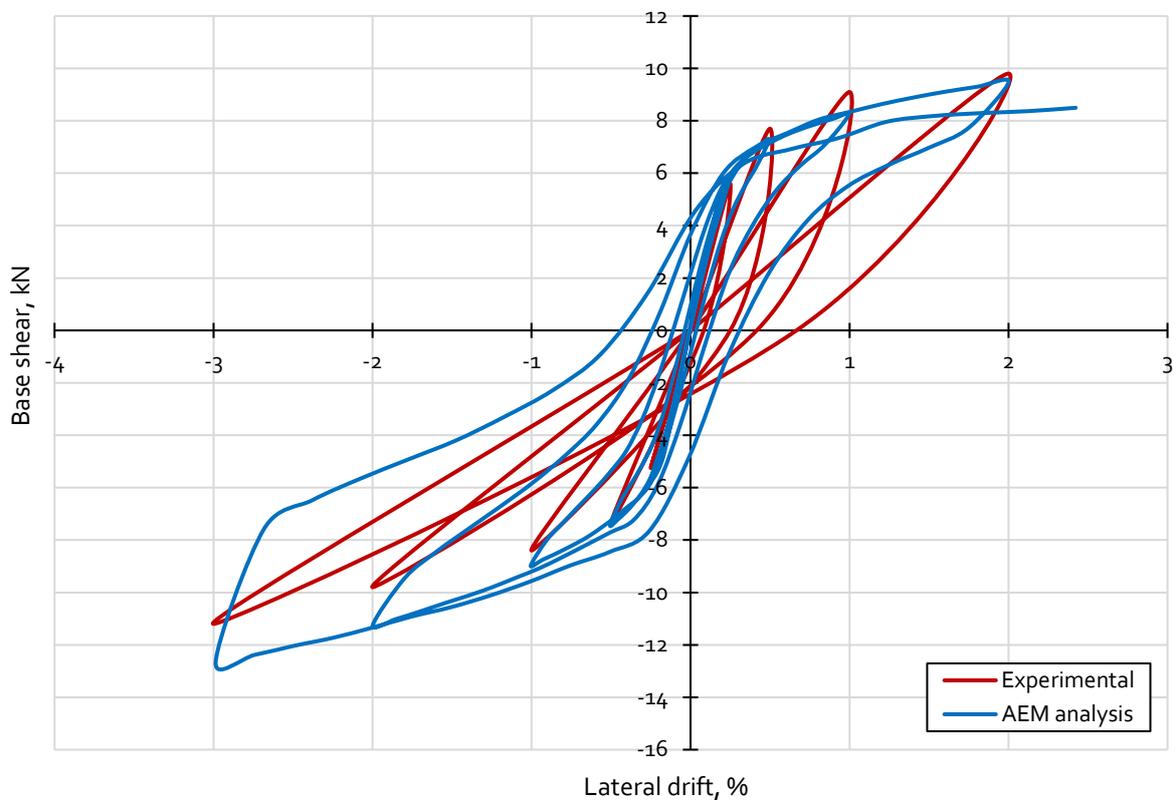
Figure 34. Comparison of experimental and AEM analysis cyclic hysteretic response under shear-compression loading.

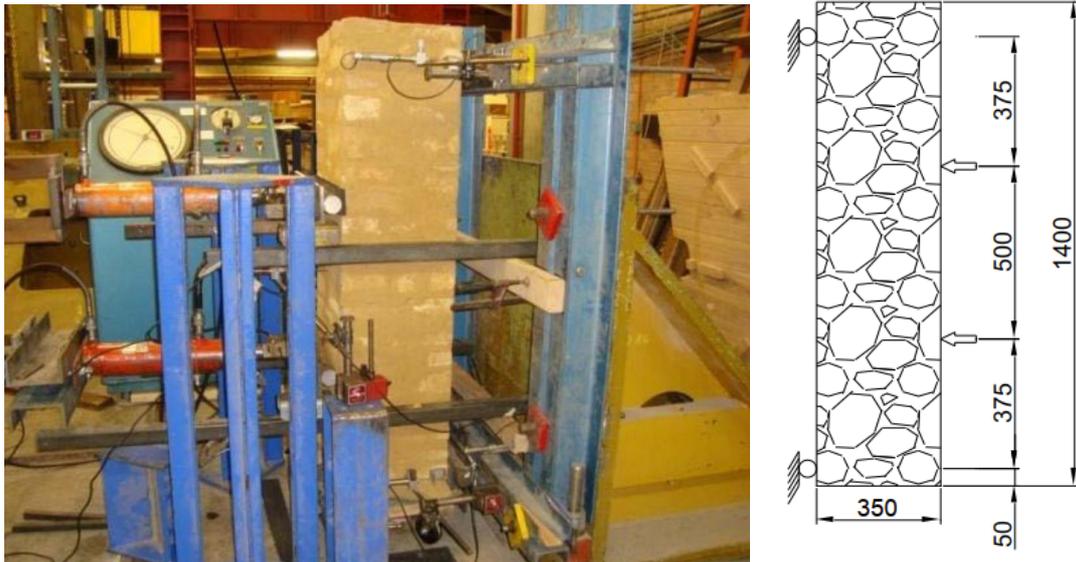
Figure 35. Wall specimen and test setup for four-point bending test (units in mm) (Pun, 2015).

In order to validate the vertical bending behaviour of mud mortar masonry walls, the experimental tests on a semi-dressed stone masonry pier conducted by Pun (2015) is considered. Figure 35 shows the details of the four-point vertical bending test setup for a SMM pier. The location of crack at ultimate stage (which is at a height of 925 mm from the bottom, as shown in Figure 36) as well as the load-deformation behaviour (Figure 37) are well reproduced by AEM analysis.

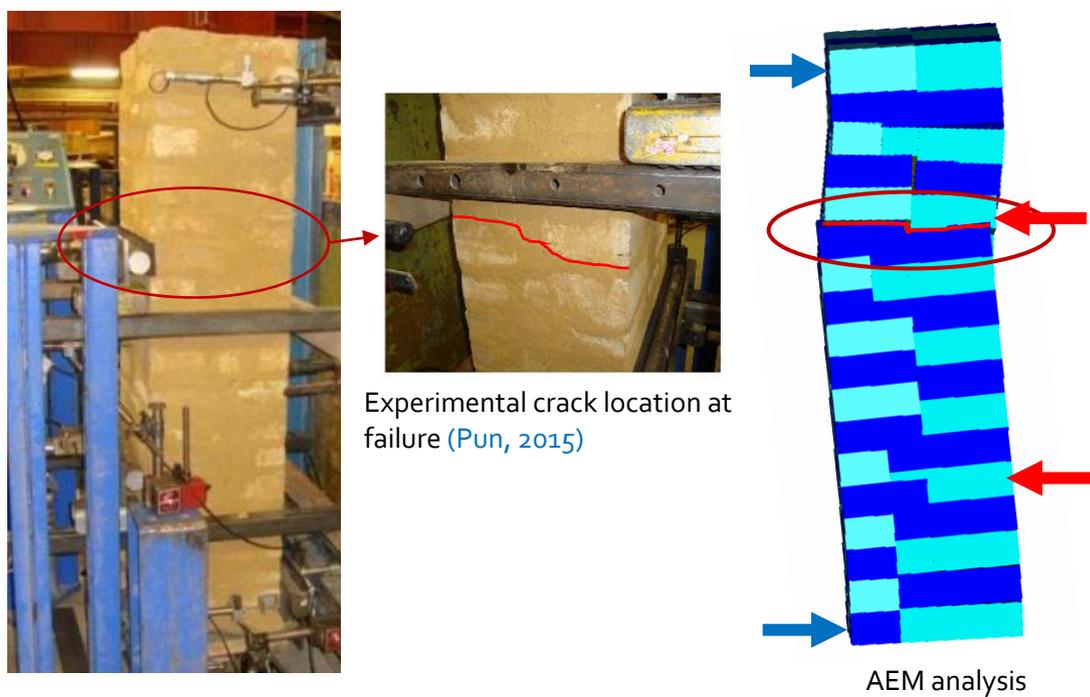
Figure 36. Comparison of experimental and AEM analysis results: location of crack at ultimate stage.

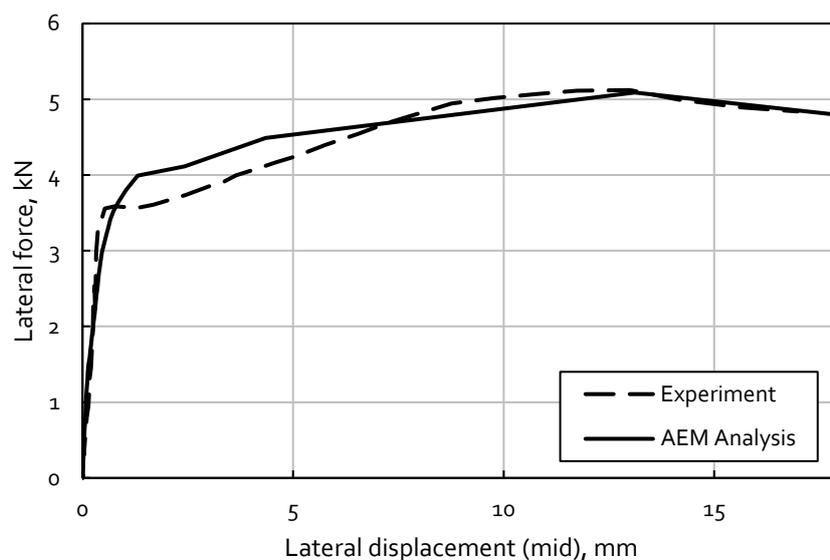
Figure 37. Comparison of AEM analysis and experimental results: load-deformation curves.

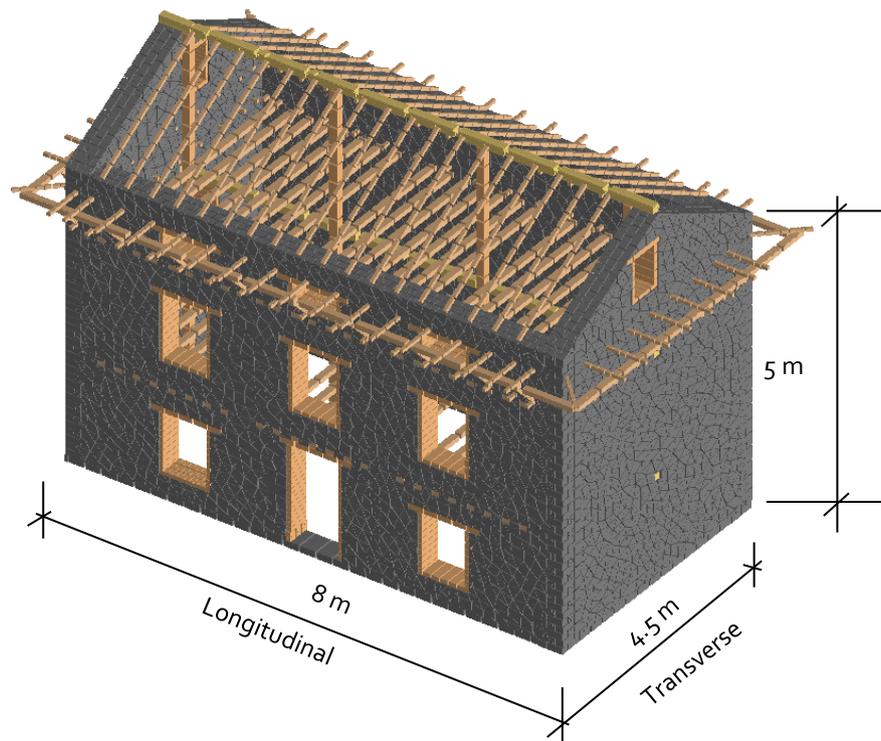
(a) PRE-SMM numerical model

In ELS, 3-D numerical models (Figure 38) of the index buildings representative of the PRE-SMM and POST-SMM typologies are created using the modelling strategy discussed in the previous section. For computational efficiency, stone units are modelled as rigid elements i.e. the cracks are assumed to develop through the mortar joints only. This assumption is justifiable from the results of the experimental and numerical studies presented in section 6.1 that most of the cracks develop through the mortar joint and interfaces in SMM masonry due to the substantial difference in stiffness and strength of mortar and units. For the joint springs, the failure criterion is defined by specifying a separation strain equal to 0.025 which is obtained from the validation and calibration studies reported in section 6.1. Once this strain limit is exceeded in a spring, this has no further tensile capacity, however contact can occur between the adjacent applied elements depending on the loading condition. In the PRE-SMM index building model, the timber lintels above the openings as well as the timber frame elements around the openings are modelled as elastic elements. The timber framed roof structure, including the keys and compression struts are also modelled to reproduce their structural action in confining and constraining the top of the walls. Corner stones are created as rectangular elements at all corners and through stones are provided in the wall at a spacing of 1.2 m and 0.6 m in horizontal and vertical directions respectively (as per [NBC 203: 2015](#)). The building is assumed to be fixed at the base. It is worth noting that the building is non-symmetric in the longitudinal direction due to the typical distribution of opening (backside long wall is solid without any openings).

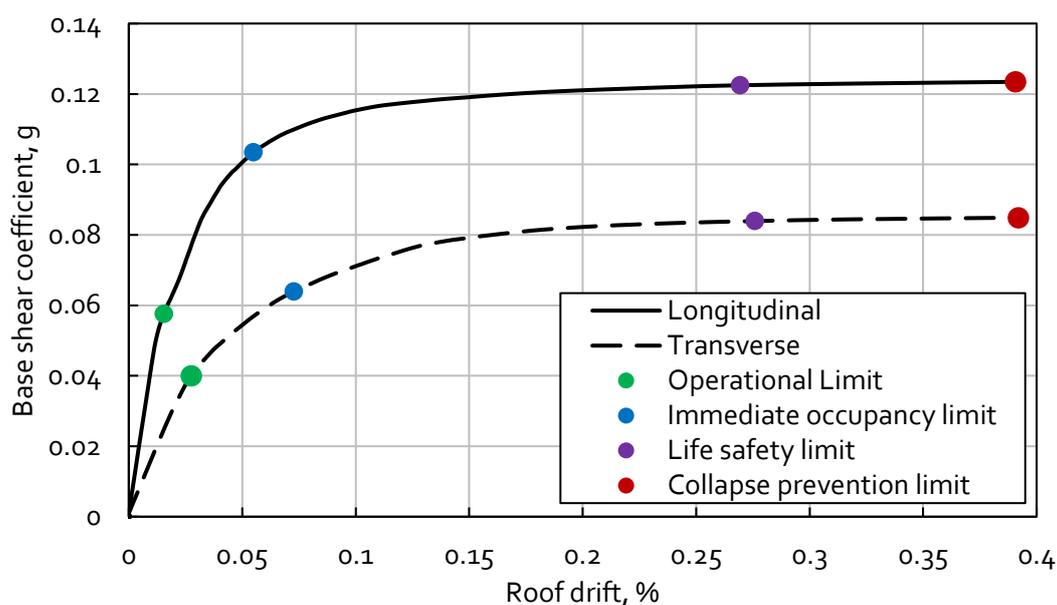
Figure 39. Capacity curves for the PRE-SMM typology in two principal directions.
