# 2015 Nepal Earthquake: Seismic Performance and Post-Earthquake Reconstruction of Stone Masonry Buildings

**Rohit Kumar Adhikari and Dina D'Ayala**

Department of Civil, Environmental and Geomatic Engineering,  
University College London

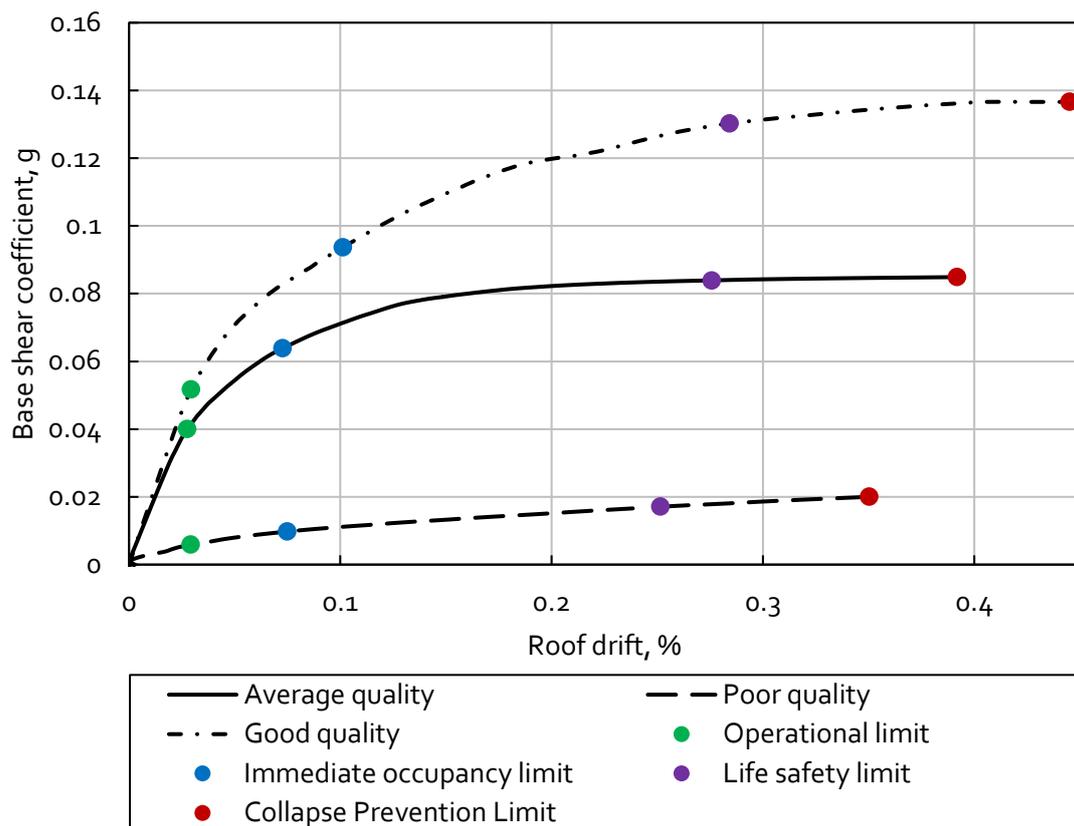
Figure 40. Effect of material quality on the PRE-SMM capacity curve (note that the capacity curves in the transverse i.e. weakest direction are compared).

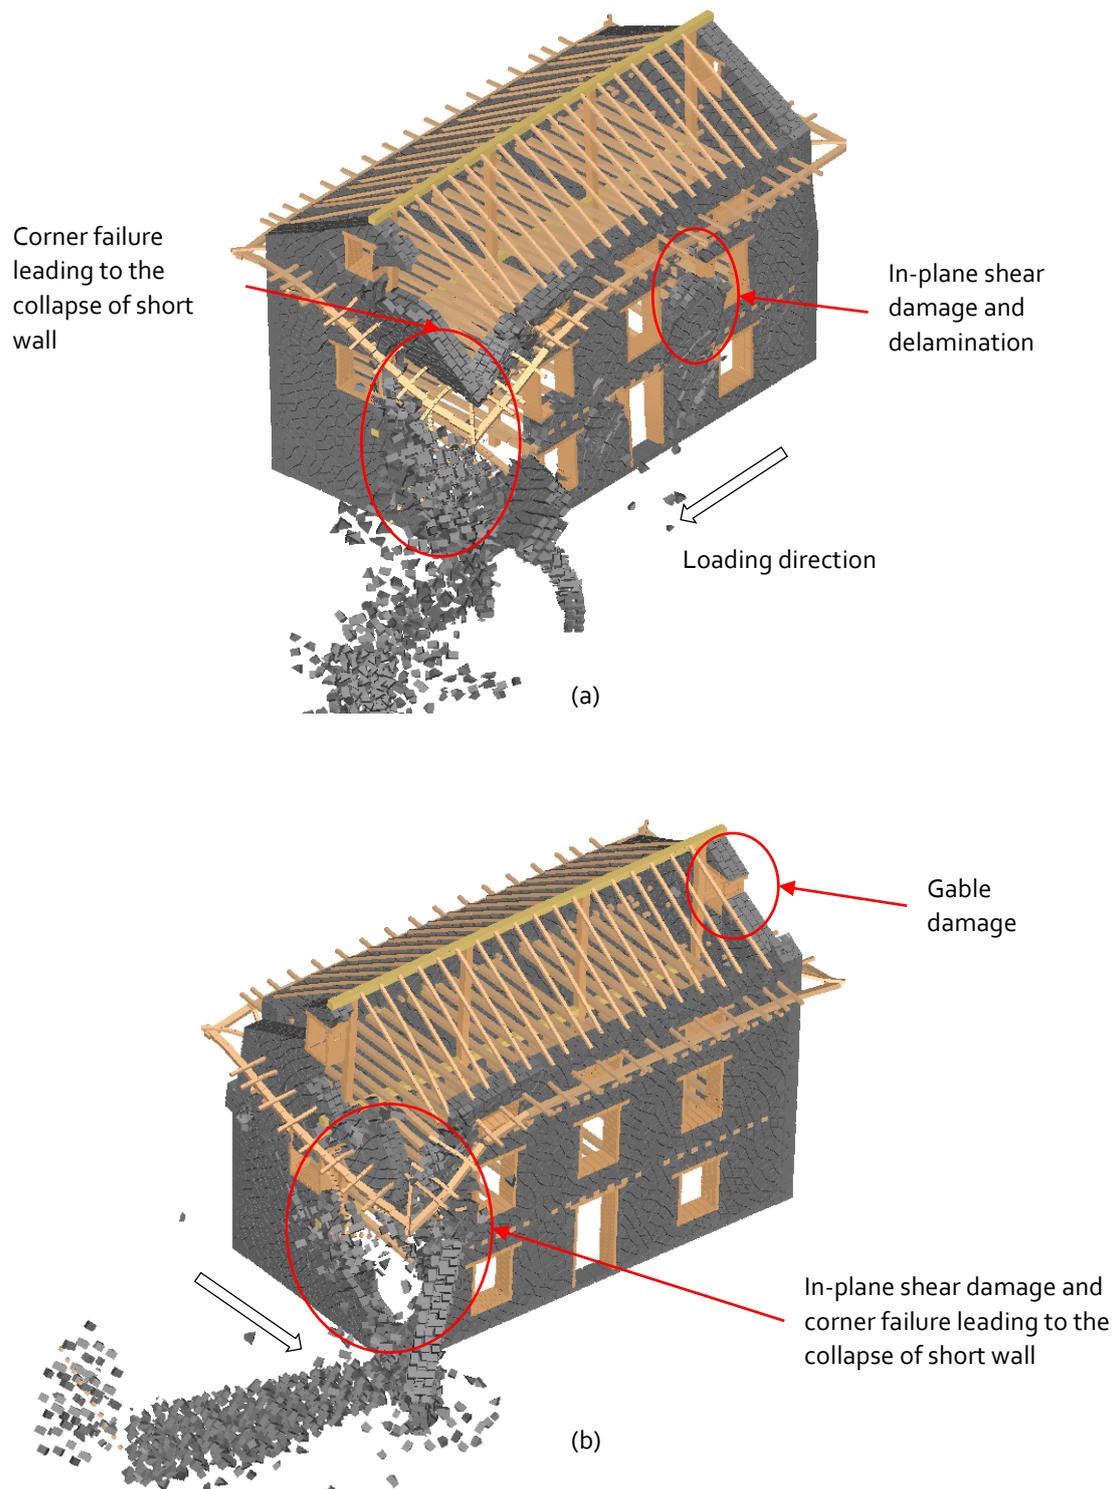
Figure 41. Ultimate collapse mechanism of PRE-SMM typology when loaded along the (a) longitudinal and (b) transverse direction.

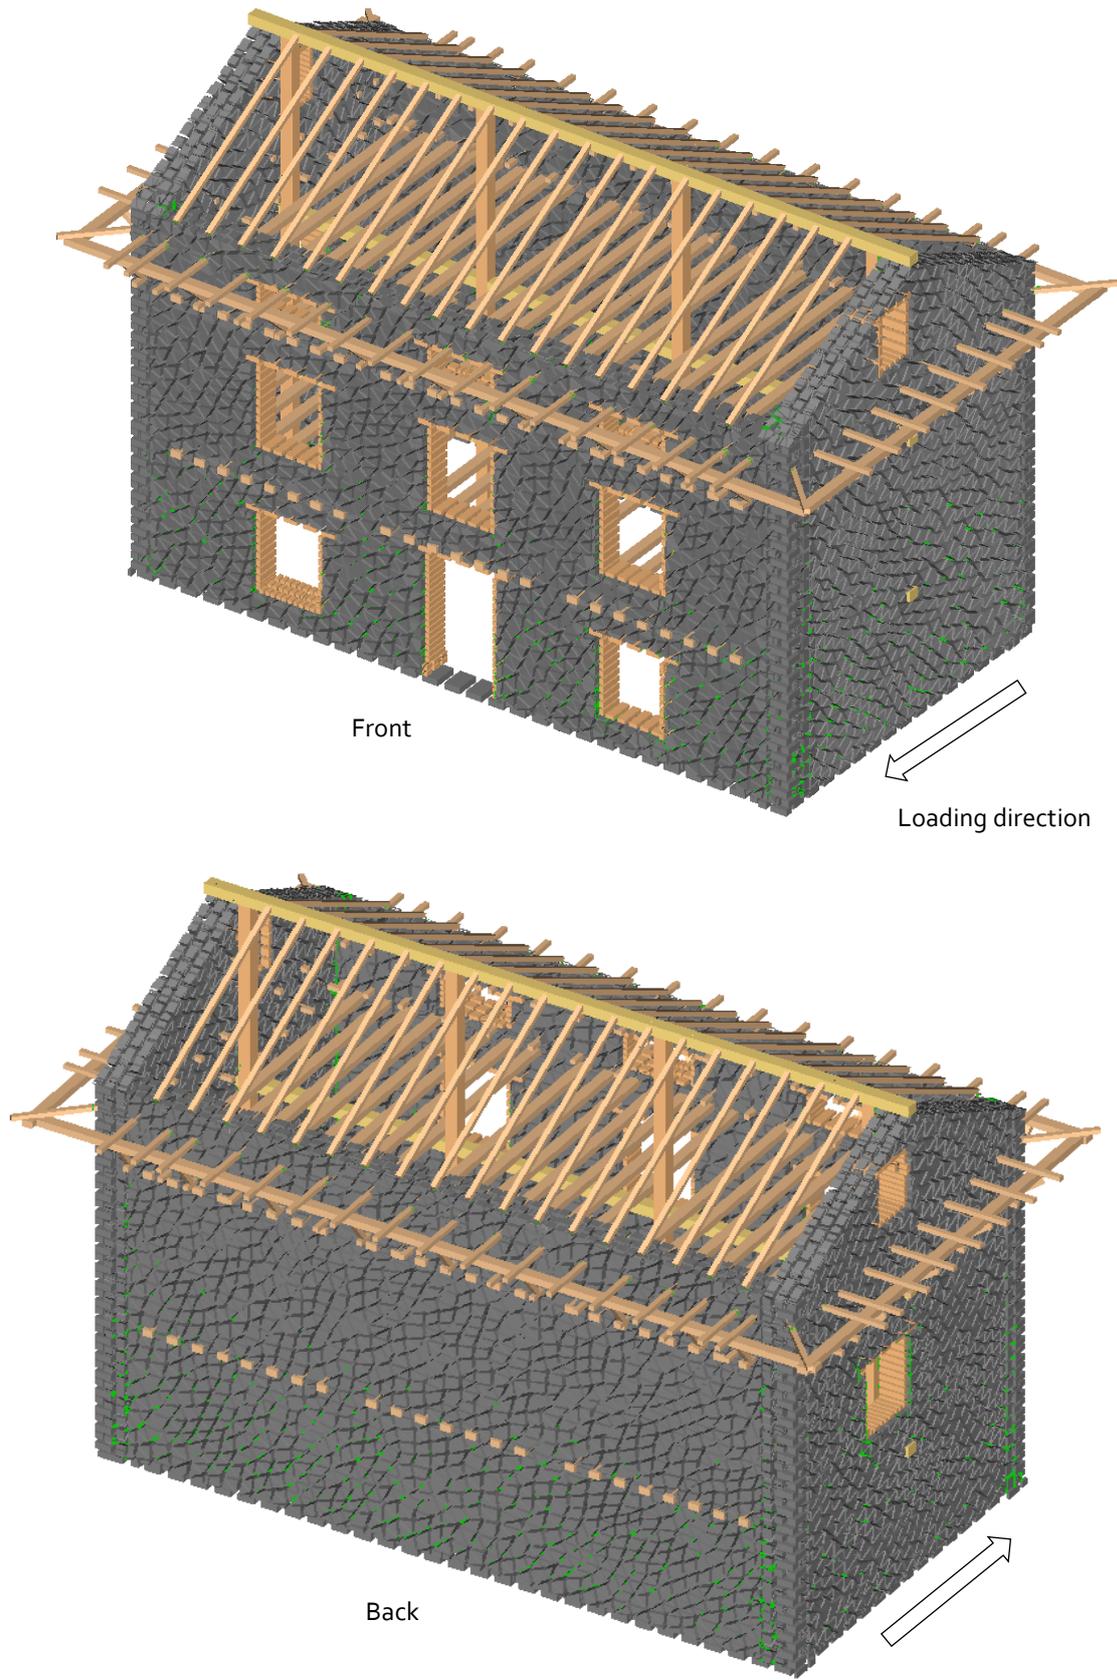
(a) **Operational limit:** Hairline cracks appear at corners of openings and wall-connections. Green cracks represent hairline cracks. Maximum crack opening is less than 0.5 mm.

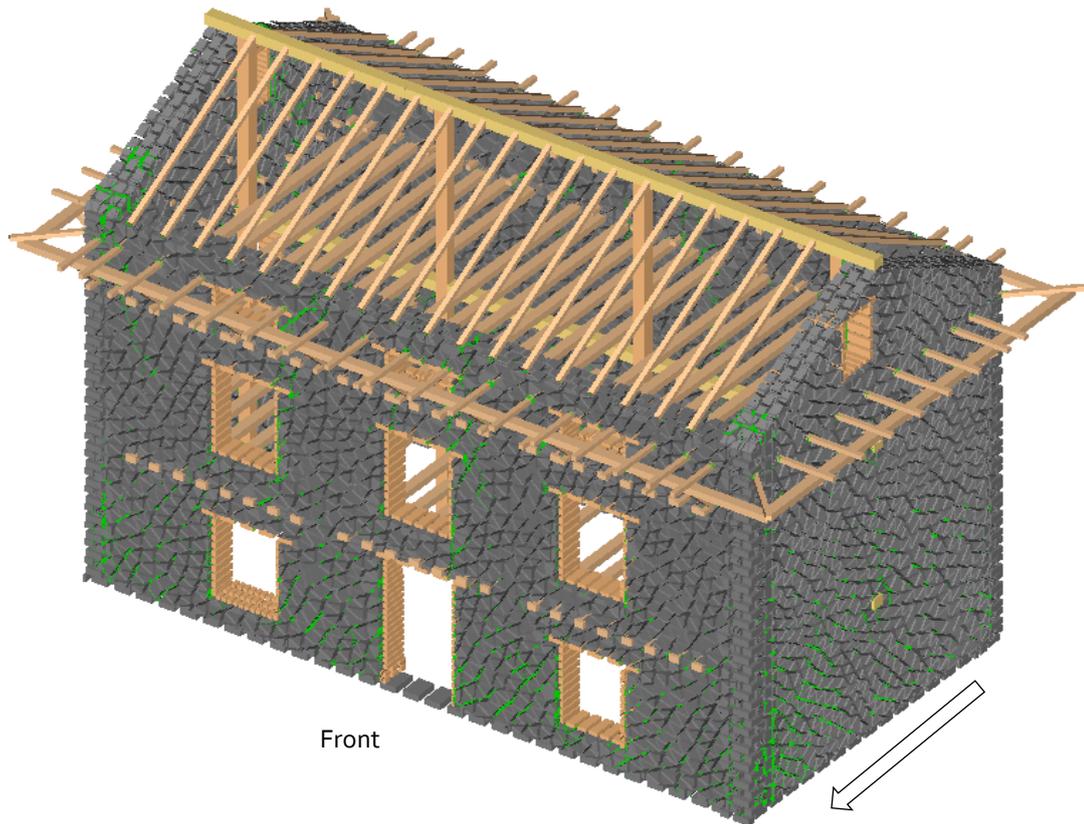
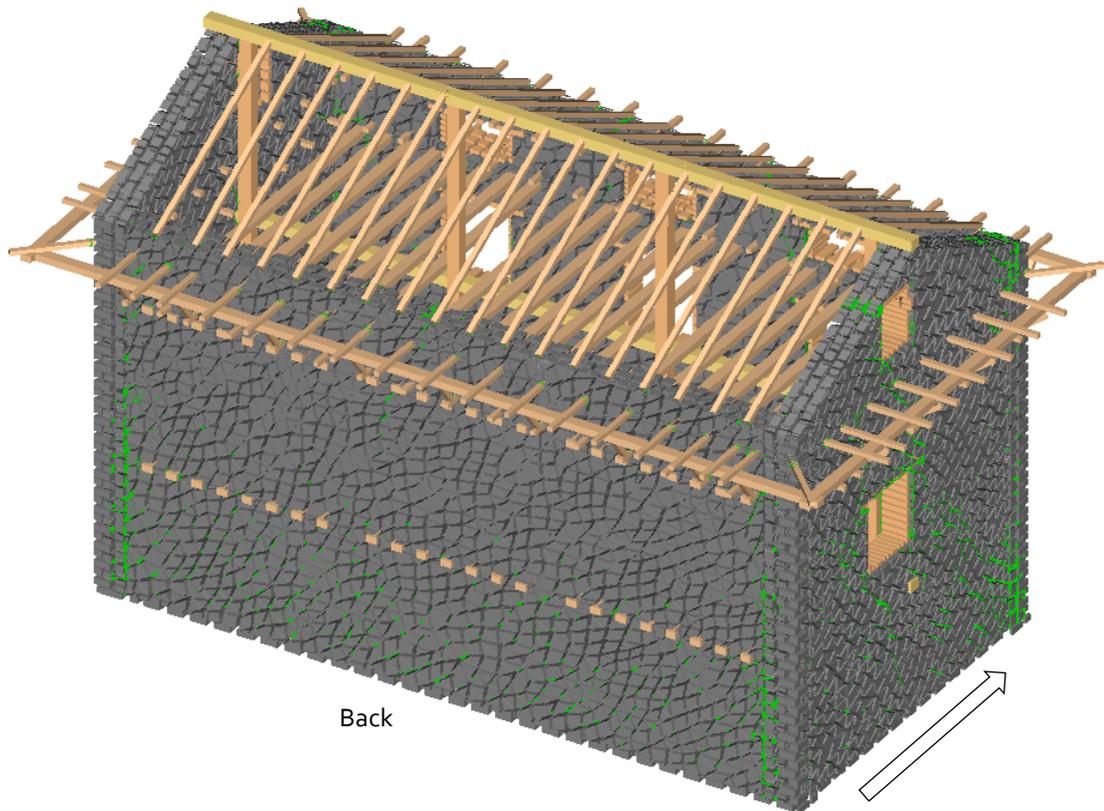
(b) **Immediate occupancy limit:** Hairline to minor cracks all over the wall surface, minor separation cracks appear at cross wall-connections. Green cracks represent hairline to minor cracks. Maximum crack opening is 5 mm. Structure reaches maximum elastic capacity and starts losing stiffness substantially (see also Figure 39).

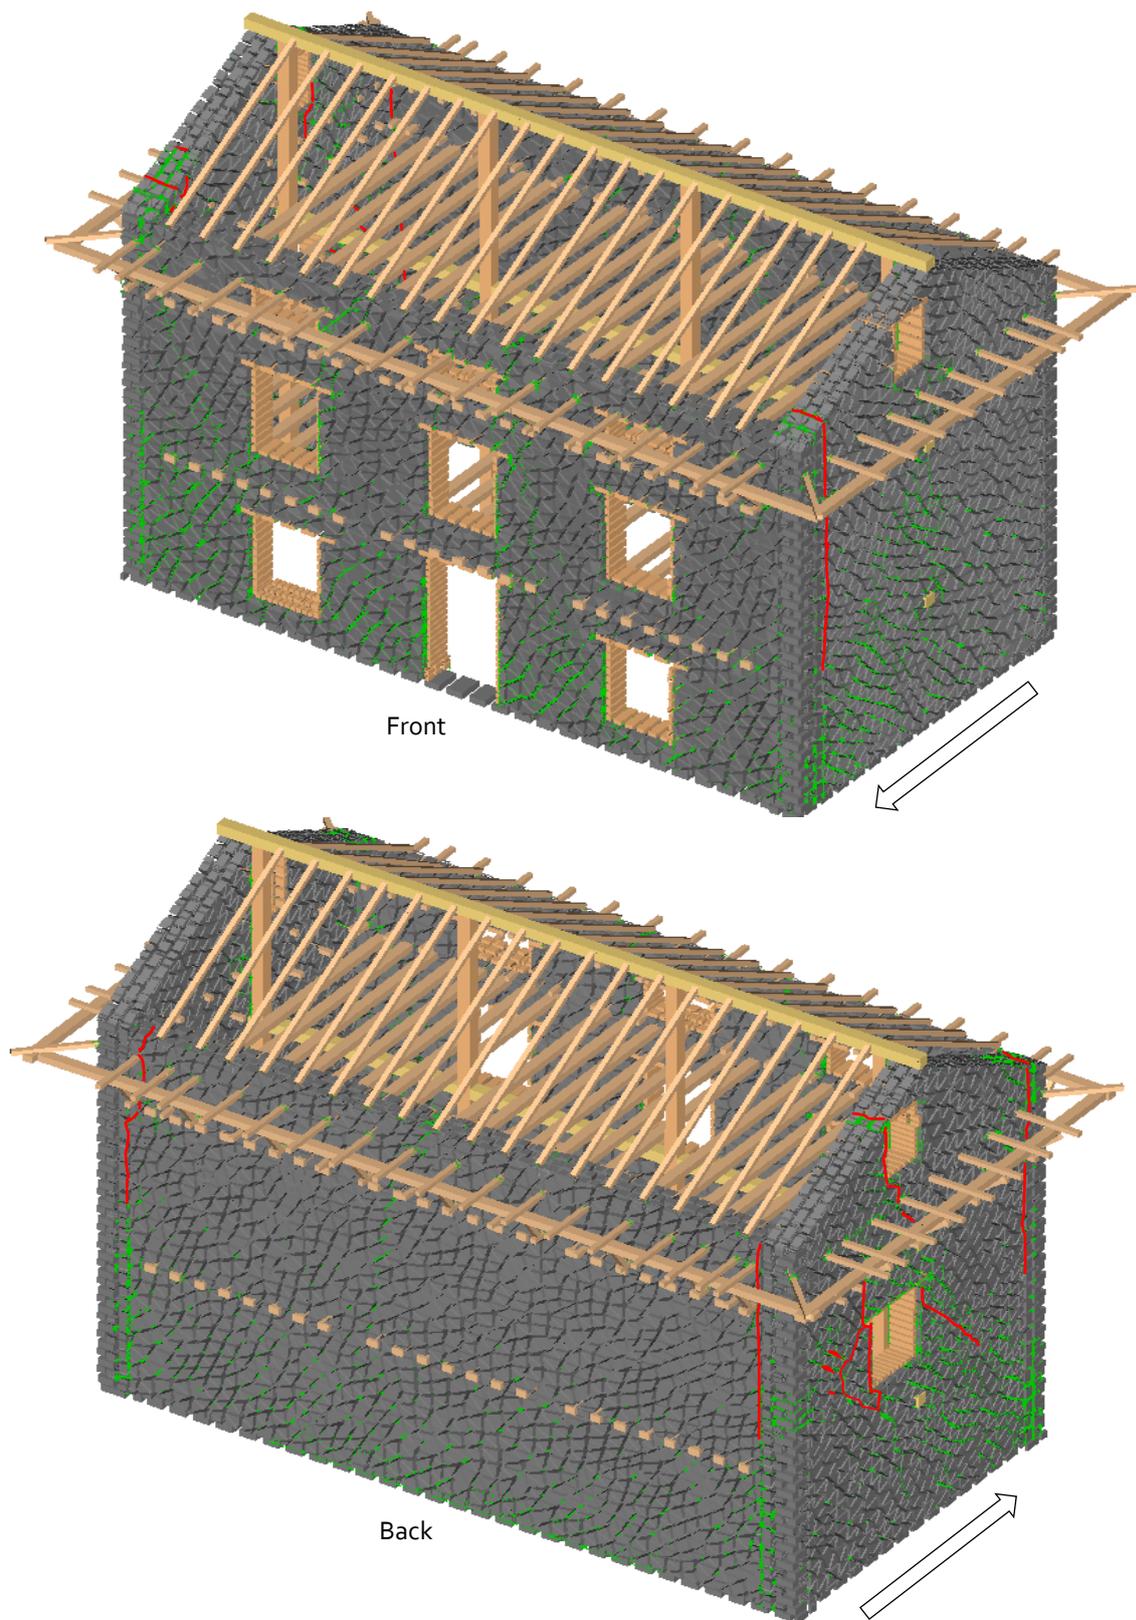
(c) **Life safety limit:** Minor to major shear cracks developed through all the masonry wall surface. The vertical separation cracks (red) become extensive (maximum crack opening of 10 mm) at the top. Visible shear damage (red) in the short in-plane wall with openings.

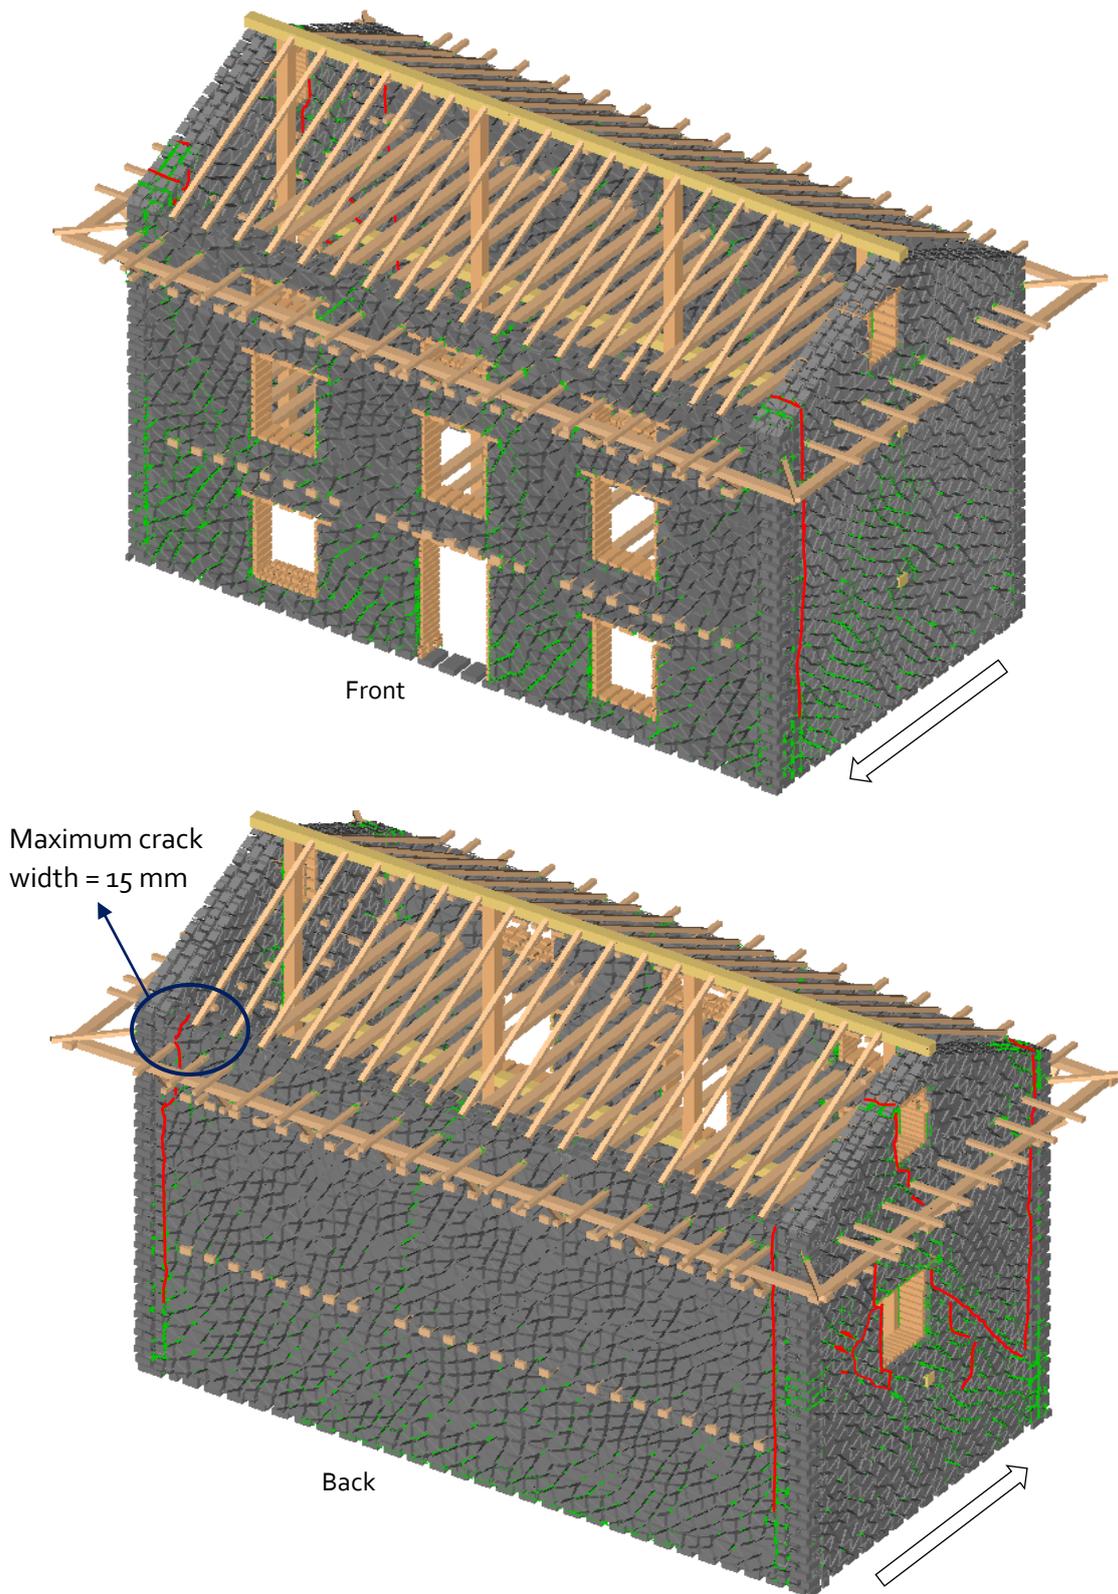
(d) **Collapse prevention limit:** Widely distributed major cracks in all the wall surfaces. The vertical separation cracks (red) and the shear cracks (red) in the short wall with openings become extensive with maximum crack opening of more than 15 mm.

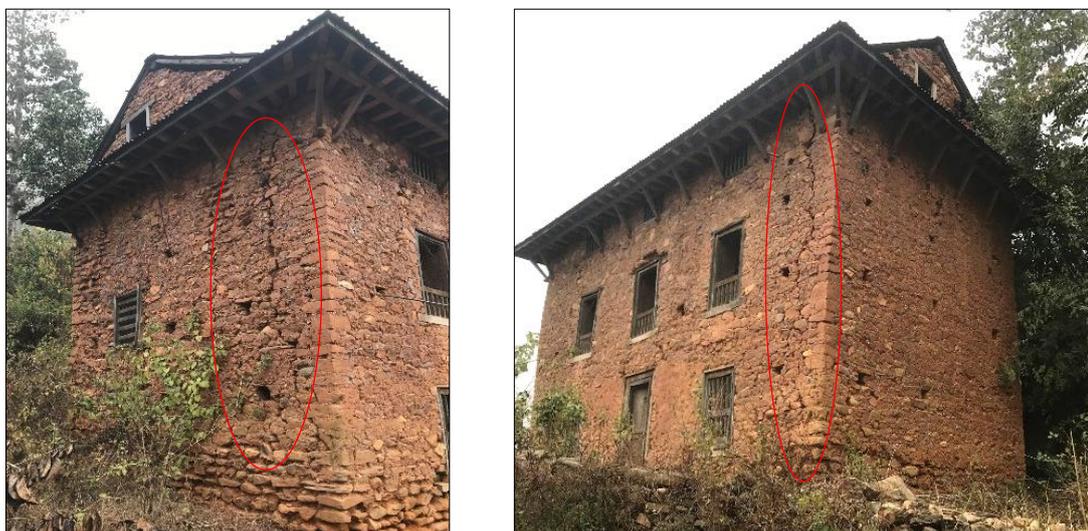
Figure 43. Actual damage due to the 2015 earthquake in the case study PRE-SMM building from Sindhupalchowk district. Vertical separation cracks have a maximum width of about 20 mm.

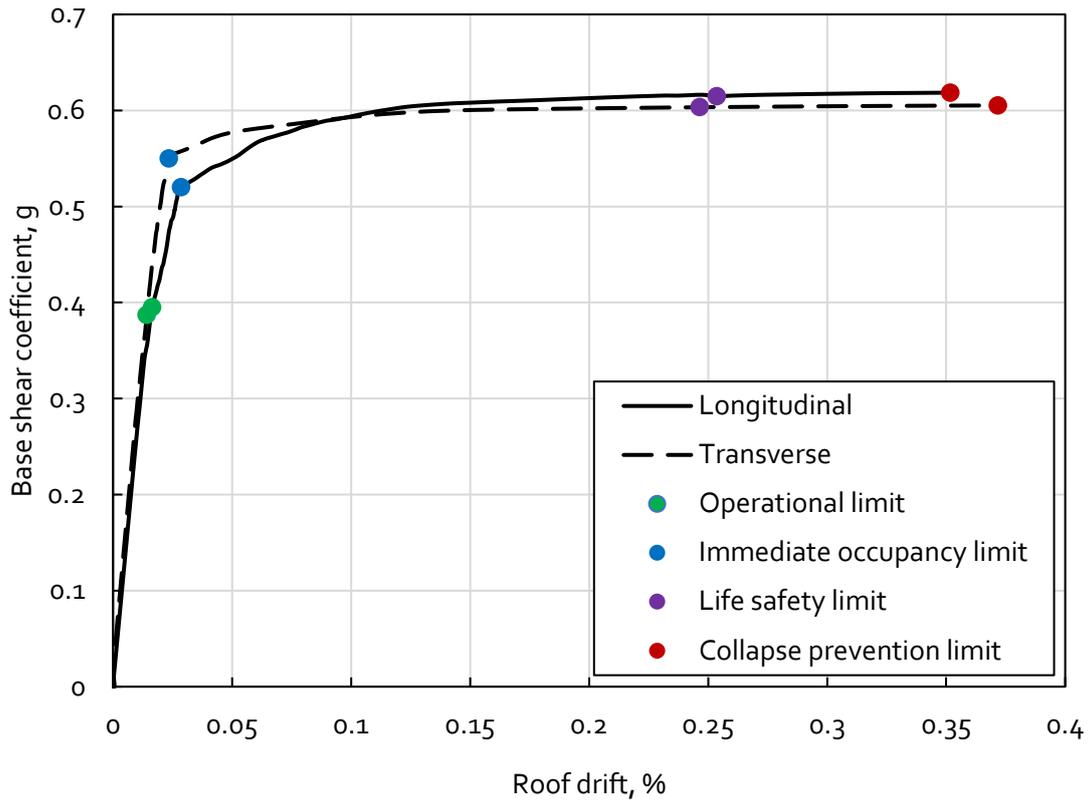
Figure 44. Capacity curves for the POST-SMM typology in two principal directions.

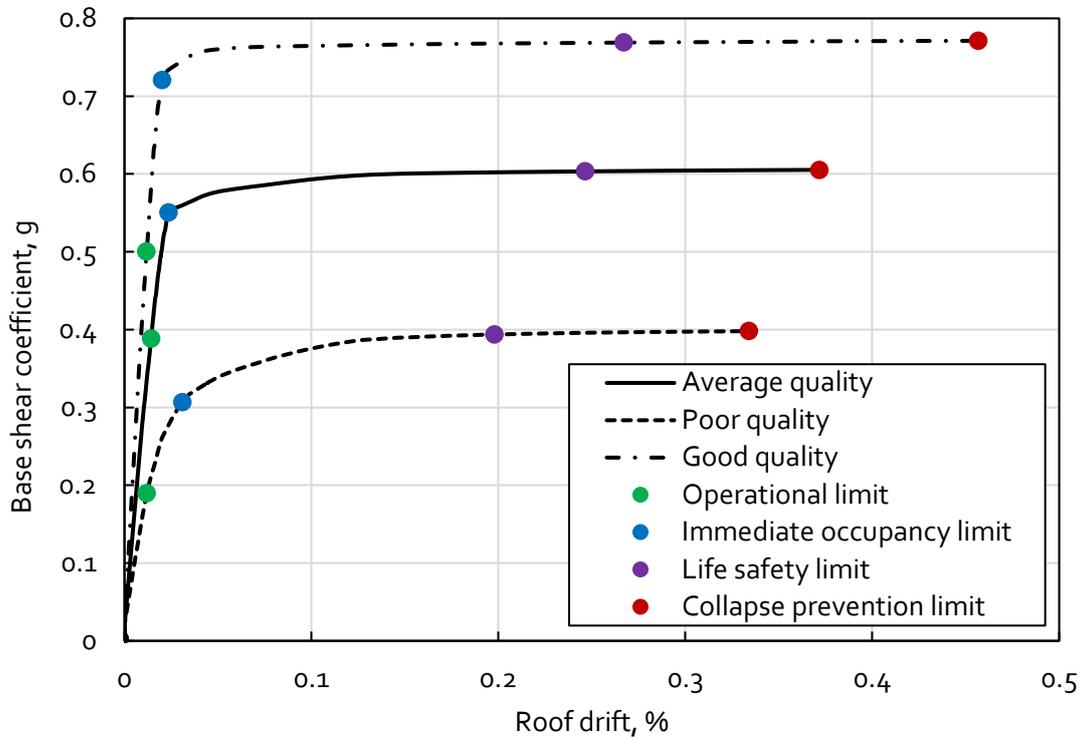
Figure 45. Effect of material quality on the POST-SMM capacity curve (note that the capacity curves in the transverse direction are compared).

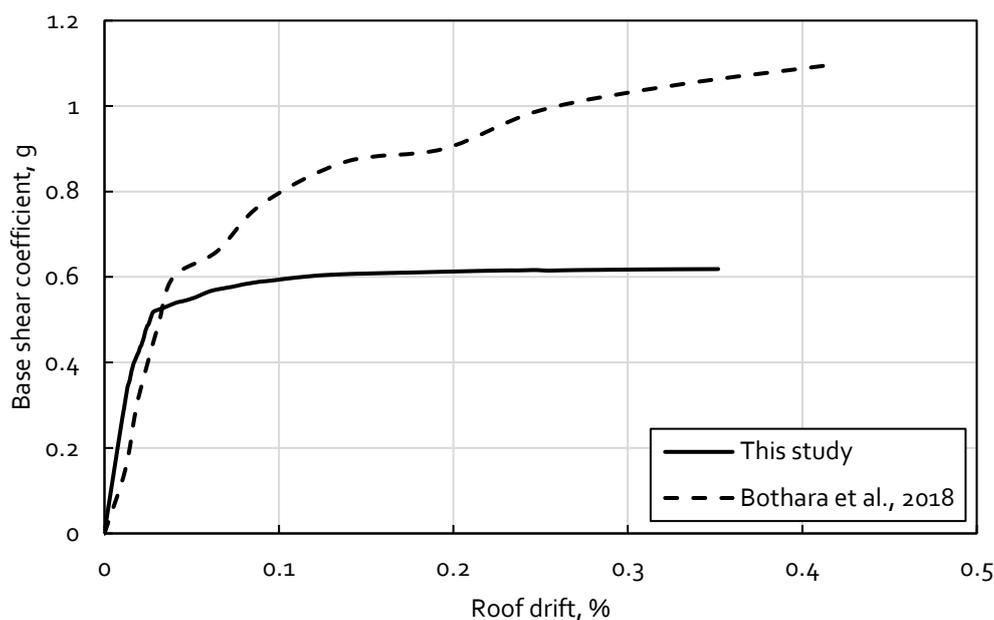
Figure 46. Comparison of capacity curve for the POST-SMM typology from this study and from literature (i.e. [Bothara et al., 2018b](#)).

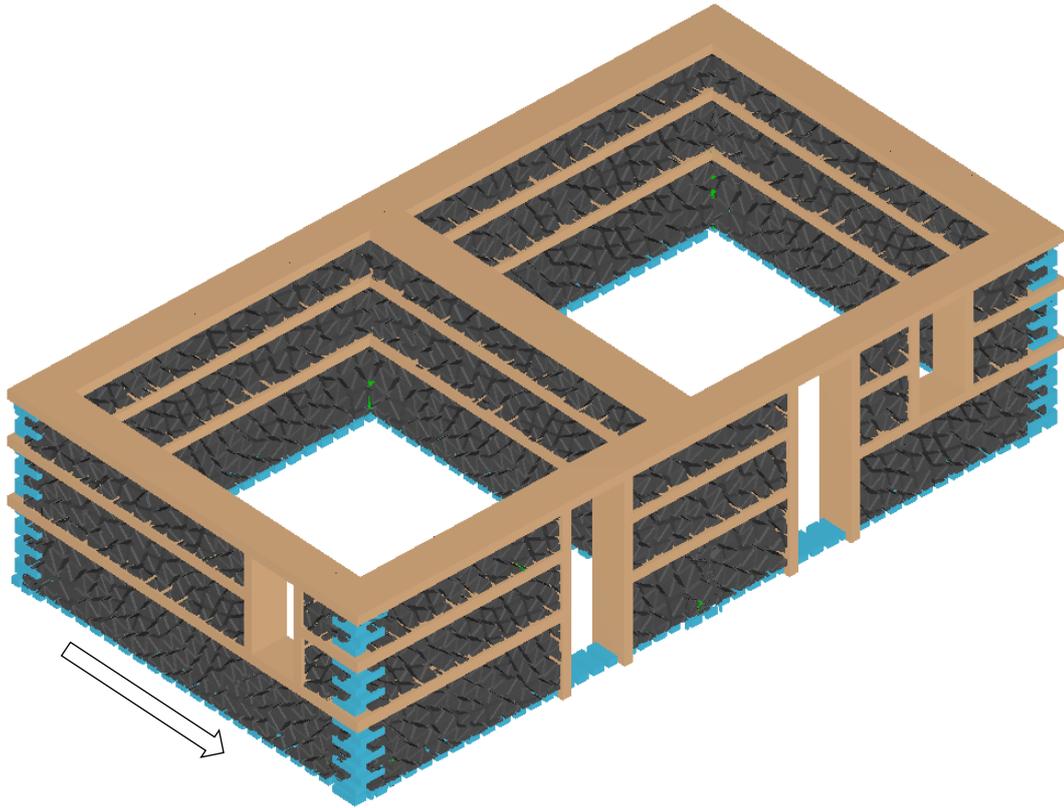
(a) **Operational limit:** Hairline cracks appeared at few corners.

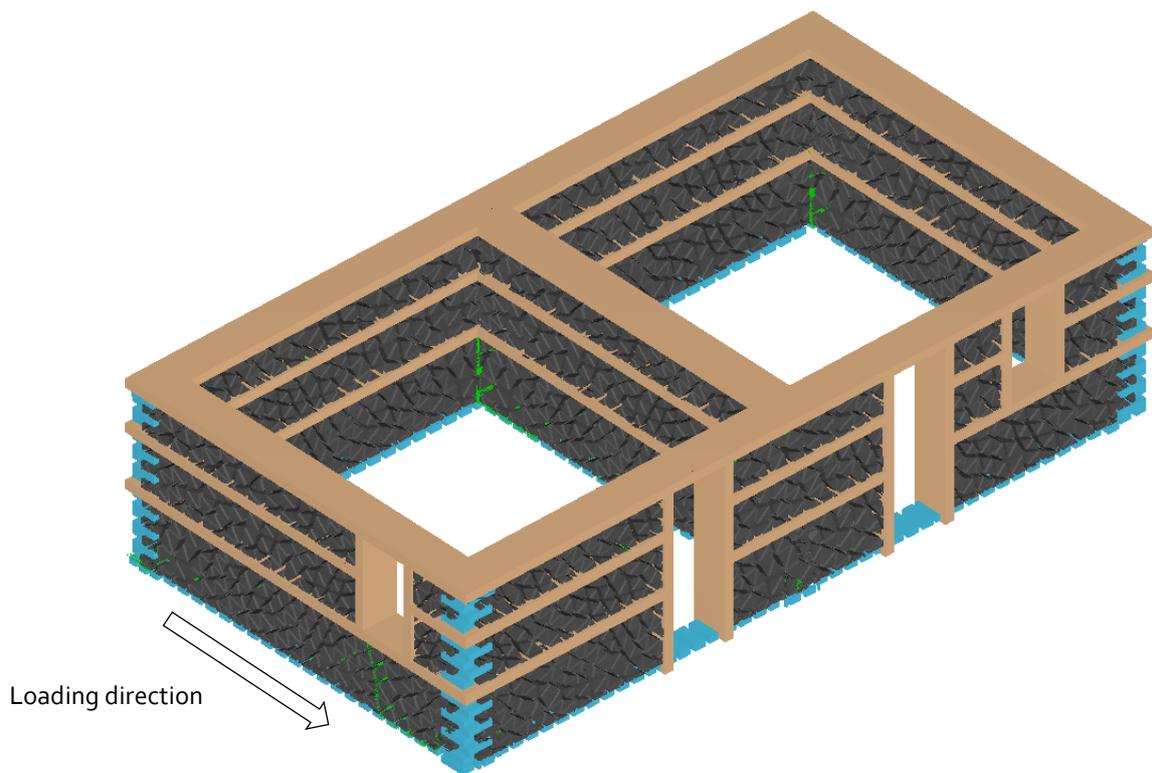
(b) **Immediate occupancy limit:** Hairline to minor cracks on the wall surfaces. Minor shear cracks and shear sliding cracks appear at the bottom most layer. Maximum crack opening is 3 mm.

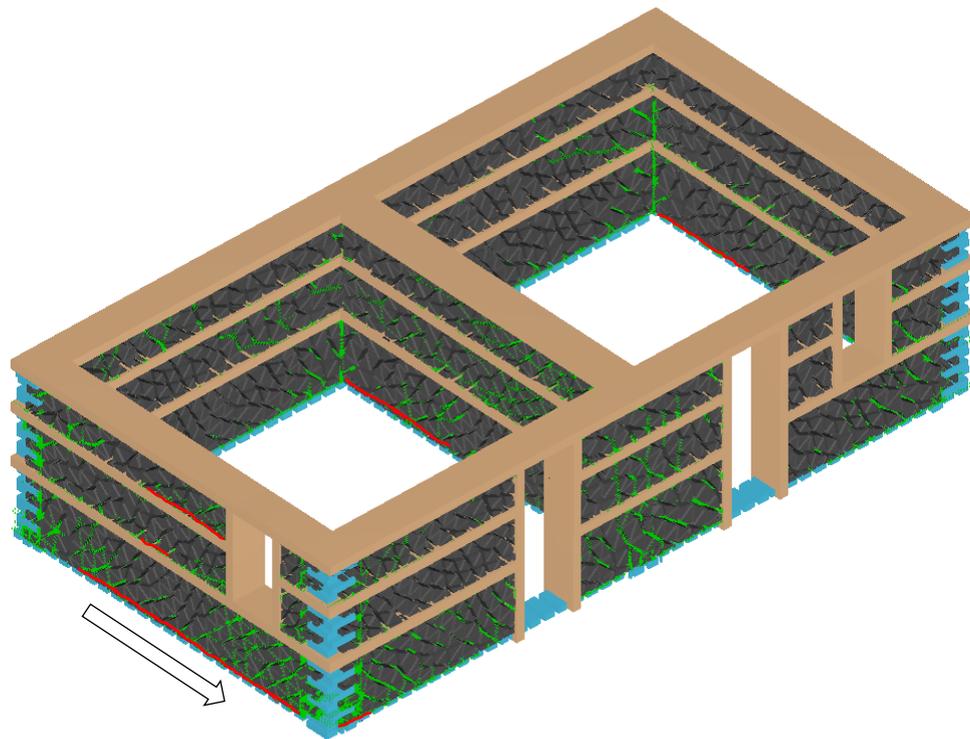
(c) **Life safety limit:** Distributed cracks on all masonry walls. Minor to major sliding shear cracks developed through all the wall-band interfaces. Maximum crack width is about 5 mm.

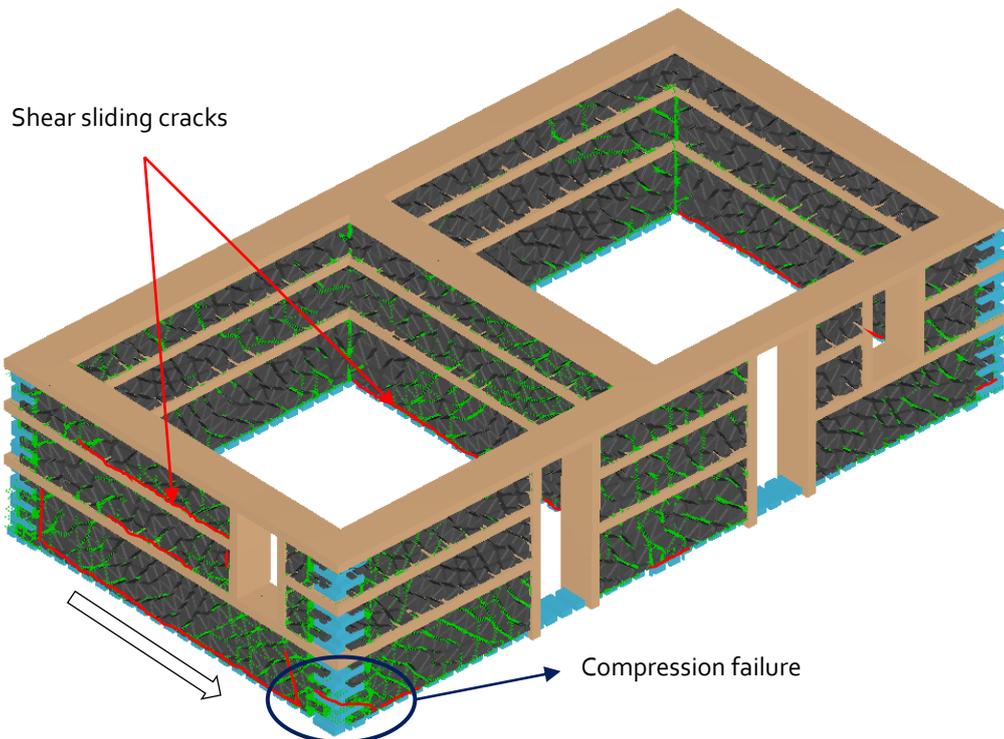
(d) **Collapse prevention limit:** Minor to extensive cracks in all the wall surfaces. The shear sliding cracks extended through full length. Weakest corner on the verge of compression failure. Maximum crack opening of more than 5 mm.

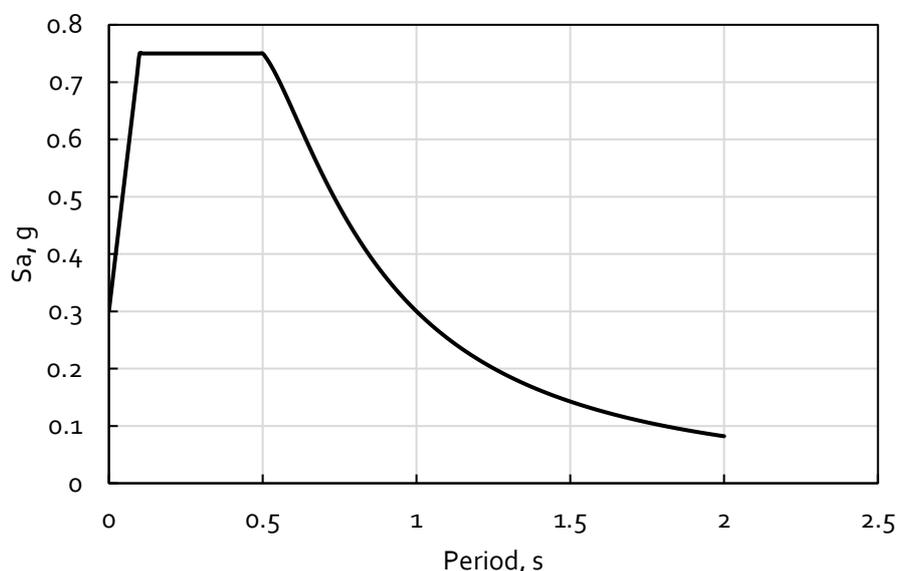
Figure 48. Elastic site spectrum as per NBC 105: 2019.

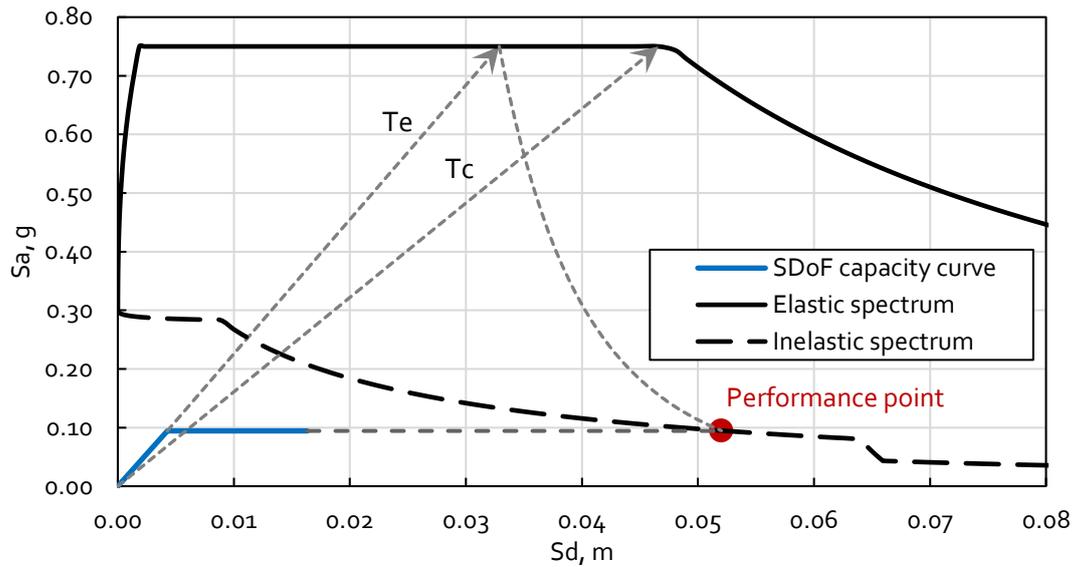
Figure 49. Application of N2 method for seismic performance assessment of PRE-SMM typology (with average quality mortar) using the NBC 105: 2019 elastic site spectrum.

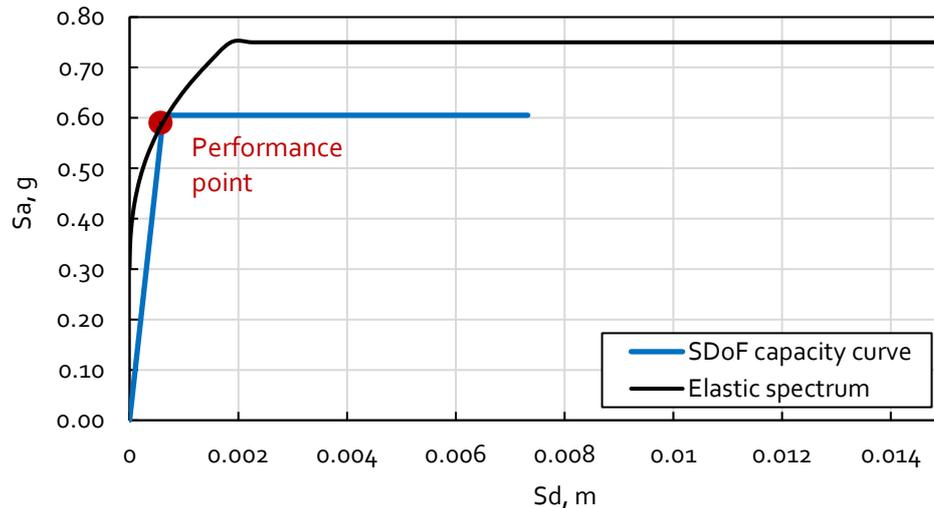
Figure 50. Application of N2 method for seismic performance assessment of POST-SMM typology (with average quality mortar) using the NBC 105: 2019 elastic site spectrum.

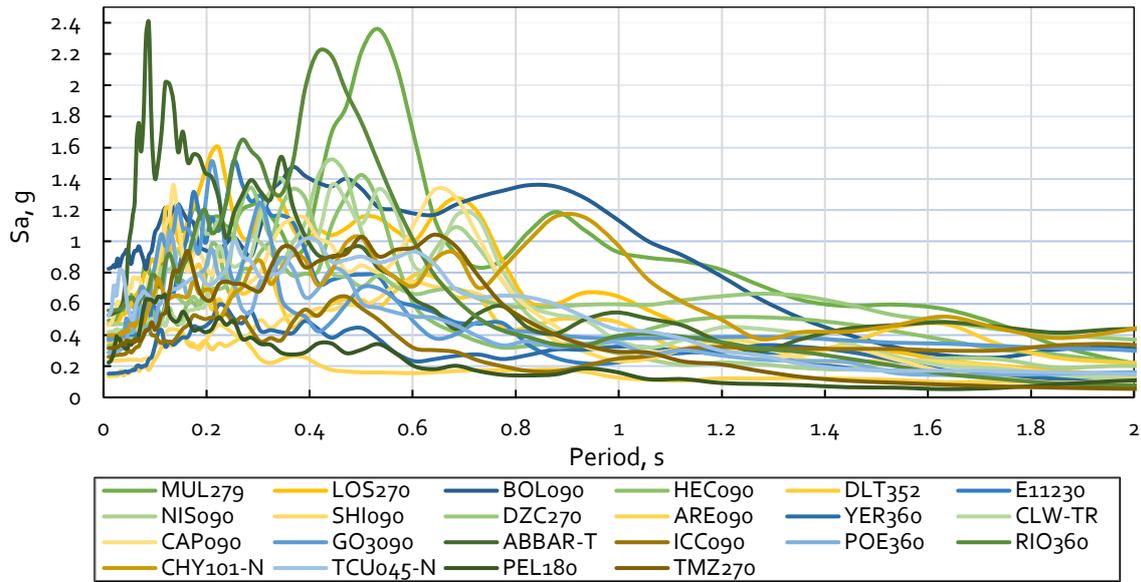
Figure 51. Response spectra of 22 ground motions components from FEMA P695 (FEMA, 2009).

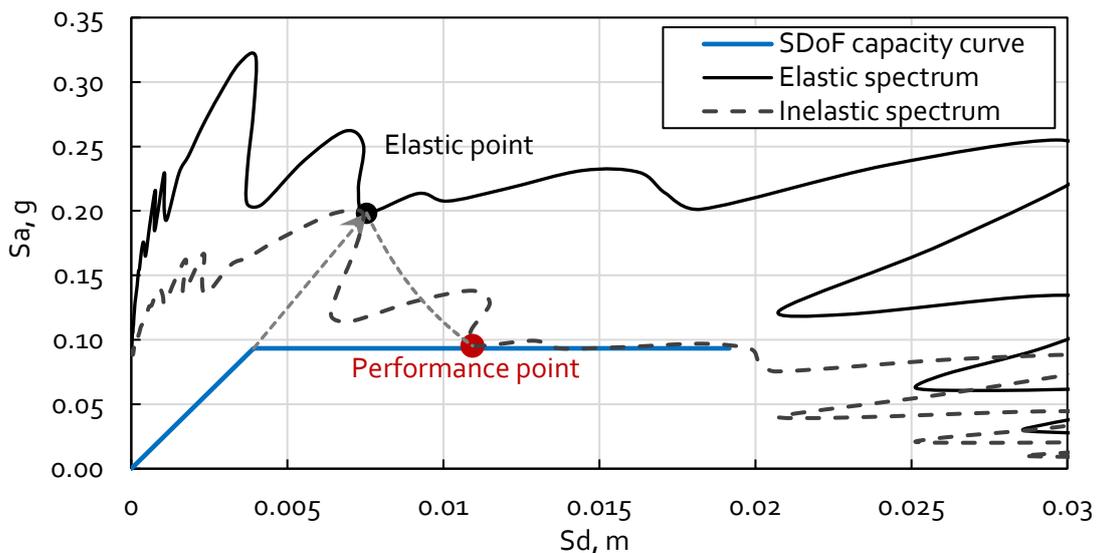
Figure 52. Illustration of seismic performance assessment under a natural record response spectrum using the N2 method.

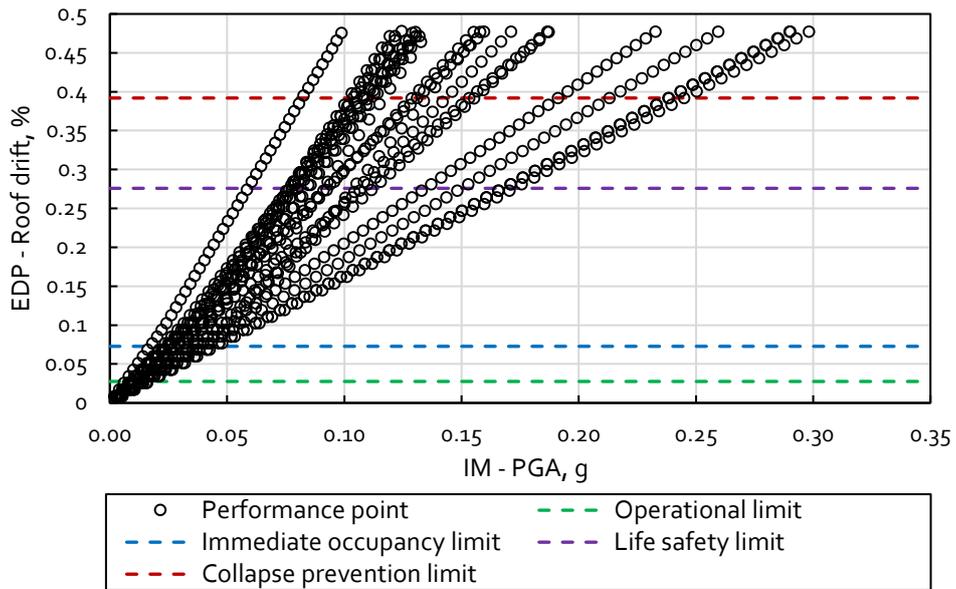
Figure 53. Cloud of performance points for PRE-SMM typology (with average quality mortar) under a suite of FEMA P695 set of 22 ground motions.

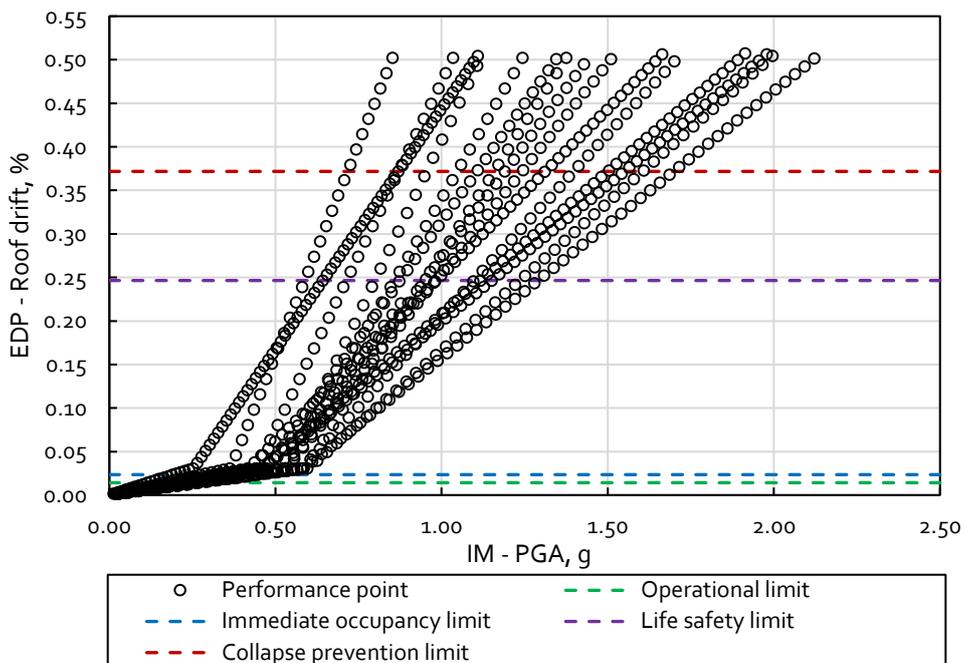
Figure 54. Cloud of performance points for PSOT-SMM typology (with average quality mortar) under a suite of FEMA P695 set of 22 ground motions.

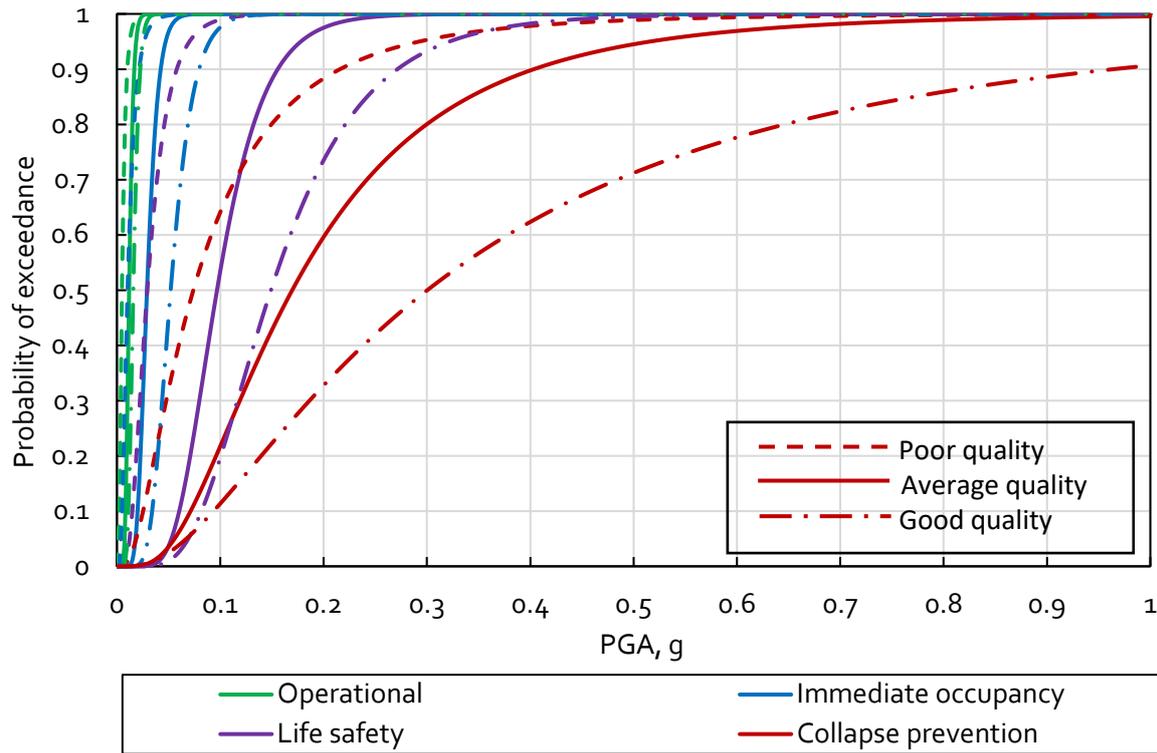
Figure 55. Seismic fragility functions for PRE-SMM typology. Dispersion due to the material quality is also shown.

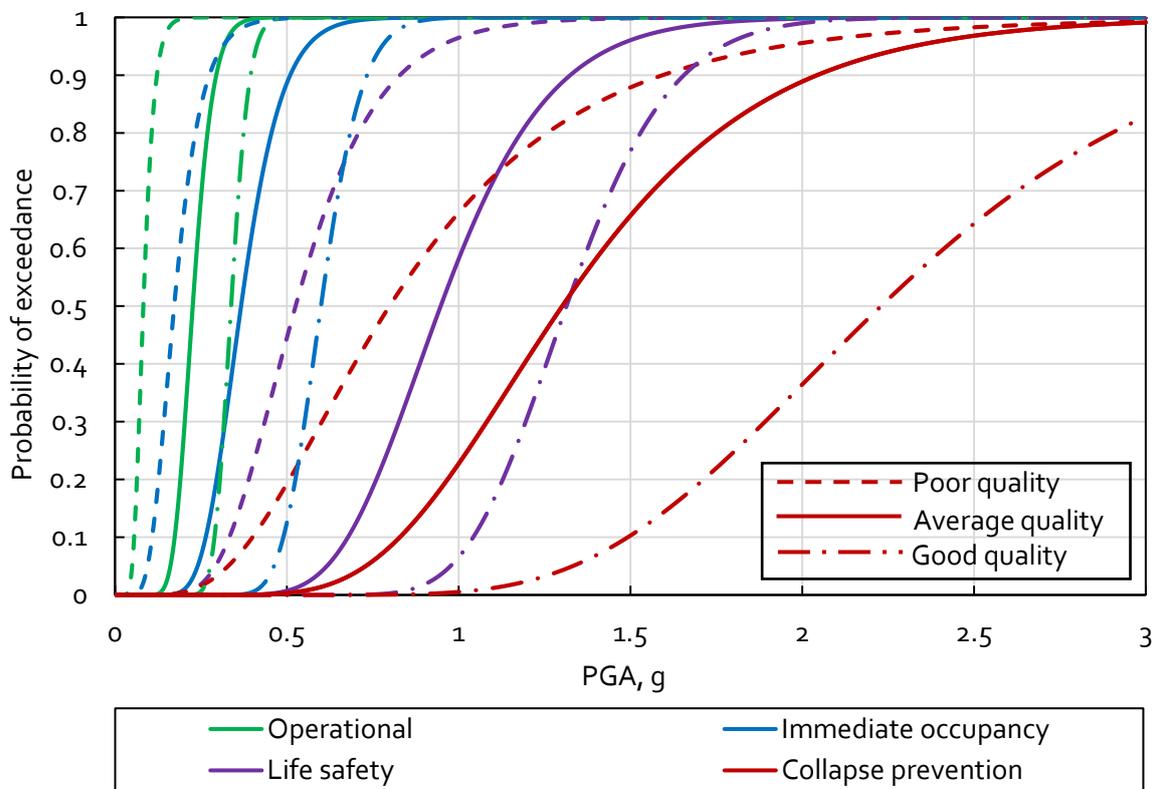
Figure 56. Seismic fragility functions for POST-SMM typology. Dispersion due to the material quality is also shown.
