# 2015 Nepal Earthquake: Seismic Performance and Post-Earthquake Reconstruction of Stone Masonry Buildings

**Rohit Kumar Adhikari and Dina D'Ayala**

Department of Civil, Environmental and Geomatic Engineering,  
University College London

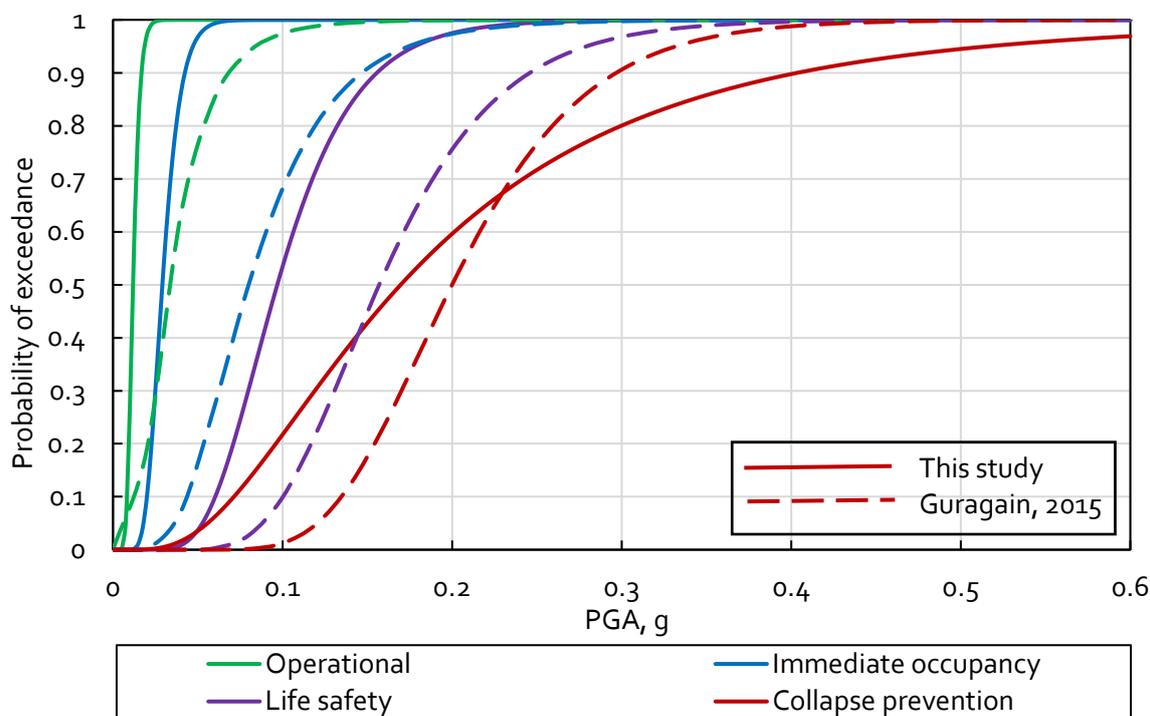
Figure 57. Comparison of fragility curves for PRE-SMM typology from this study with the same from Guragain (2015).

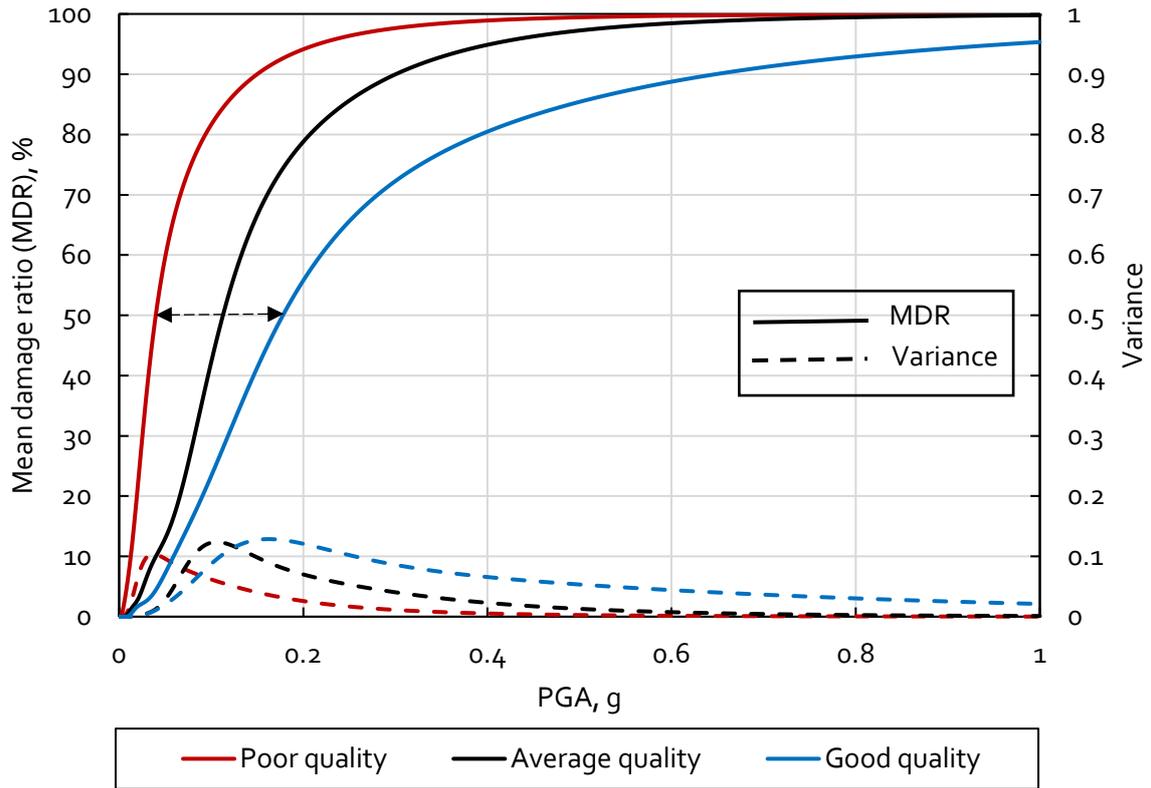
Figure 58. Seismic vulnerability functions for the PRE-SMM typology. Dispersion due to the material quality is also shown.

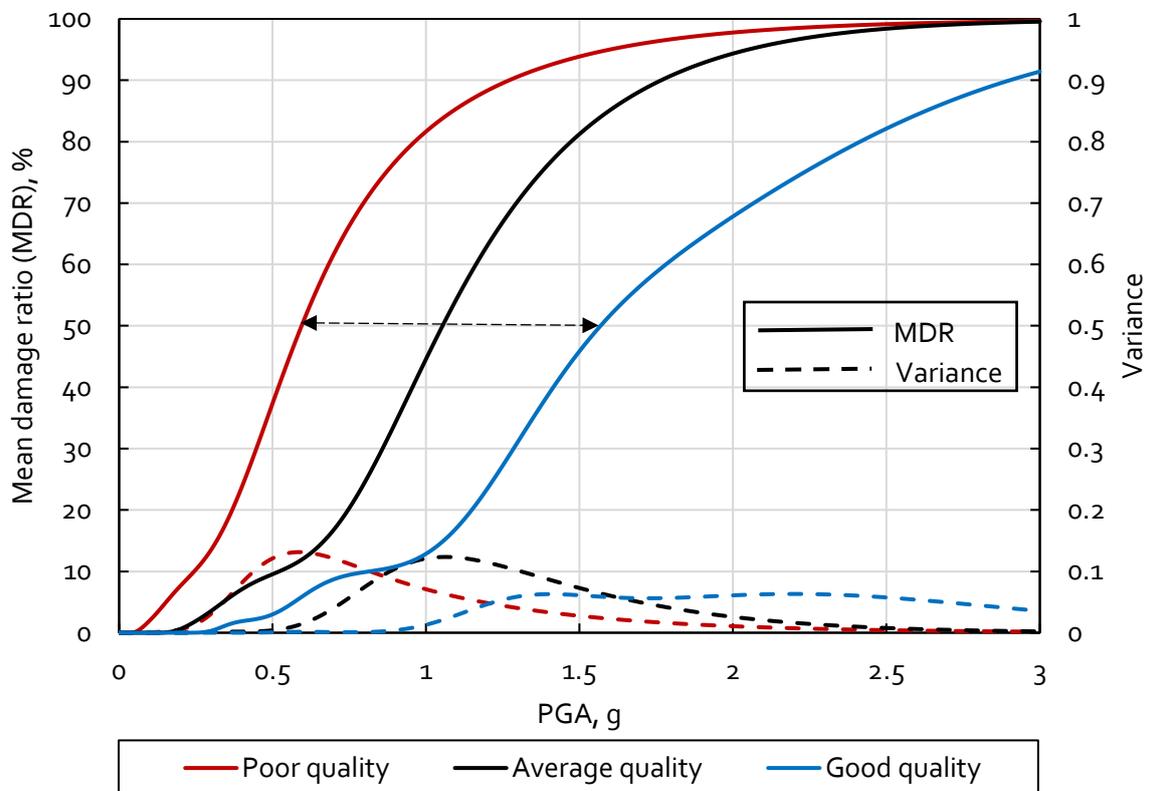
Figure 59. Seismic vulnerability functions for the POST-SMM typology. Dispersion due to the material quality is also shown.

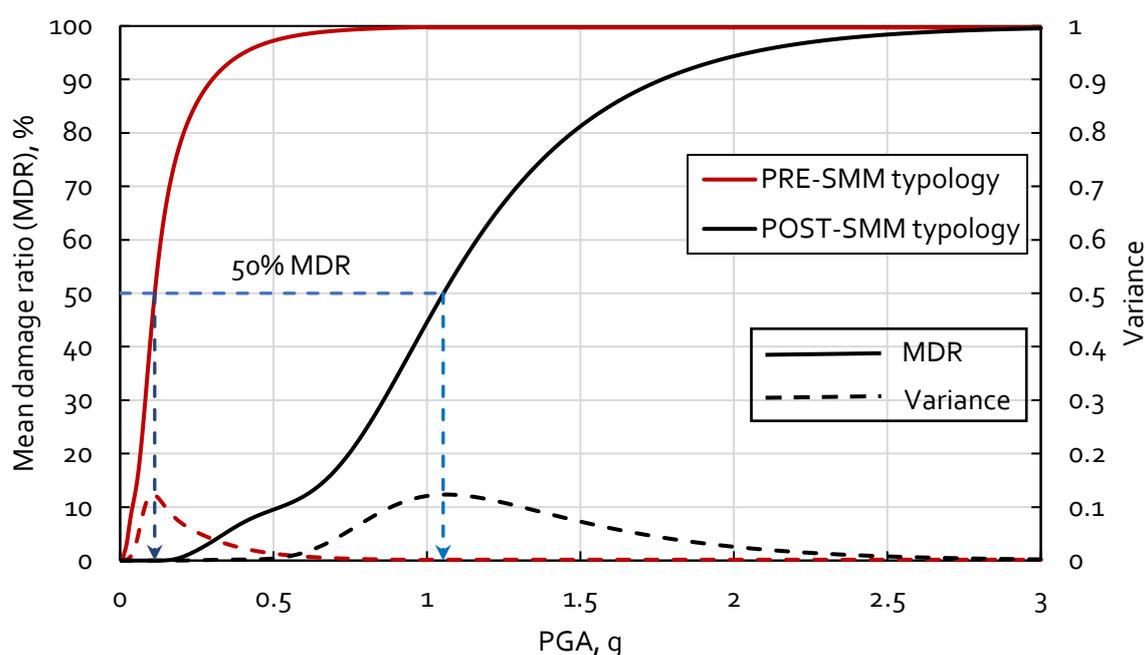
Figure 60. Comparison of seismic vulnerability functions for the PRE- and POST-SMM typologies (with average material quality).
