THE ERZINCAN, TURKEY EARTHQUAKE OF 13 MARCH 1992

A FIELD REPORT BY EEFIT

EEFIT

SYNOPSIS

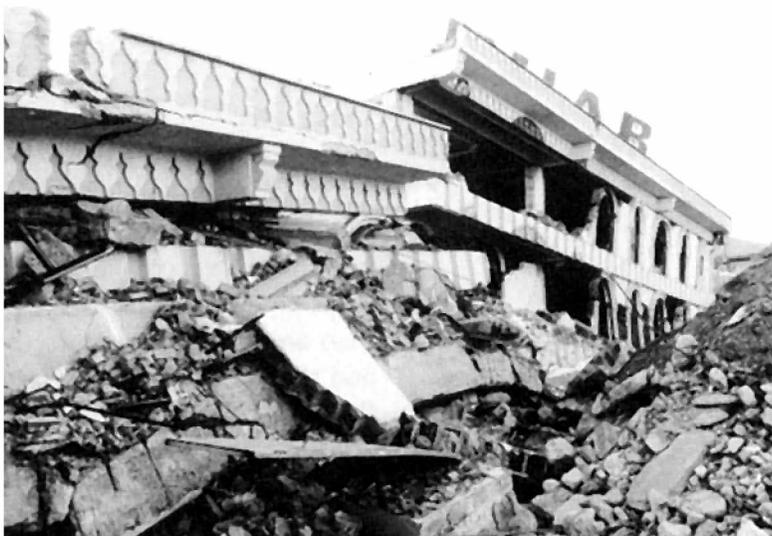
Plate 4.9
Bottom-top collapse of four
storey RC frame with
double basement. The
structure has split at a
movement joint, with the
near half suffering a
complete pancake collapse,
while in the other half the
top two storeys have
survived. *Location 5.*

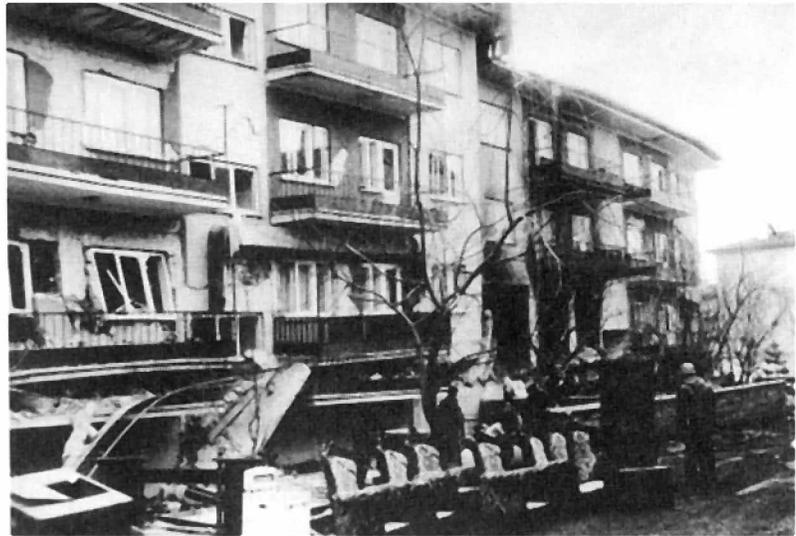
Only one instance was noted of a building in which the top storey had collapsed but the others had remained standing (Plate 4.11). Top-down collapse usually involves structures of more than six storeys, very few of which have been built in Erzincan (Pomonis, 1992). No instances of basement collapse were observed.

Plate 4.11
Building with top floor
collapse. *Location 6.*

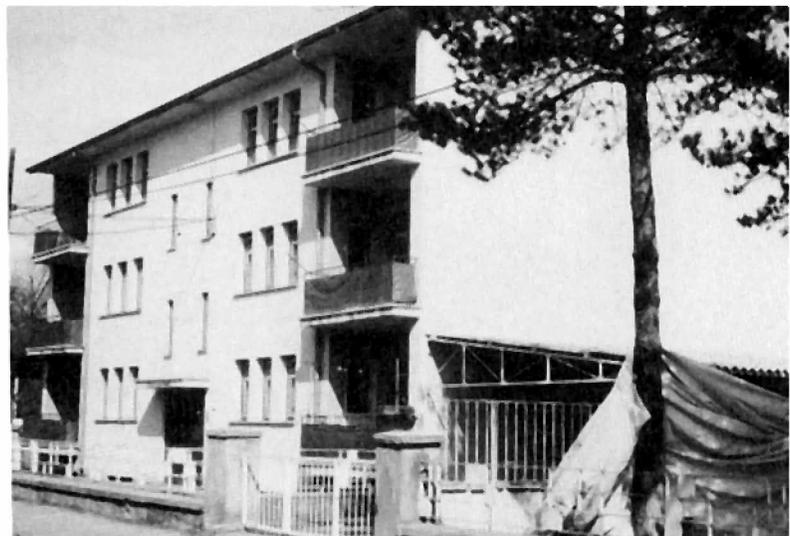
Plate 4.13
New town hall, Erzincan.
Location 8.

Similar ratios were calculated for the southern end of the new Town Hall (Plate 4.13) in Erzincan, a five storey building which was structurally complete but unoccupied at the time of the earthquake. The building also had a moment resisting reinforced concrete frame with limited concrete shear walls and infill blockwork. The building appeared to have suffered no structural damage but there was extensive cracking to finishes and infill walls. The ratios calculated from equation 2 were 0.79 east-west (the likely direction of maximum excitation) and 0.51 north-south. These values would not in themselves be unacceptable in Japanese practice but would necessitate a further check to be carried out.

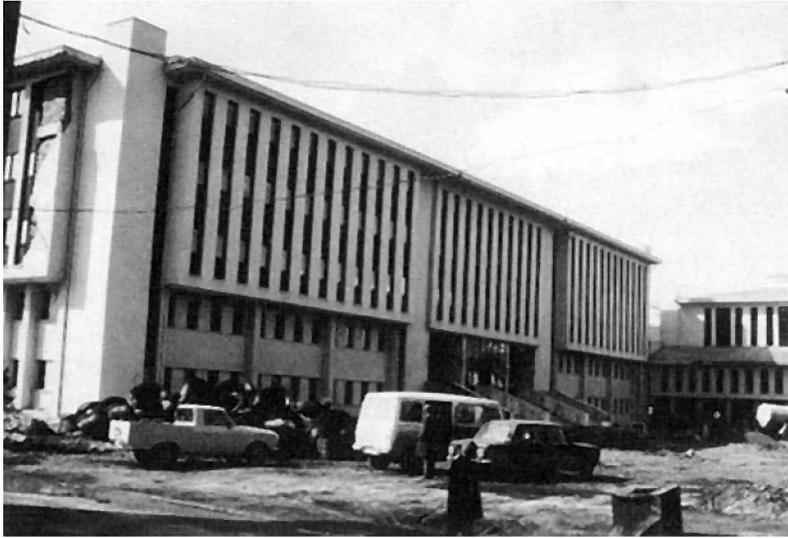
Plate 4.14
New town hall, Erzincan,
the elevated auditorium.
Location 8.

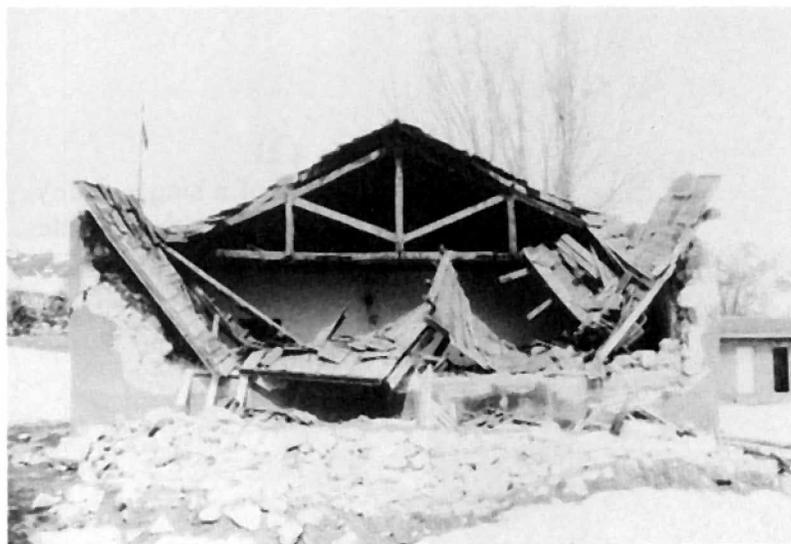
Plate 4.18

Roof collapse of a single storey stone masonry school building. *Location: Mecediyeh.*

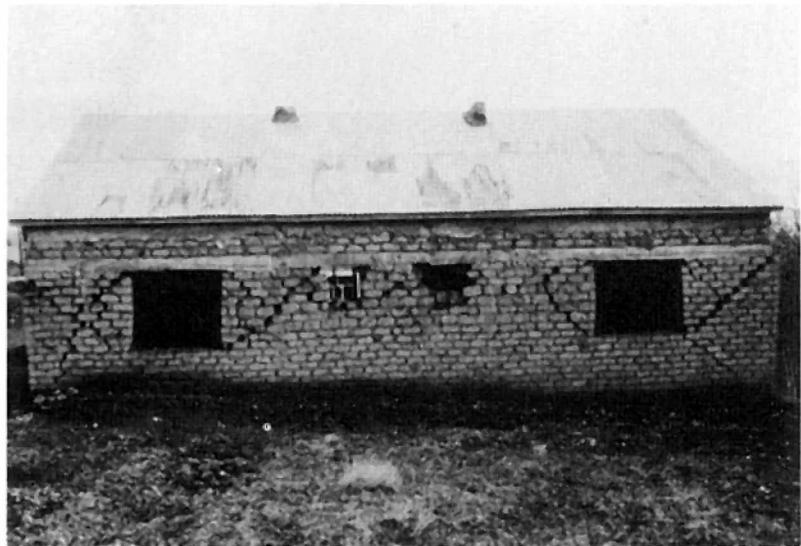
Plate 4.21
Collapse of a single storey adobe house with concrete ring beam. The roof was heavier than that in Plate 4.20, as it was clad with clay tiles. *Location: Yalnizbag.*

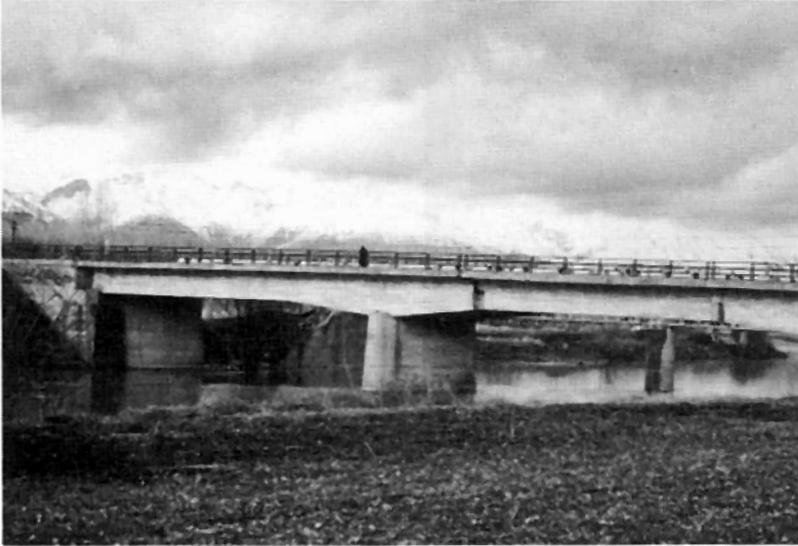
Plate 4.29
Main road bridge over
Euphrates river south of
Erzincan.

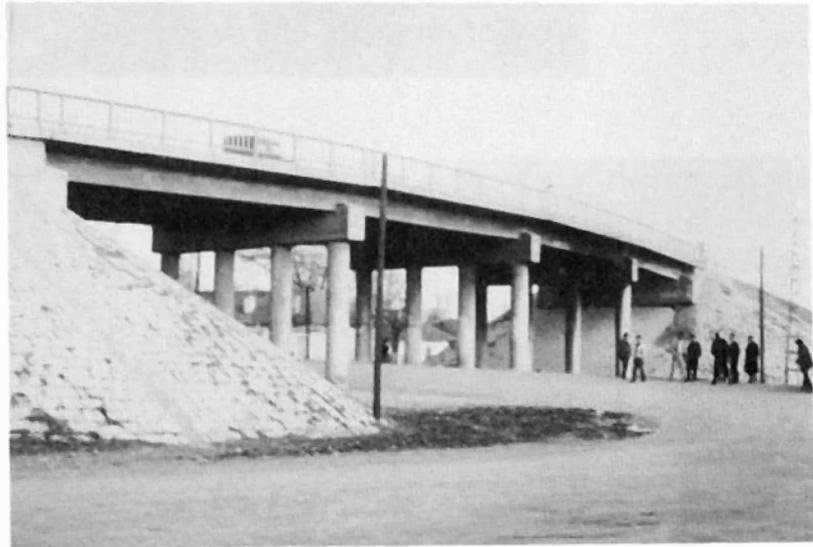
Plate 4.30
Bridge taking main North-
South road over the railway
to the south of the city.

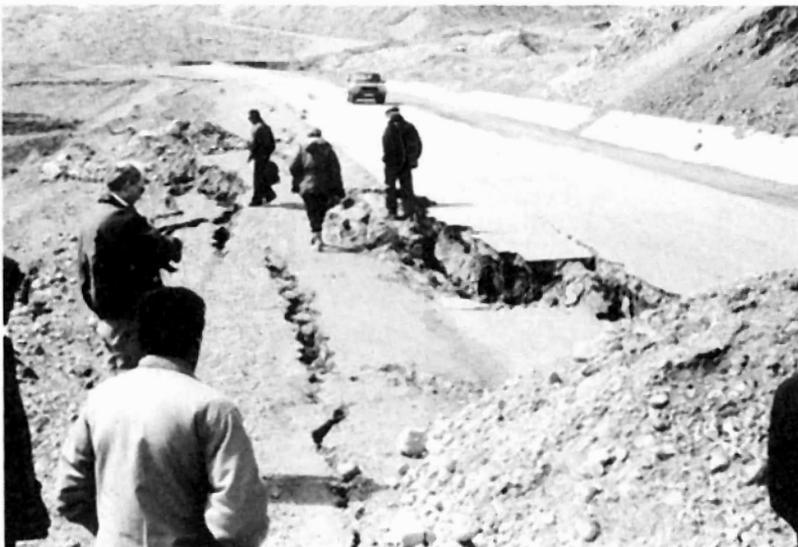
Plate 4.31
Failure of road embankment
near Eksisu.

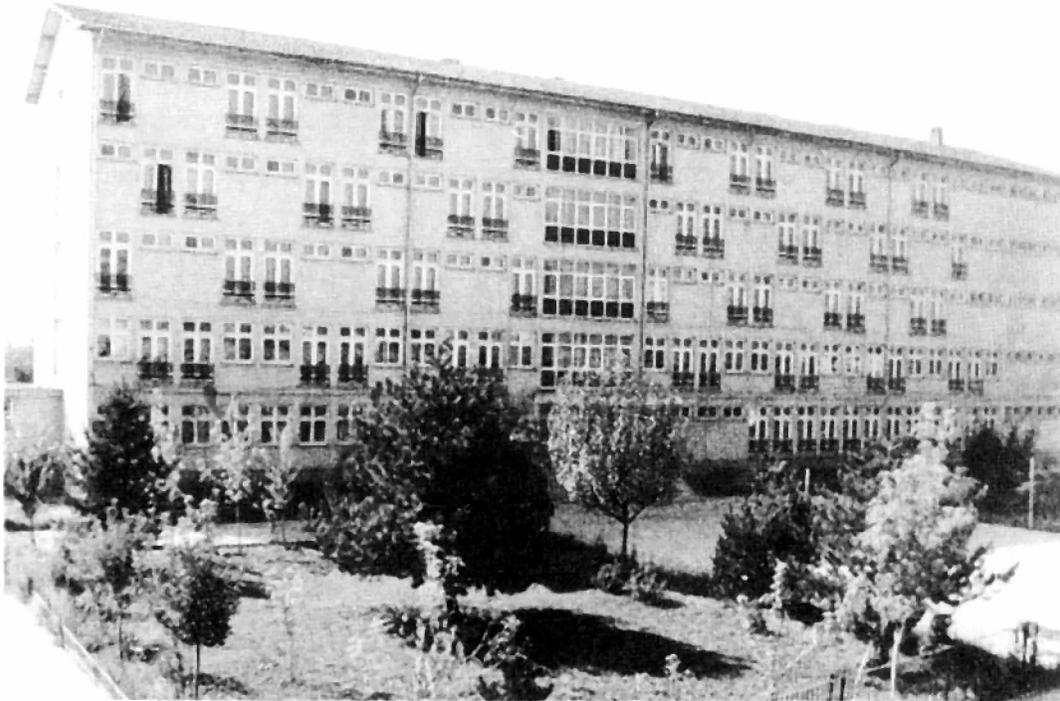
Plate 5.1

The nursing school in the state hospital, before the earthquake. Notice the irregular distribution of openings from floor to floor. The northern façade of the building is identical apart from the entrance canopy. *Location 13.*

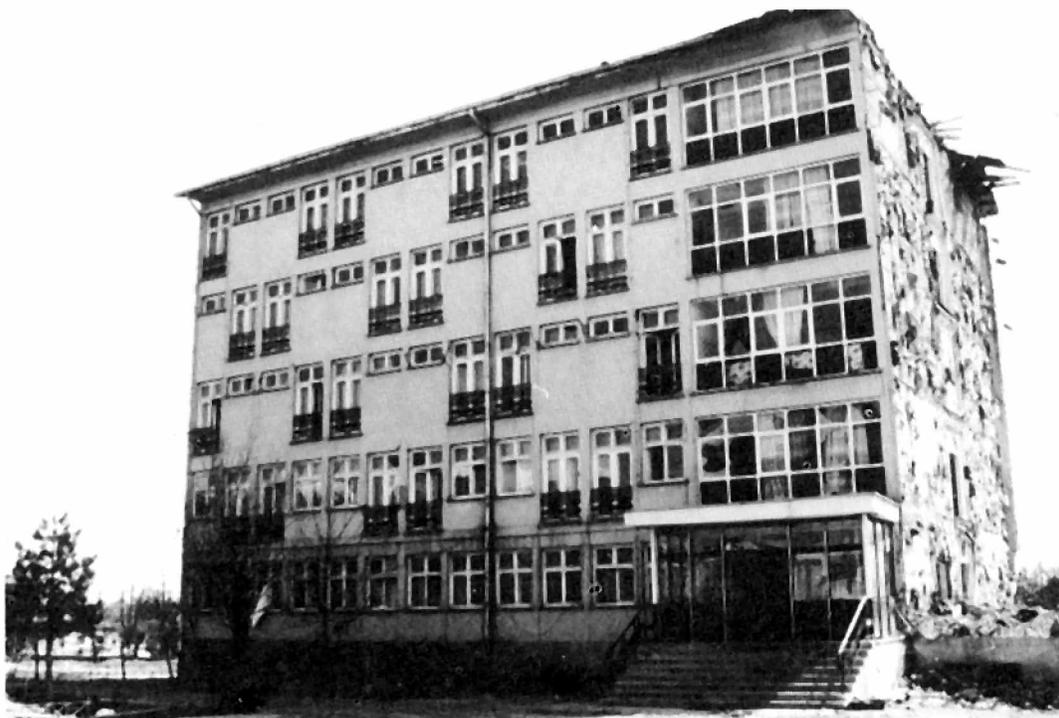
Plate 5.2

The same side of the nursing school after the collapse and debris clearance. *Location 13.*

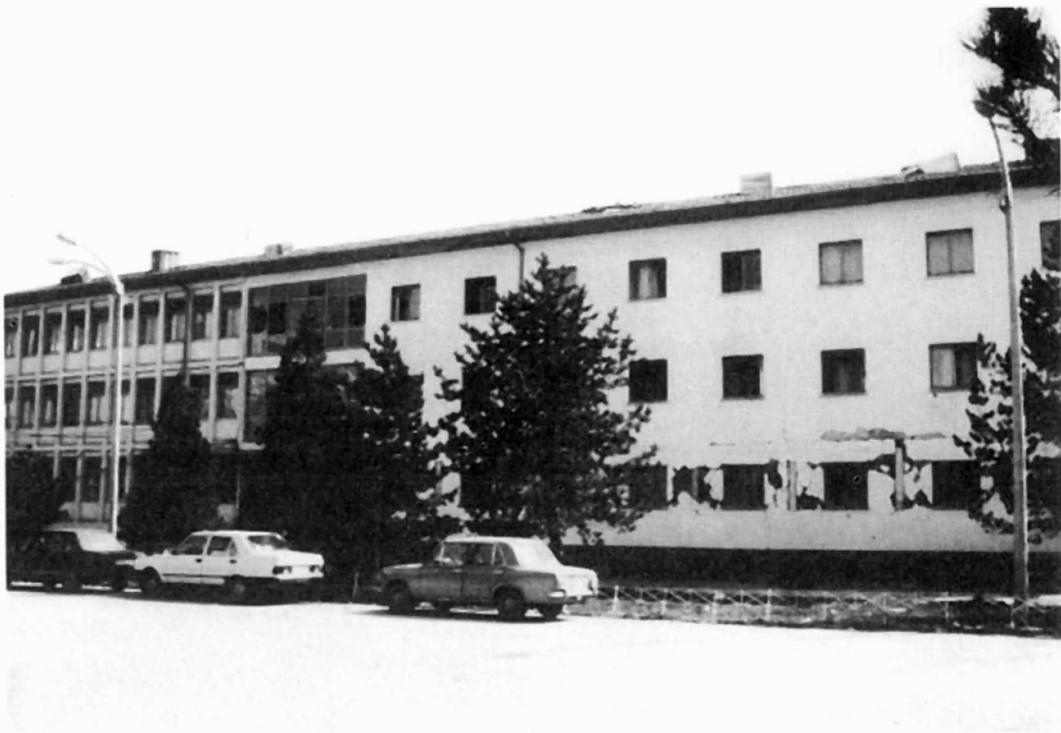
Plate 5.3
Operations clinic, state hospital, southern façade. *Location 14.*

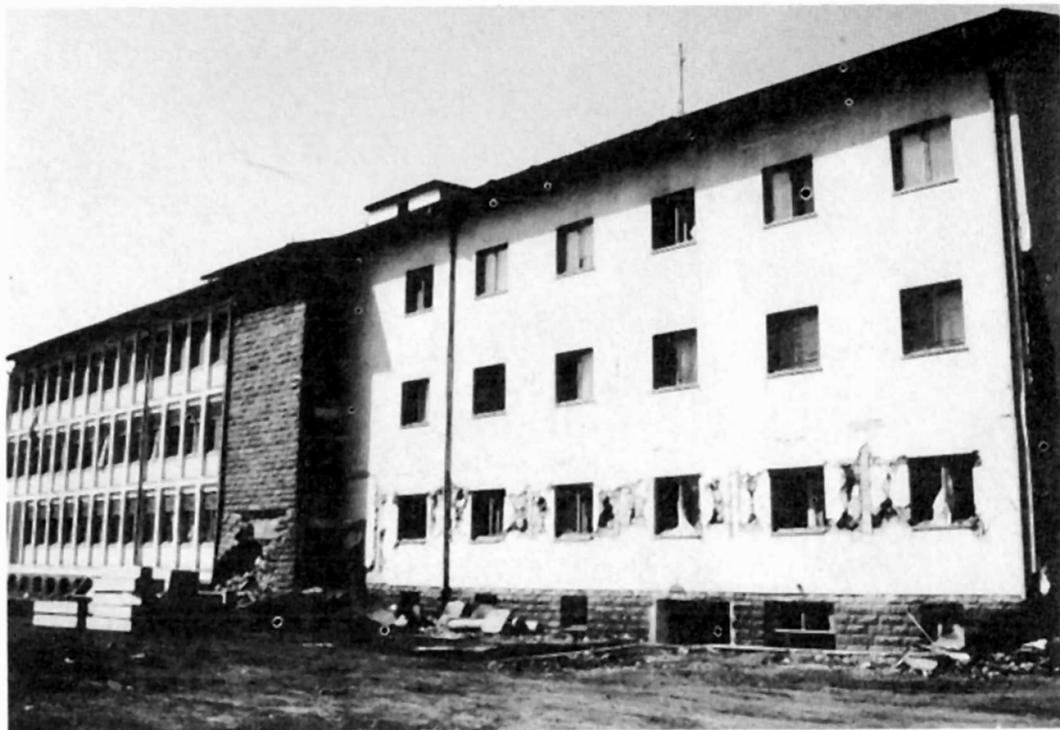
Plate 5.4
Operations clinic, state hospital, northern façade. Notice the identical location of damage to the infill walls at ground floor level. *Location 14.*

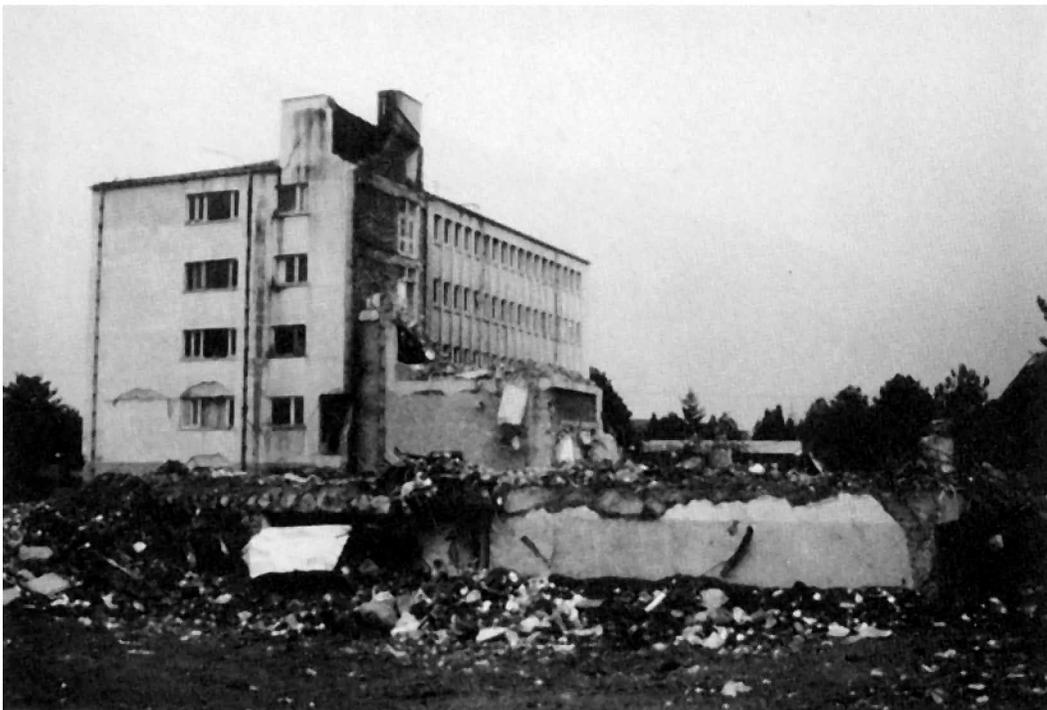
Plate 5.6

The insurance hospital after the earthquake and debris clearance, looking eastwards. *Location 15.*

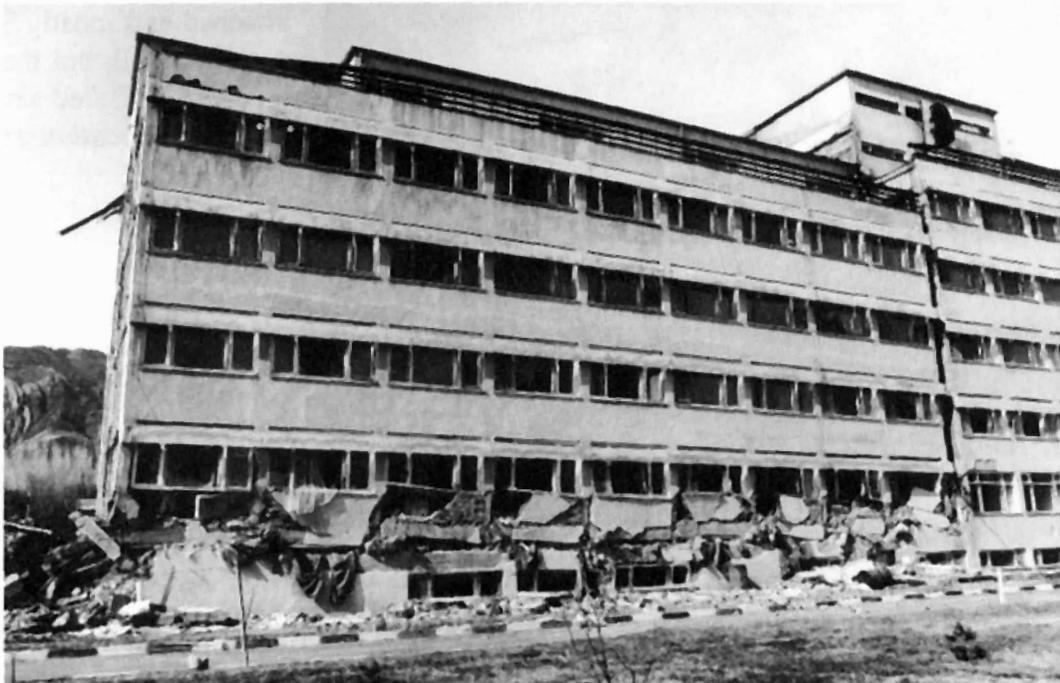
Plate 5.8

Western half of the military hospital after the earthquake. The end section has collapsed completely while the remainder has lost its first floor. The eastern half was severely damaged but remained standing.

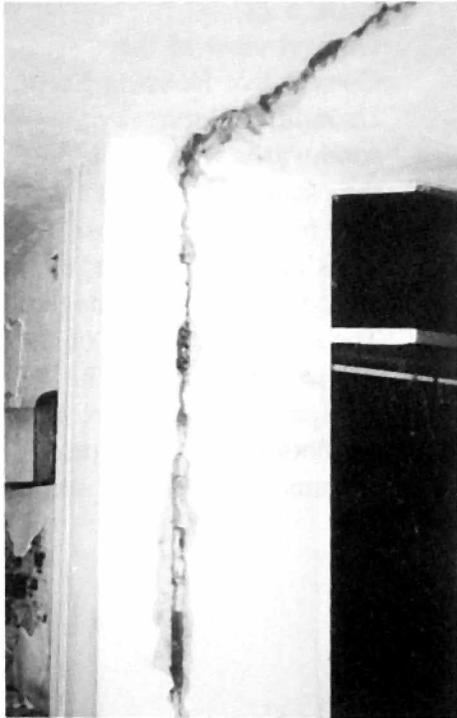
▲ **Plate 5.18**
City centre. Opening of movement joint. *Location 17.*

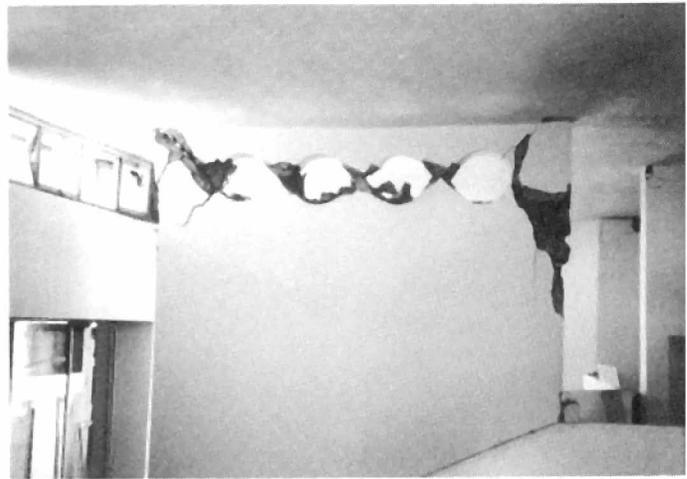
▲ **Plate 5.19**
City centre. Failure induced by openings in reinforced concrete wall. *Location 17.*

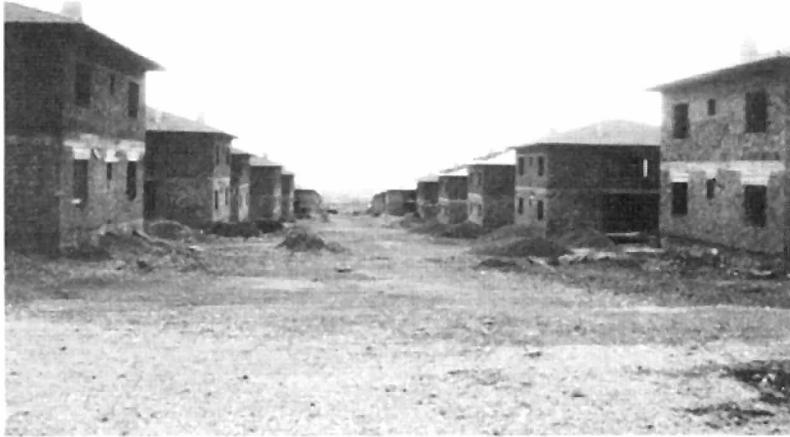
Plate 5.22

General view of the Cooperative Housing Estate, Uzumlu, looking southwards from the top of the estate. Notice that the first few houses, whose roofs are already finished, are completely undamaged. The significant slope of the site is also visible. The collapsed buildings are at the bottom of the estate, presumably in deeper soil.

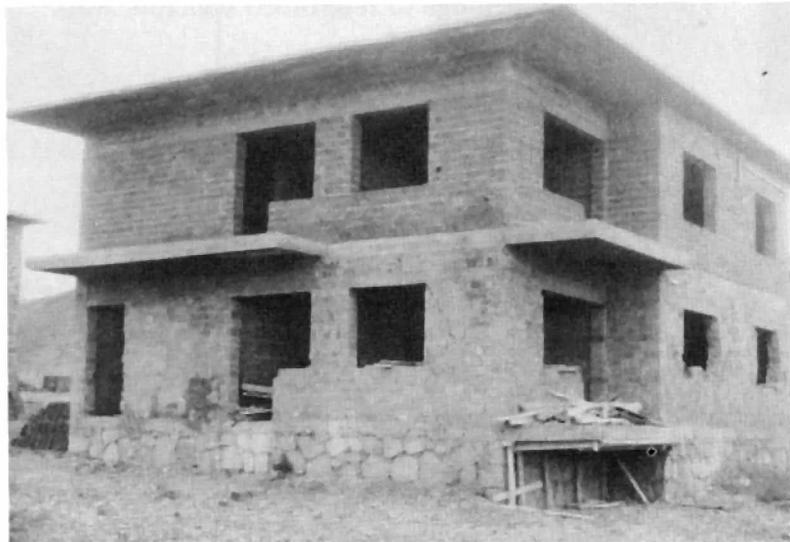
Plate 5.23

Cooperative Housing Estate, Uzumlu. View of house no. 12, one of the first to exhibit slight damage in the form of diagonal shear cracks at the right hand corner of the ground floor.

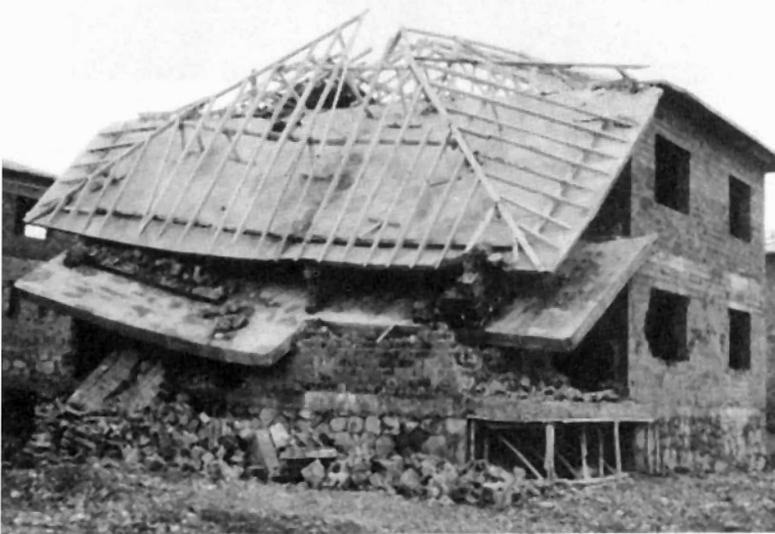
Plate 5.26

Cooperative Housing Estate,
Uzumlu. House no. 14.
Collapse of both floors
(only in the western part).

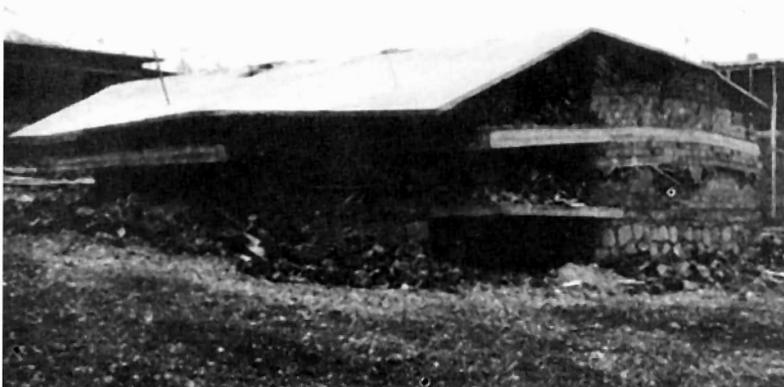
Plate 5.27

Cooperative Housing Estate,
Uzumlu. House no. 20.
Complete collapse of both
floors in all parts of the
building.

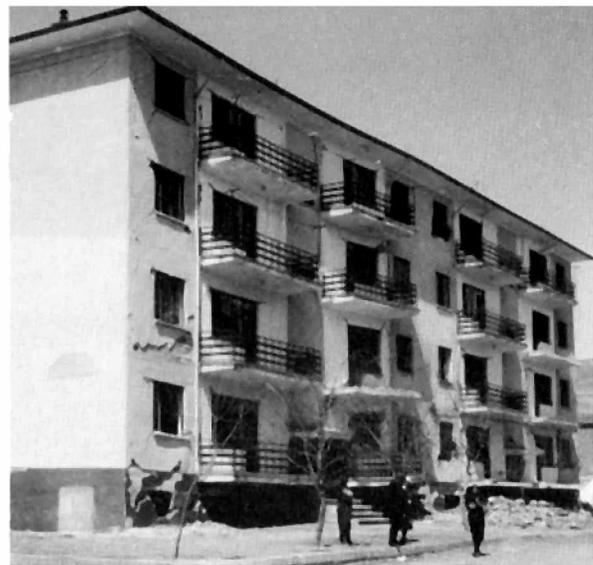
Plate 5.30

Recent apartment block in housing estate of Plate 5.28. *Location 18.*

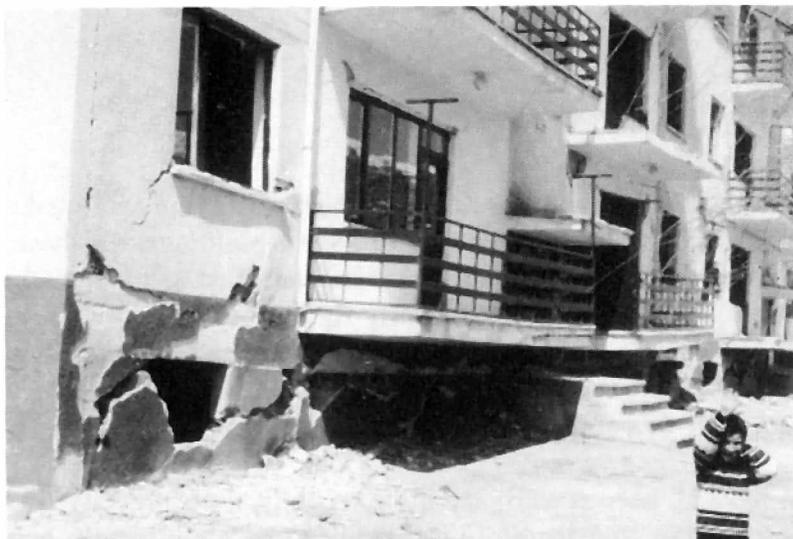
Plate 5.31
Weak storey failure in
recent apartment block.
Location 18.

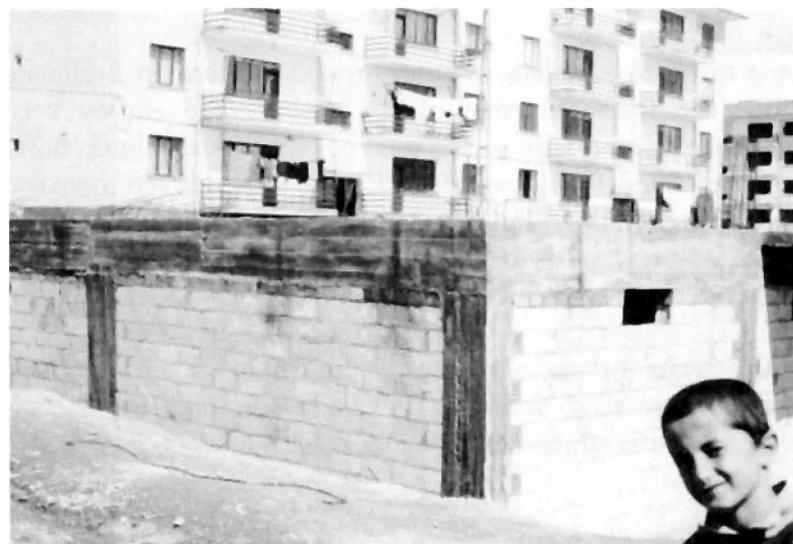
Plate 5.33
Concrete block infill at
semi-basement level in
apartment under
construction. *Location 18.*

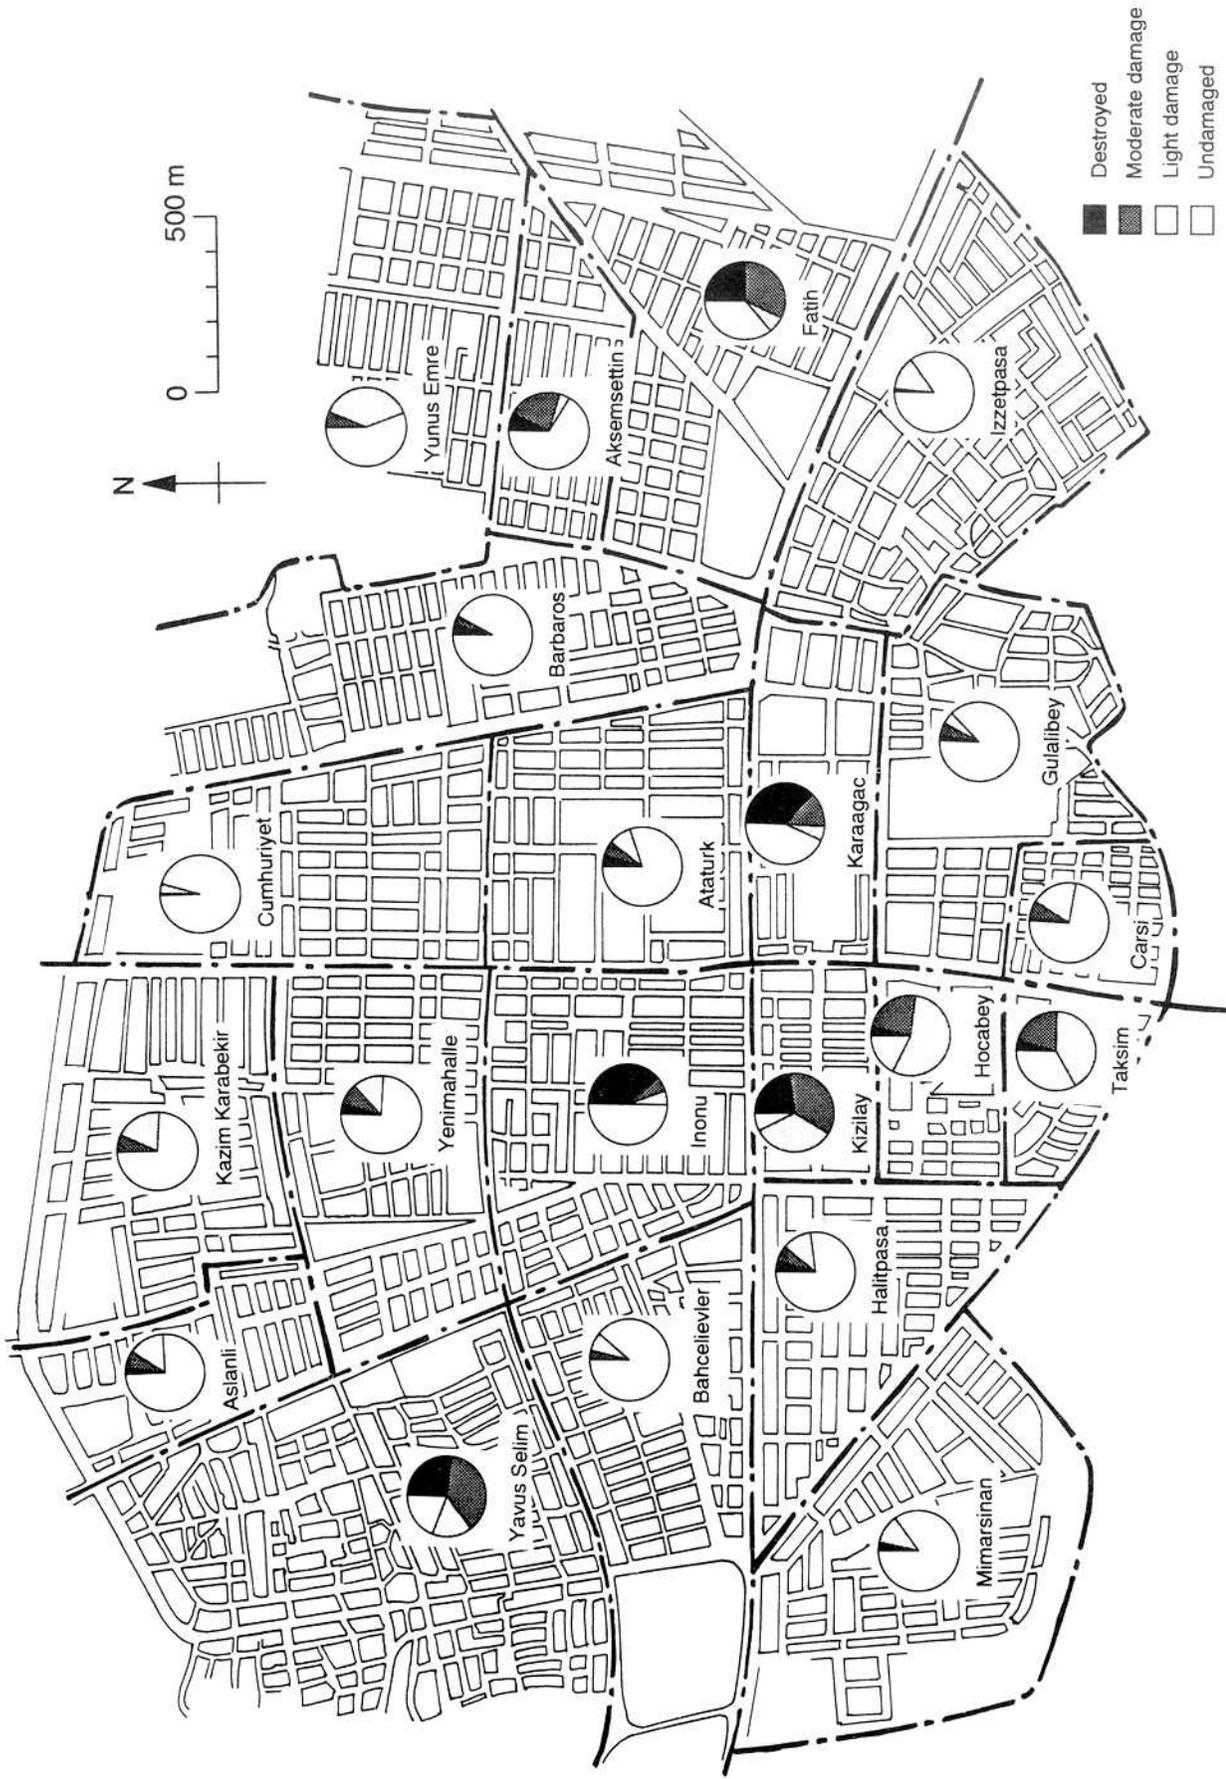
Figure 6.1 shows the distribution of building damage by district (data provided by the Turkish Directorate of Disaster Affairs). The three central districts of Karaagaç, Kızılay and İnönü, where many of the major mid-rise office and hotel buildings are located, all suffered very high levels of damage, with around half of their buildings moderately damaged or collapsed. High levels of damage are also apparent in the outlying districts of Yavus Selim, on the north-west of the city, and Fatih to the east. Both of these districts contain a large number of newly constructed, multi-storey housing complexes, built in response to the recent population boom in the city. On the whole, districts containing predominantly low-rise buildings suffered much less severe damage.

Figure 6.1 Distribution of building damage in Erzincan by district, all construction types
(data provided by Ministry of Public Works and Resettlement)

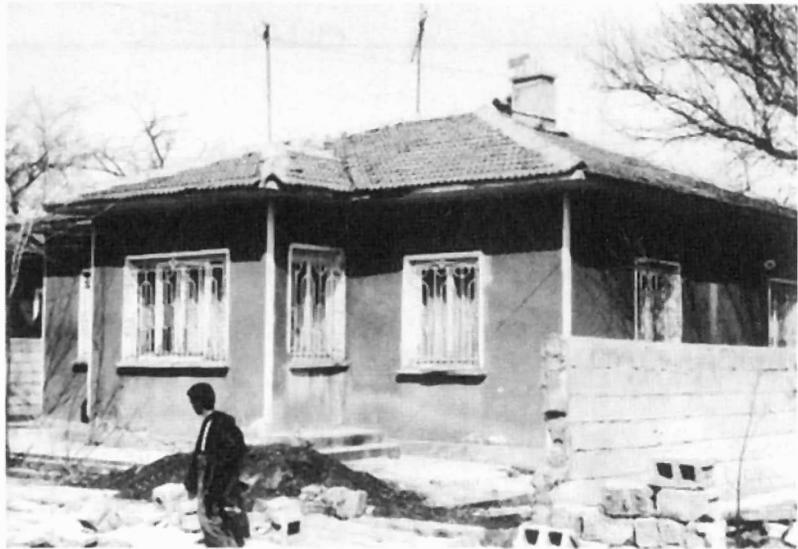
Plate 6.1

- *Timber Frame:* There were 39 single-storey buildings made of timber frame covered by diagonal timber laths (sheathing) with a vapour barrier, a 2mm mesh and 5mm render. These usually rested on reinforced concrete foundations and had a concrete walled semi-basement for storage. These houses were built during the reconstruction after the 1939 earthquake (Plate 6.1).

Damage survey around meteorology station. Typical timber frame house, the main building type during the post-1939 reconstruction. They suffered little damage.

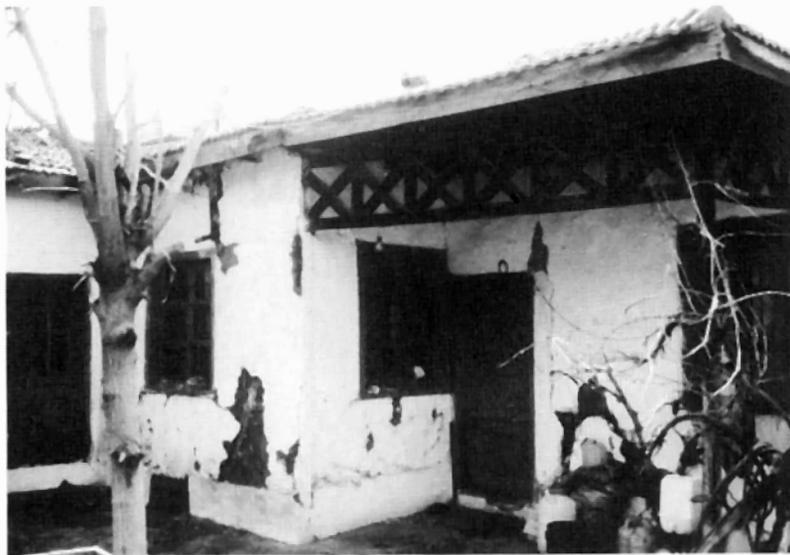
Plate 6.2

- *Himis:* There were 35 one-storeyed timbered buildings, having infill mostly of adobe bricks covered with plaster, without a semi-basement (Plate 6.2).

Damage survey around meteorology station. Himis timbered houses with adobe infill are one of the most common traditional Turkish building types in rural areas, but their number is gradually decreasing due to scarcity of timber material. These houses performed reasonably in the earthquake.
